# Due Diligence Assessment

Produced for Bald Head Island Transportation Authority

March 5, 2019

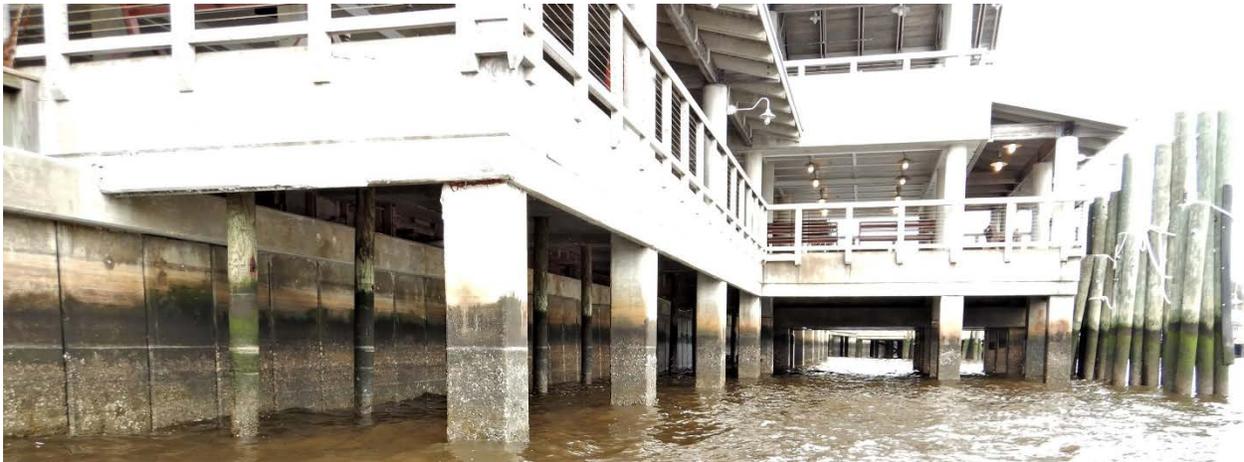
**FIGURE 2-2: DPM A-GATE PASSENGER LANDING (LOOKING NORTH)**

End view of concrete support piles, timber fender piles (right), and adjacent concrete bulkhead (left)

Seven of the 24 concrete support piles have been retrofitted with fiberglass and epoxy jackets, reportedly following original construction (pile driving). These were found to be good condition with no signs of deterioration or damage. A series of timber piles along the bulkhead wall were installed to support construction loads and are no longer serving any function. The mudline along the bulkhead wall has been fortified at the south end with cut off sections of concrete pile laid sideways and rip rap stone at the north end between Bent 1 and Bent 5. See the marine pile plan layout (FIG-A1) in Appendix A for more detail.

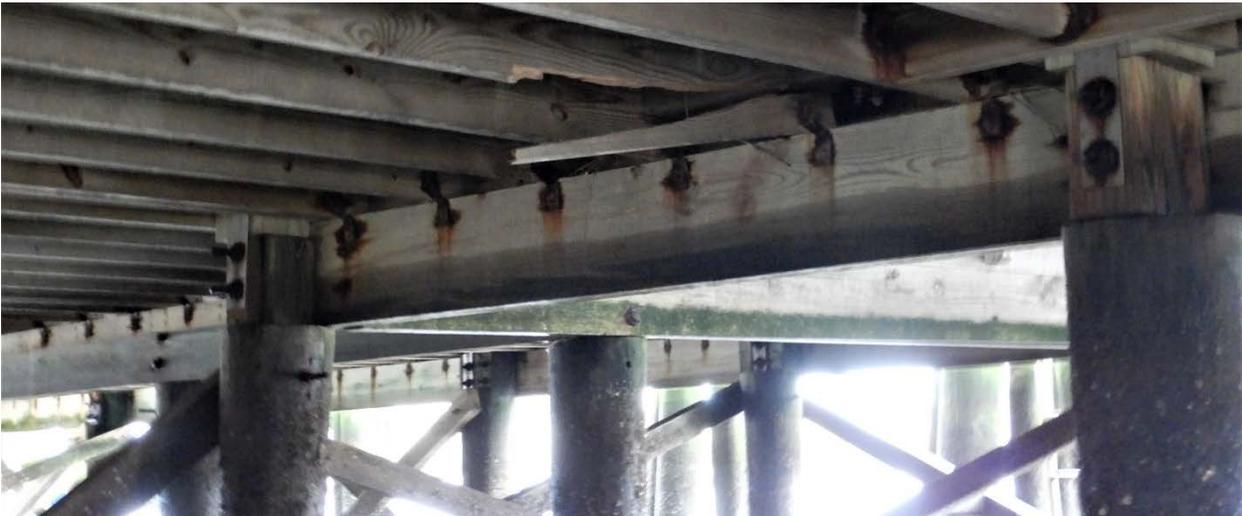
FIGURE 2-4: DPM B-GATE CONTRACTOR LANDING UNDER DECK FRAMING

The B-Gate Contractor Landing is constructed of timber piles and framing with aluminium gangways and a series of timber pile dolphins along the berthing face. The structure was found to be in satisfactory overall condition with minor decay found on the timber piles and framing—typical for timber structures of this age in the marine environment. There are split/ broken timber joists in two locations and steel tie straps between the under-deck joists and the timber stringers below are severely corroded throughout the structure and should be replaced.

Note the corroded tie straps at each joist and broken joist at one location

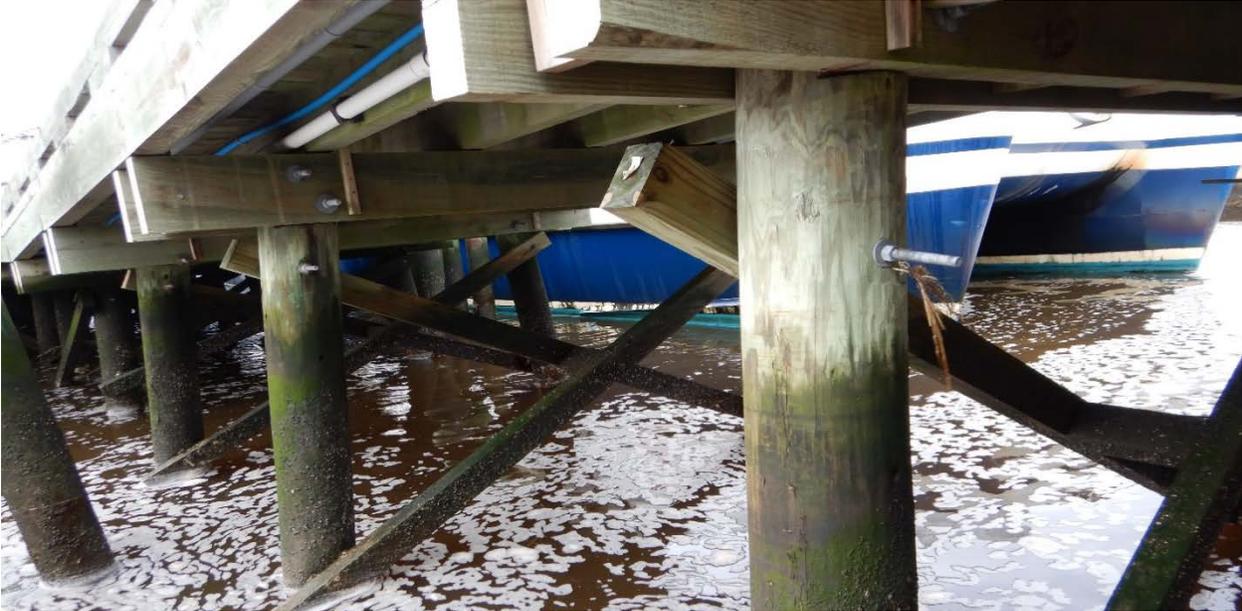
FIGURE 2-6: DPM MAINTENANCE FIXED PIER TIMBER PILE BENTS

The maintenance fixed pier is constructed of timber pile bents and timber deck rated for a nominal 250 psf. Timber pile dolphins on either side of the pier are used to berth and moor vessels. The structure is in good overall condition with minor defects including open bolt holes and a split cross-brace board in one location. These can be addressed with routine maintenance efforts in order to preserve the structural capacity of the dock.

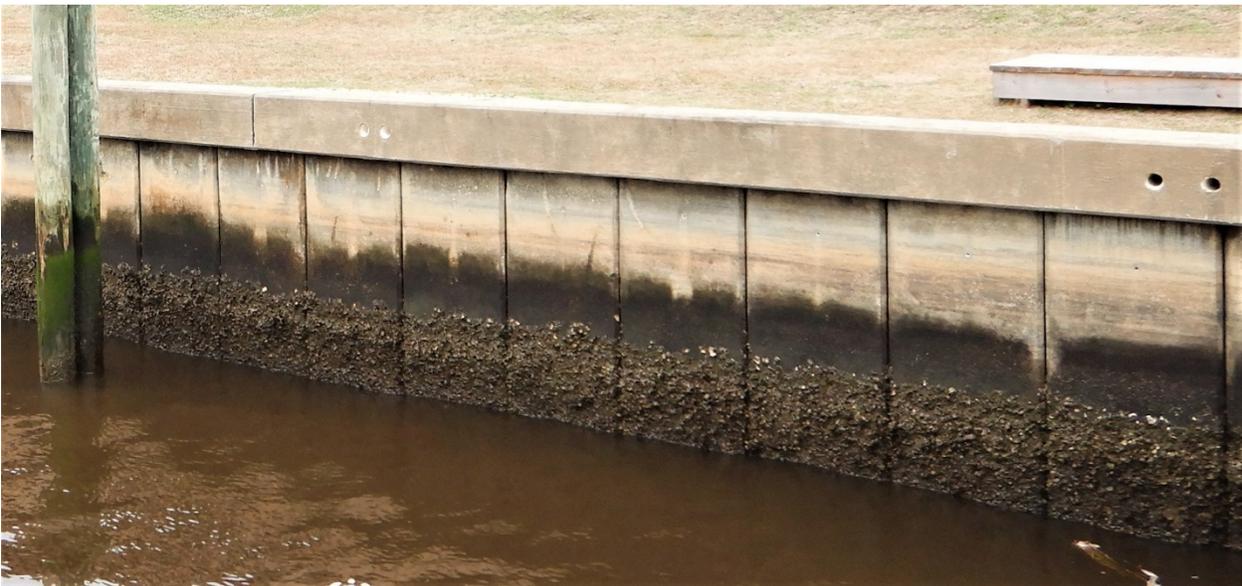
FIGURE 2-12: TYPICAL BULKHEAD WALL ELEVATION AT LOW TIDE

The DPM bulkhead wall is constructed of concrete sheet pile panels which interlock with a tongue-and-groove type fit and a reinforced concrete cap along the top of the wall, typically level with the adjacent sand fill/lawn. Inspection of the above water portion of the wall was performed during low tide. With the exception of the section adjacent to the barge ramp (see next section). The bulkhead is in overall good condition with isolated/localized spalls and cracks.

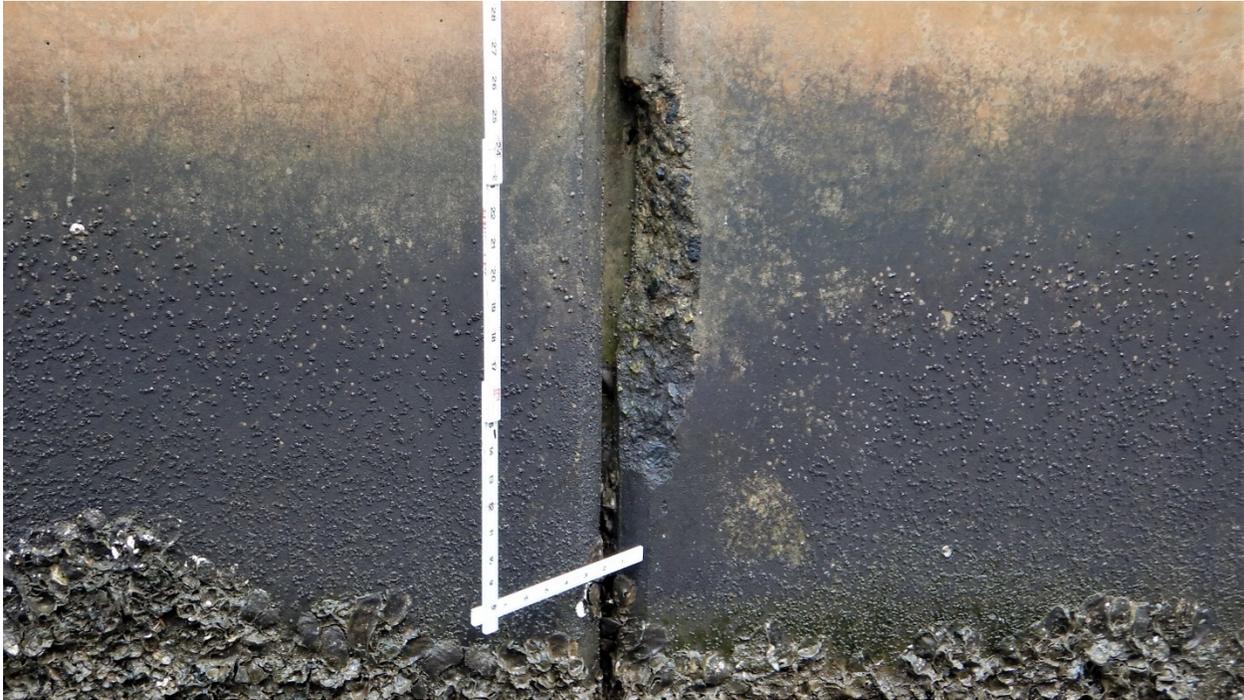
**FIGURE 2-13: TYPICAL CONCRETE SHEET PILE SPALL**

The spalls and cracking in the sheets are typically along the groove side of the tongue-and-groove interlock, exposing the tongue from the adjacent sheet but not creating open voids. Areas behind the wall have loss of fill or “sinkholes” which are typical for this type of construction. Locations with minor fill loss and sinkholes can be addressed by regular maintenance with replacement sand/stone fill material when needed.

Note tongue-and-groove fit between the sheets, visible inside the spall

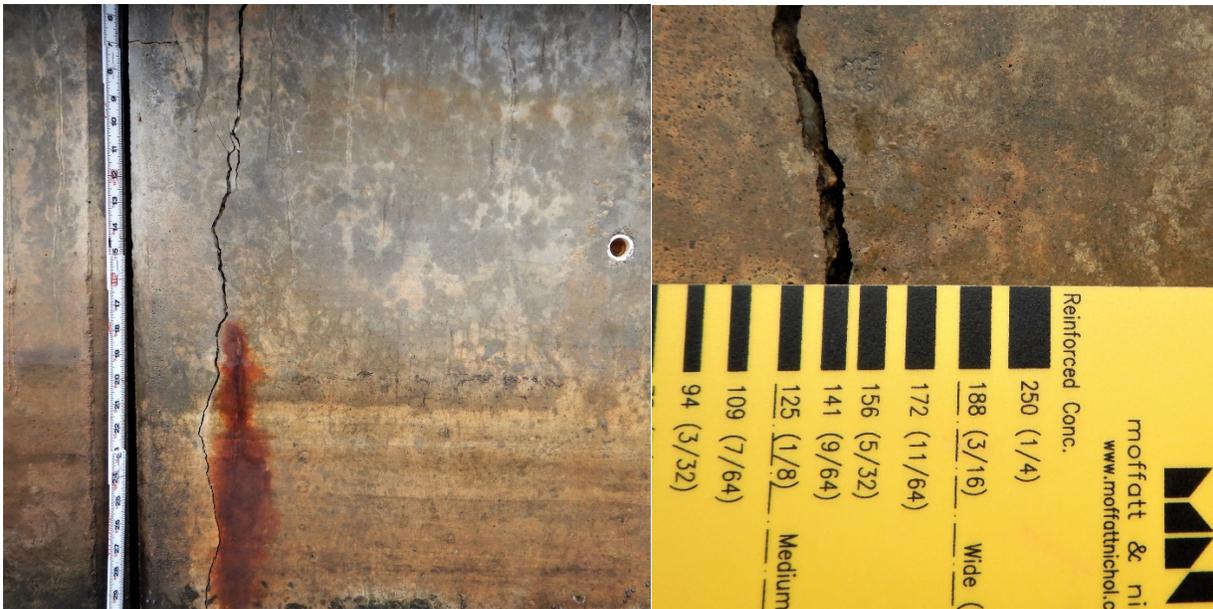
**FIGURE 2-14: CONCRETE SHEET PILE CRACKING**

Overall and close up view shown of medium-width “worst case” cracking observed in the bulkhead wall at intermittent locations

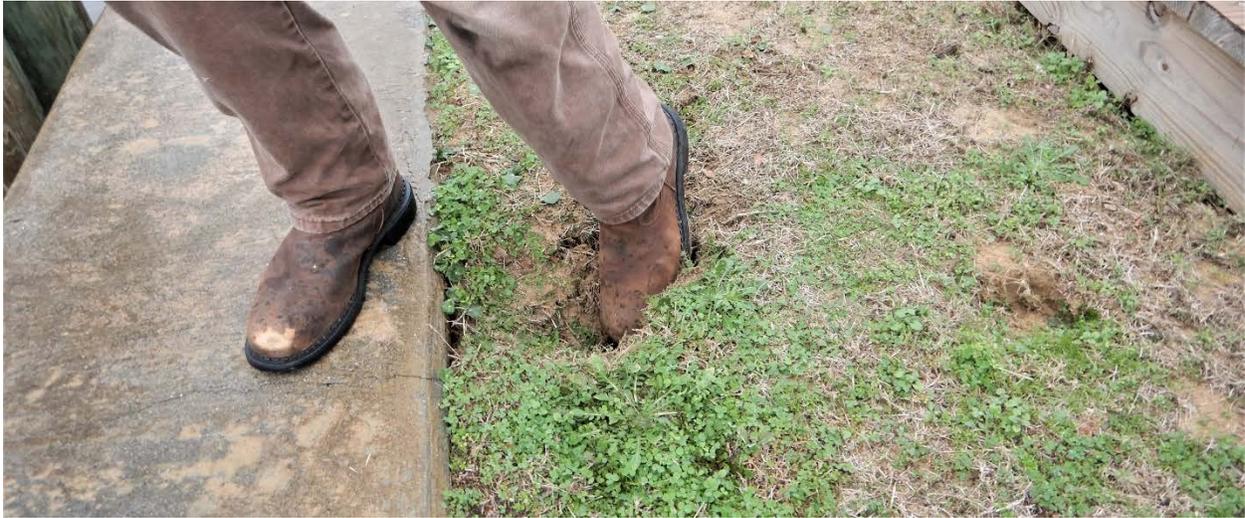
**FIGURE 2-15: TYPICAL SINKHOLES BEHIND WALL**

Numerous sinkholes were evident behind the concrete sheet pile bulkhead wall along the DPM shoreline which have been filled with sand; these are typical of this type of construction and will likely continue to require ongoing maintenance. Repair with engineered fill including varying types/sizes of fill material (stone, etc.) or more substantial grout fill may stop the sinkholes from recurring in these areas.

Sinkholes in sand fill behind interlocking concrete sheet pile construction of this type is typically caused by migration of the sand backfill through the joint. This may be mitigated by varying the size and gradation of repair materials, i.e. backfilling with larger size gravel or stone. More robust repairs including the installation of filter fabric and/or the use of grout or flowable fill could be considered in the future if sinkholes become larger or more prevalent. Fill loss should be monitored during routine inspections to determine if more substantial repair methods are recommended.

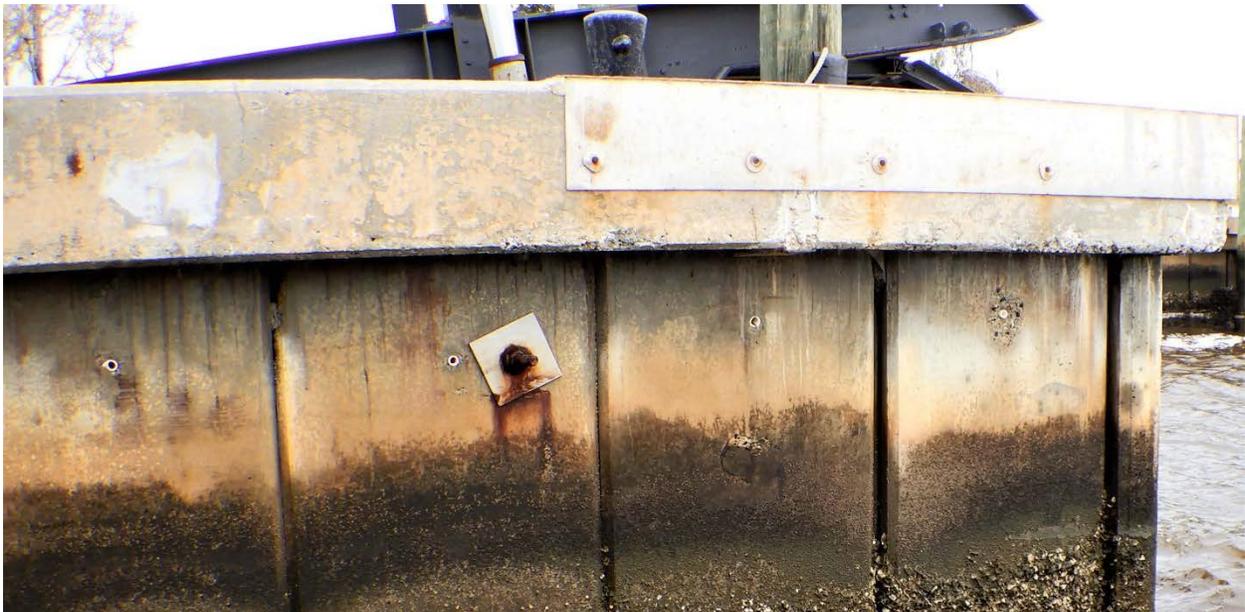
**FIGURE 2-16: BULKHEAD REPAIR SECTION ELEVATION VIEW (LOOKING NORTH)**

An area of the bulkhead wall along the inlet channel and adjacent to the barge ramp has previously been repaired after developing a “tension crack” and displacement of the concrete sheet pile, likely due to the forces imposed by the tug and barge.

Photo taken from inlet channel showing affected concrete panels, steel tie rod with square plate washer, and steel repair plate on the concrete cap

A permanent repair should be planned for the next major Capital Expenditure (CAPEX) cycle and should be designed to address the berthing/mooring forces imposed by the tug and barge at the adjacent DPM Barge Ramp.

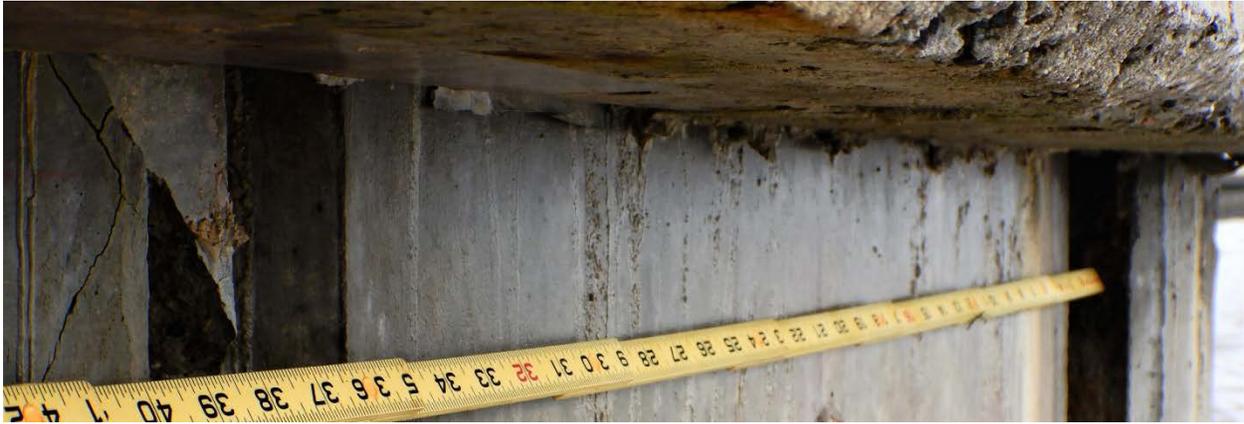
FIGURE 2-17: DISPLACED CONCRETE SHEET PILES AT BULKHEAD REPAIR SECTION

The bulkhead repair section was inspected above and below water and found to be in satisfactory condition. The sheets were found to be intact with no voids or signs of recent movement.

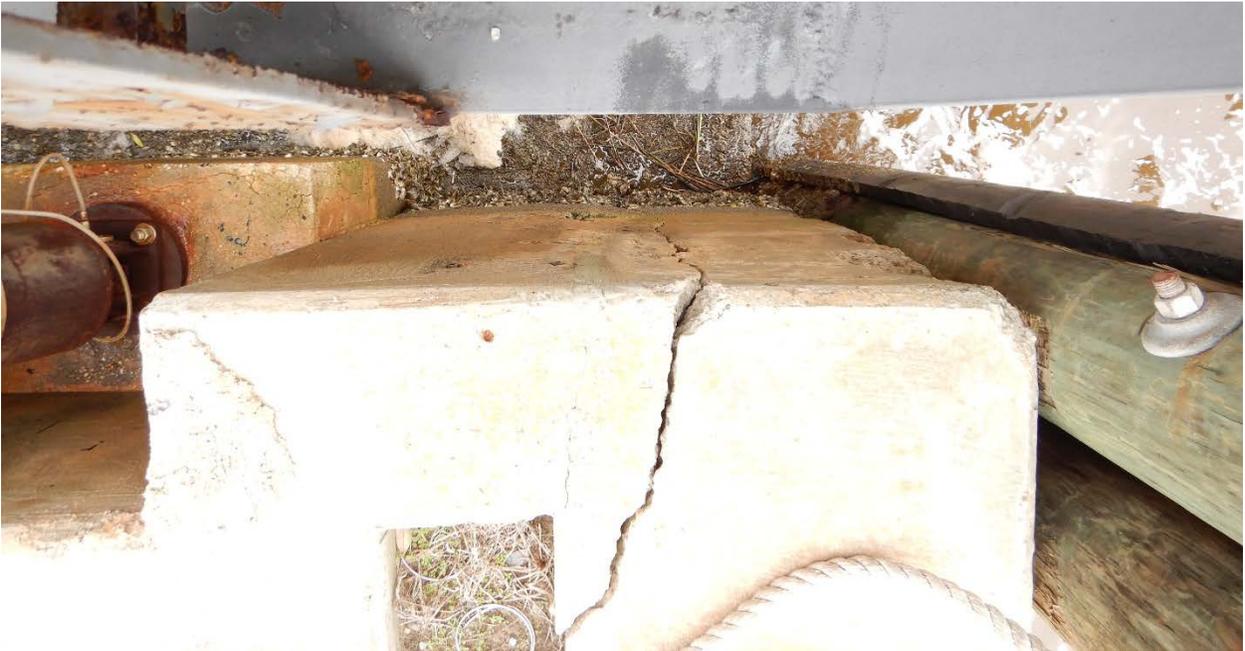
FIGURE 2-19: DPM BARGE RAMP TENSION CRACK IN CONCRETE SUBSTRUCTURE

The DPM barge ramp concrete substructure and adjacent sheet pile bulkhead repair area are in satisfactory condition but may require retrofit/replacement within the 10-year planning horizon or beyond. A tension crack has developed in the ramp substructure and the adjacent section of bulkhead wall has previously displaced and been repaired. The crack damage appears to be caused by the berthing/mooring forces imposed by the tug-barge. This area should be monitored for signs of worsening and the forces evaluated in greater detail for

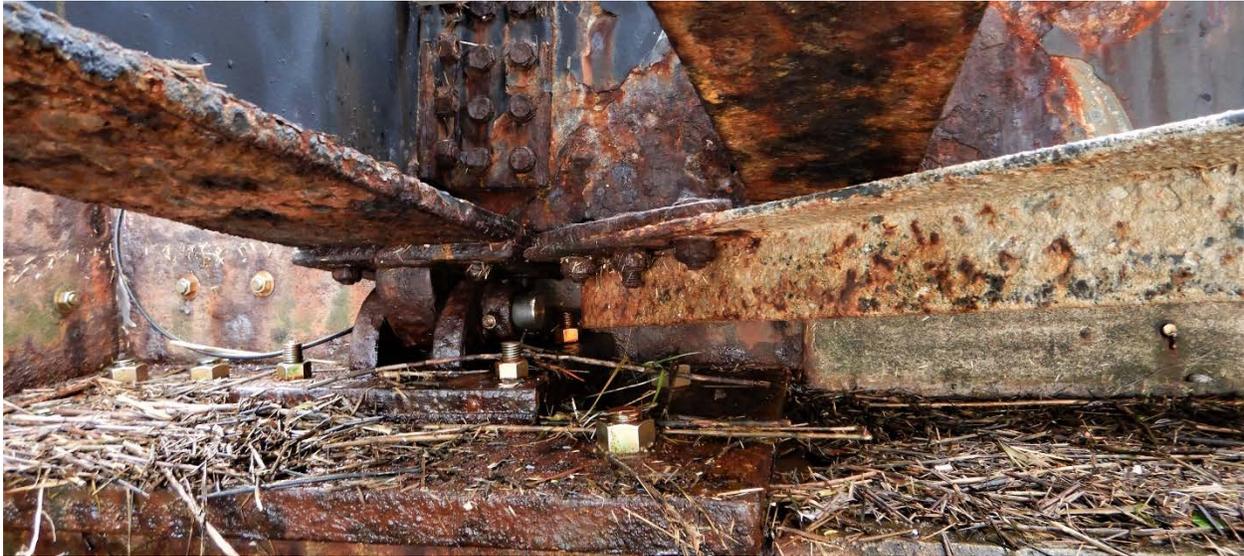
**FIGURE 2-21: BHI BARGE RAMP STEEL FRAMING MODERATE CORROSION**

The steel barge ramps at DPM and BHI are in satisfactory condition however may require refurbishment/replacement within the 10-year planning horizon due to corrosion of framing elements. In order to minimize disruption to barge operations, replacement is preferable and fabricating at least one new ramp would allow the shortest time for removal and installation. It may be cost effective to refurbish one of the existing ramps after it has been replaced (instead of fabricating a second replacement) and then return it to service in place of the remaining original.

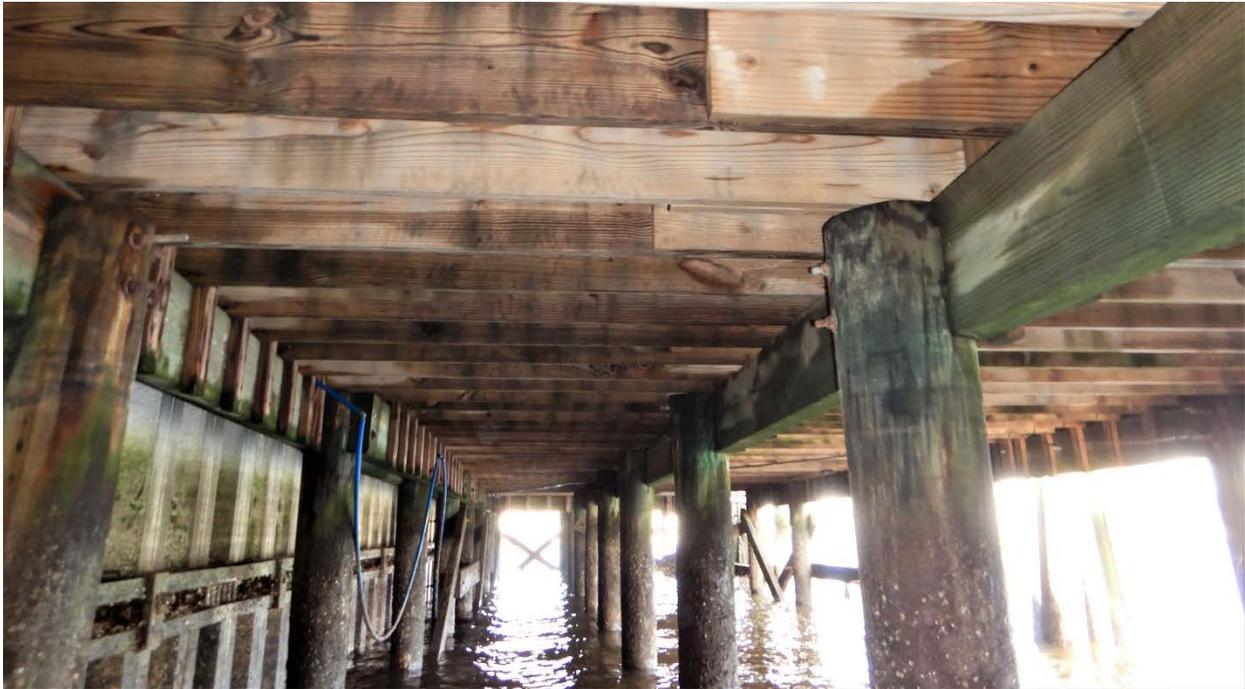
FIGURE 2-23: BHI CONTRACTOR LANDING UNDERDECK VIEW (LOOKING NORTH)

The BHI Contractor landing is a timber structure fully supported by timber piles; the deck cantilevers over the bulkhead wall along the shoreline but does not bear on it. A series of timber pile dolphins along the berthing face provides fendering and moorings for vessels. Above and below water inspection found the structure to be in good overall condition with minor defects on the timber piles, typical of timber structures in a marine environment. These include internal and external decay (10% section loss or less), open bolt holes, and other surface defects such as abrasions, checks, and shakes.

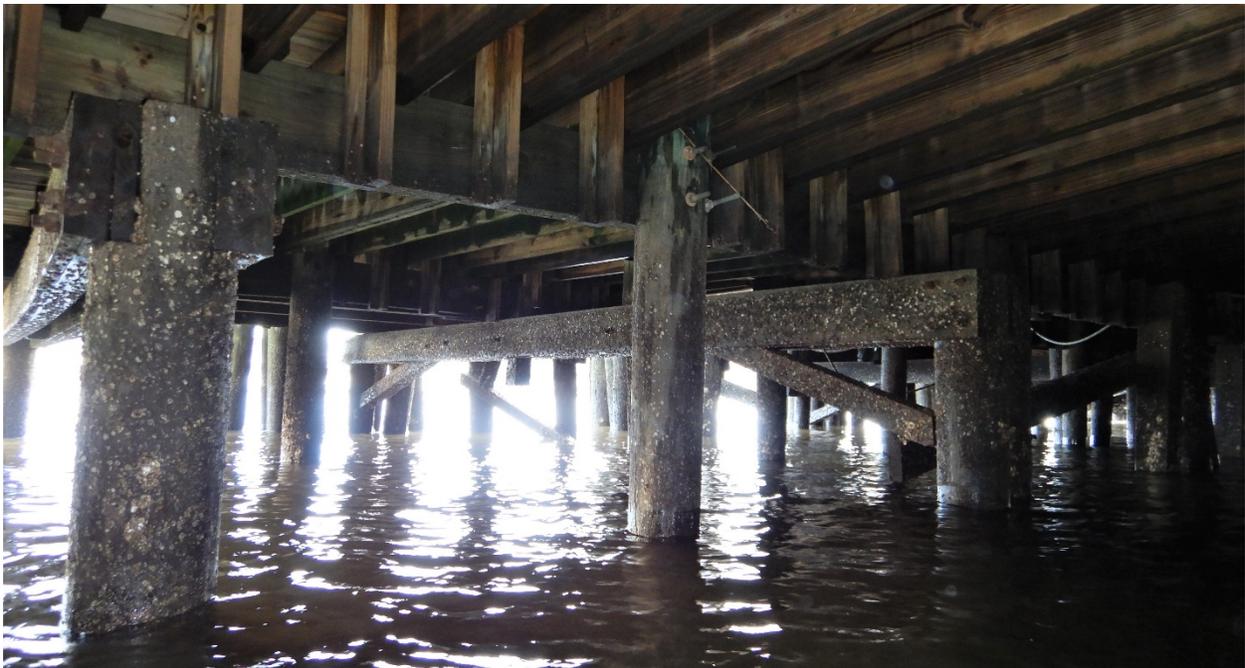
FIGURE 2-25: BHI PASSENGER LANDING UNDERDECK VIEW (LOOKING EAST)

Two long-span crutch bents are visible at left and center of the photo. Bowing of timber crutch bent cap visible to the left (others similar).

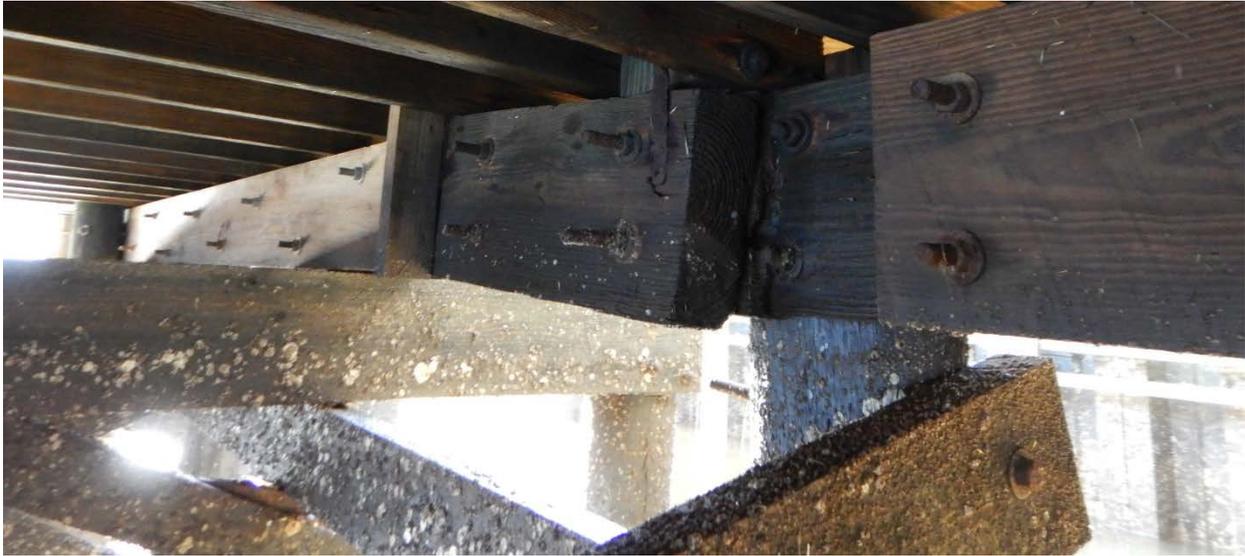
FIGURE 2-26: UNDERDECK VIEW OF TIMBER STRINGER

Stringer has been repaired with thru-bolts "sistered" boards. Note the various repairs do not form a continuous member and are out of alignment.

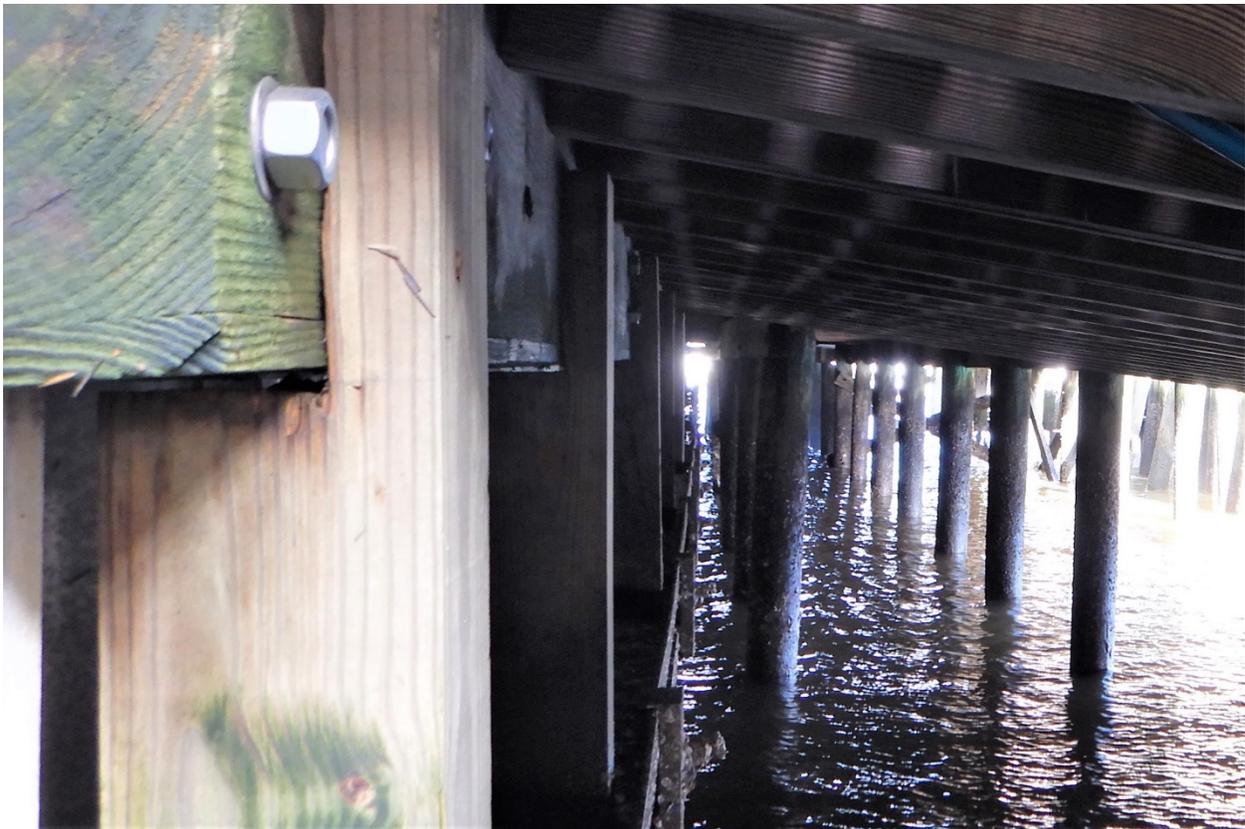
FIGURE 2-27: UNDERDECK VIEW OF CARGO RAMP

Cargo ramp at Passenger Landing is supported by the marina bulkhead wall (foreground). For comparison, the adjacent Contractor Landing is fully supported with a row of timber piles (center background).
