**NOVEMBER 20, 2021
NORTH BALD HEAD WYND
STRUCTURE FIRES
AFTER ACTION ANALYSIS**

EXECUTIVE SUMMARY

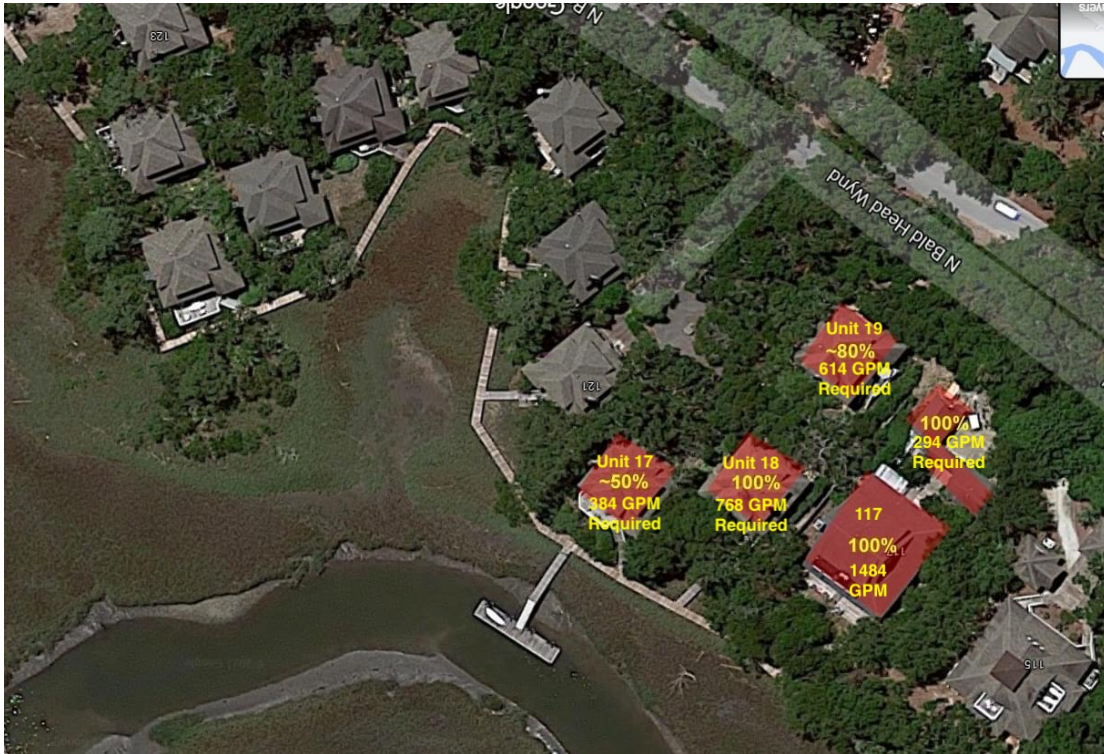
National Fire Academy (NFA) Fire Flow Calculation Method was used to determine estimated needed gallons per minute of water based on the incident commanders first reported percentage of fire involvement (percentages shown on aerial photo below).
