Phase I Environmental Site Assessment  
Bald Head Island Ferry Terminal  
Southport, Brunswick County, North Carolina  
S&ME Project No. 4305-19-004

Reference: **Phase I Environmental Site Assessment**  
**Bald Head Island Ferry Terminal**  
Southport, Brunswick County, North Carolina  
S&ME Project No. 4305-19-004

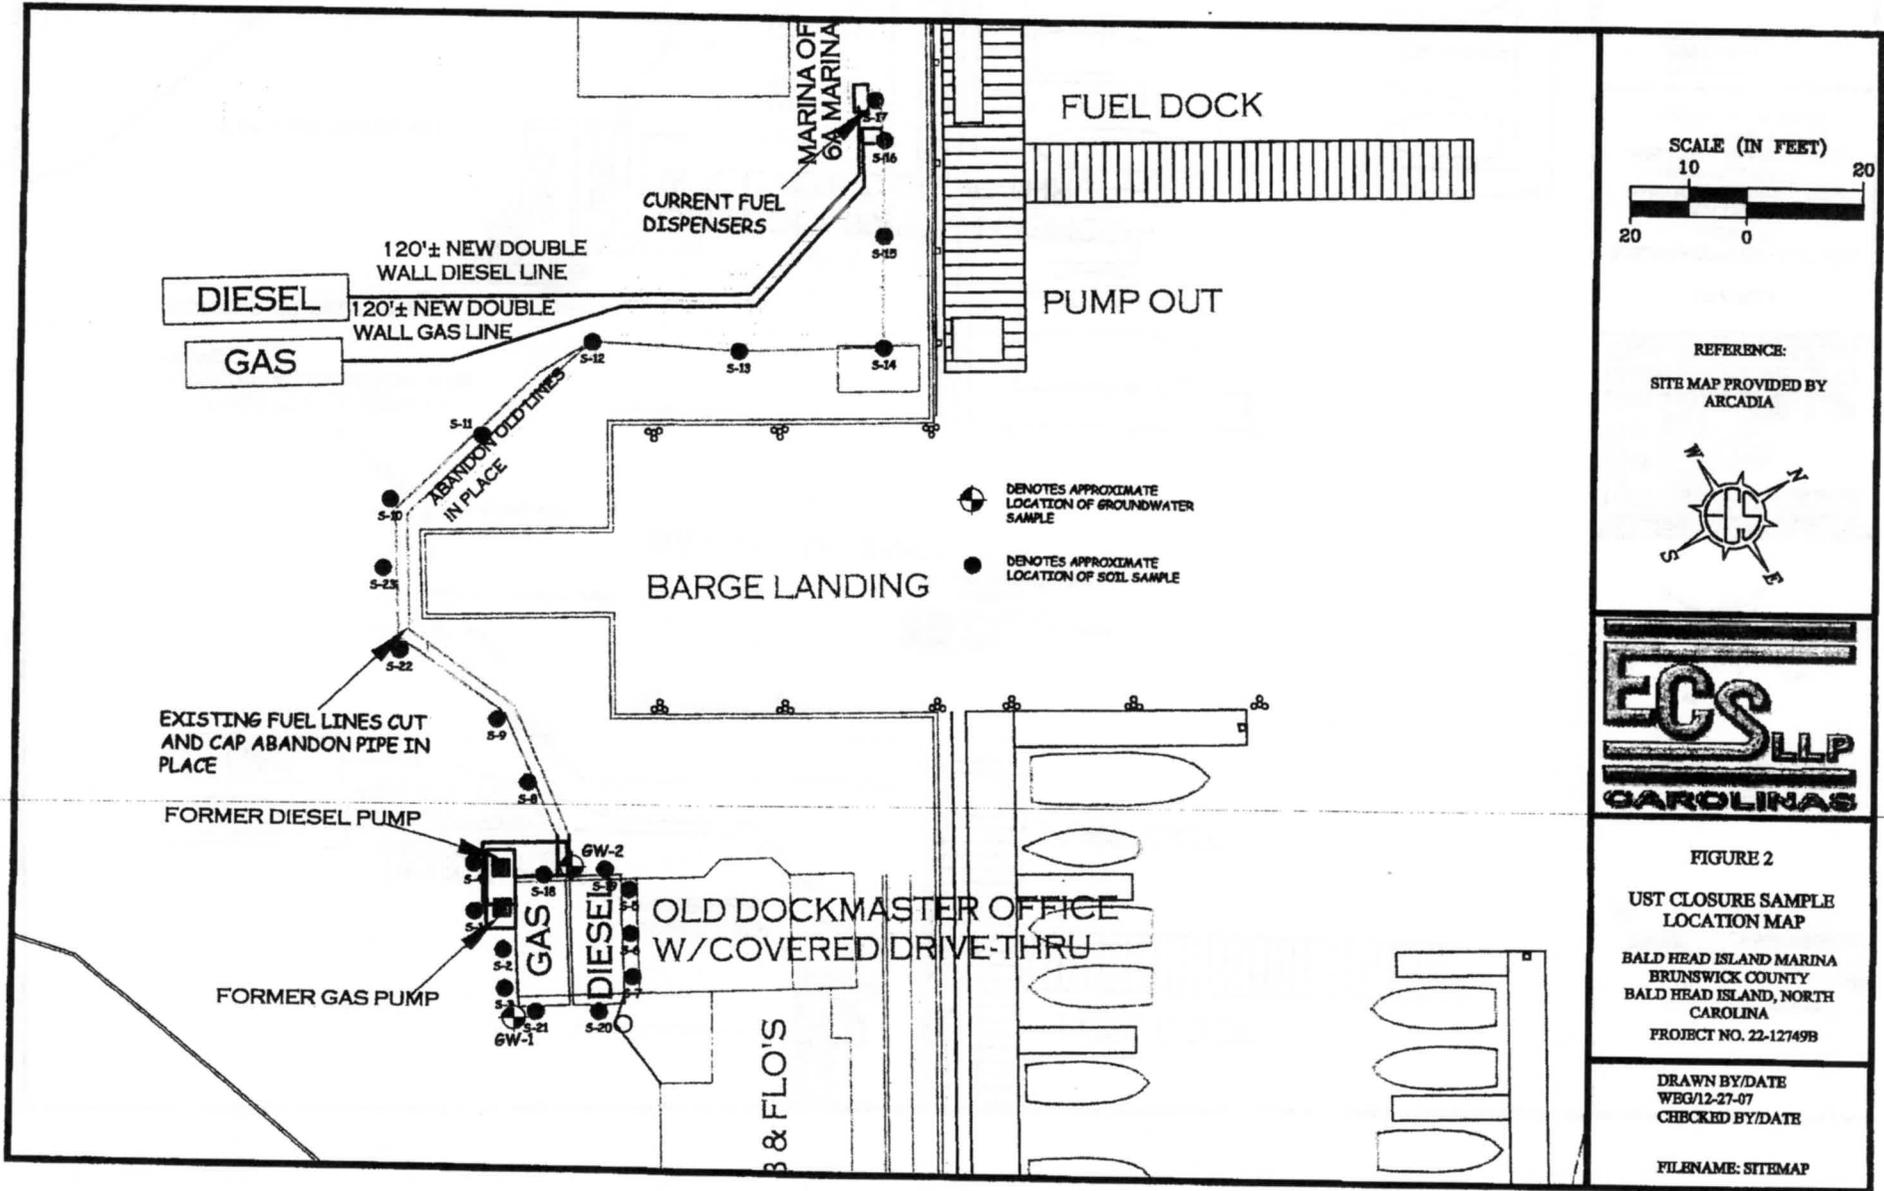
120'± NEW DOUBLE WALL DIESEL LINE  
 120'± NEW DOUBLE WALL GAS LINE

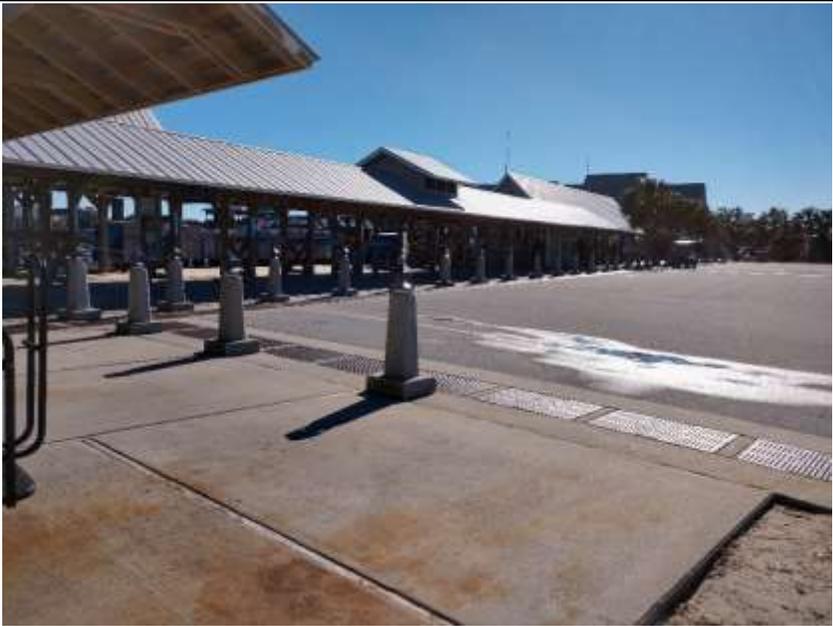
1/9/2019
			Photographer: Claudia Irvin
1	<b>Location / Orientation</b>	View looking south from the north end of subject property.	
	<b>Remarks</b>	View of Passenger Ferry terminal and waiting area.

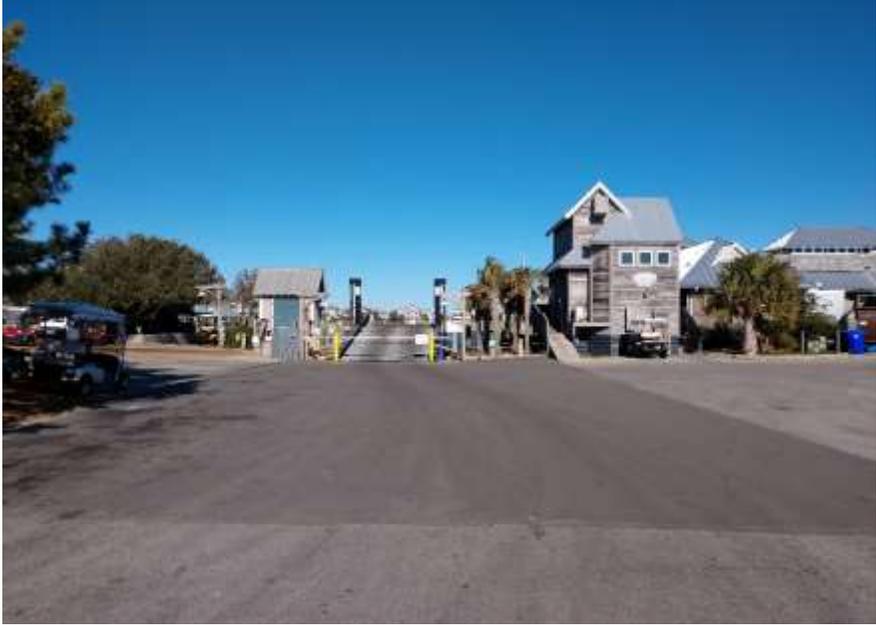
1/9/2019
			Photographer: Claudia Irvin
2	<b>Location / Orientation</b>	View looking northeast along eastern side of subject property.	
	<b>Remarks</b>	View of barge landing and hydraulic pumps building.

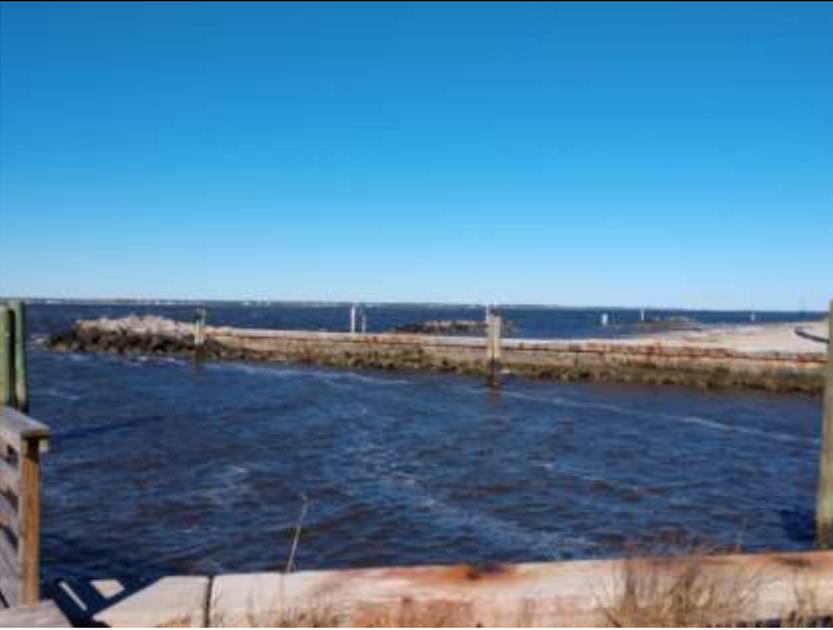
1/9/2019
			Photographer: Claudia Irvin
3	<b>Location / Orientation</b>	View looking northwest from northwestern corner of subject property.	
	<b>Remarks</b>	View of channel entrance off Cape Fear River for ferry and barges into the marina.

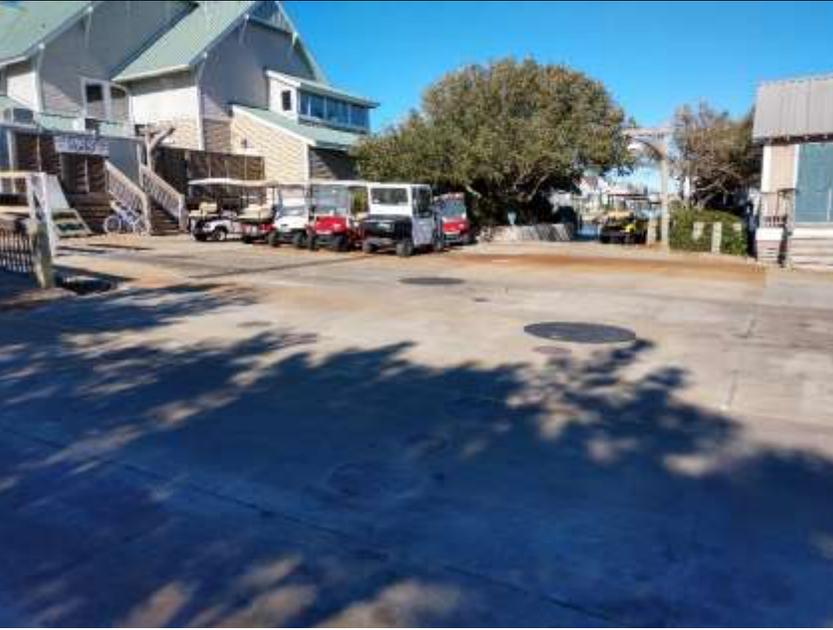
1/9/2019
			Photographer: Claudia Irvin
4	<b>Location / Orientation</b>	View looking north from barge landing area.	
	<b>Remarks</b>	Western adjacent Harbormaster building and USTs.

- Two petroleum underground storage tanks and associated lines are located on the western adjacent Harbormaster property. Although there are no reported releases, USTs systems commonly develop leaks and present a material threat of a release of petroleum product to the soil and groundwater, which could potential impact the groundwater at the subject property.

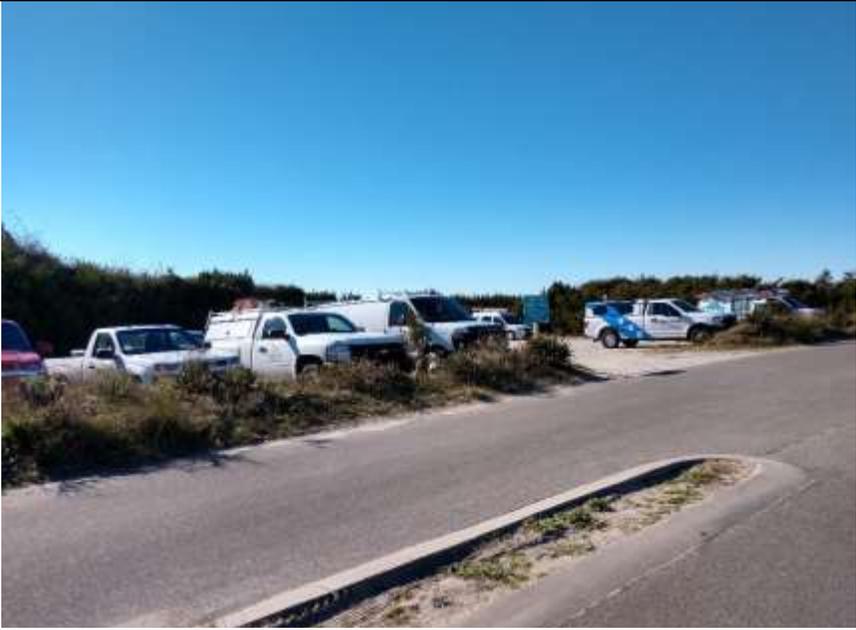
1/9/2019
			Photographer: Claudia Irvin
5	<b>Location / Orientation</b>	View looking south from southern portion of Marina Wynd Road.	
	<b>Remarks</b>	Adjacent contractors parking area.

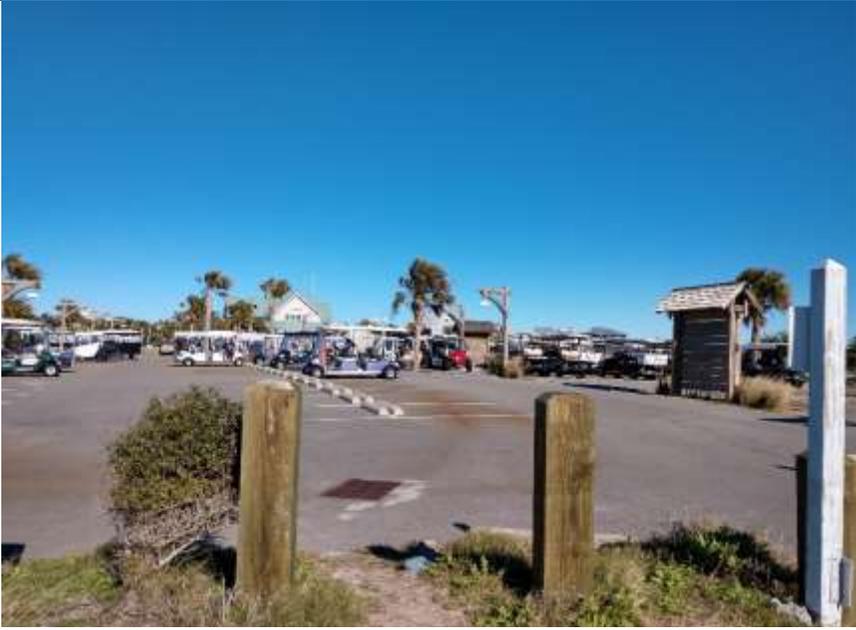
1/9/2019
			Photographer: Claudia Irvin
6	<b>Location / Orientation</b>	View looking north from southern portion of Marina Wynd Road.	
	<b>Remarks</b>	View looking at golf cart rental parking area.

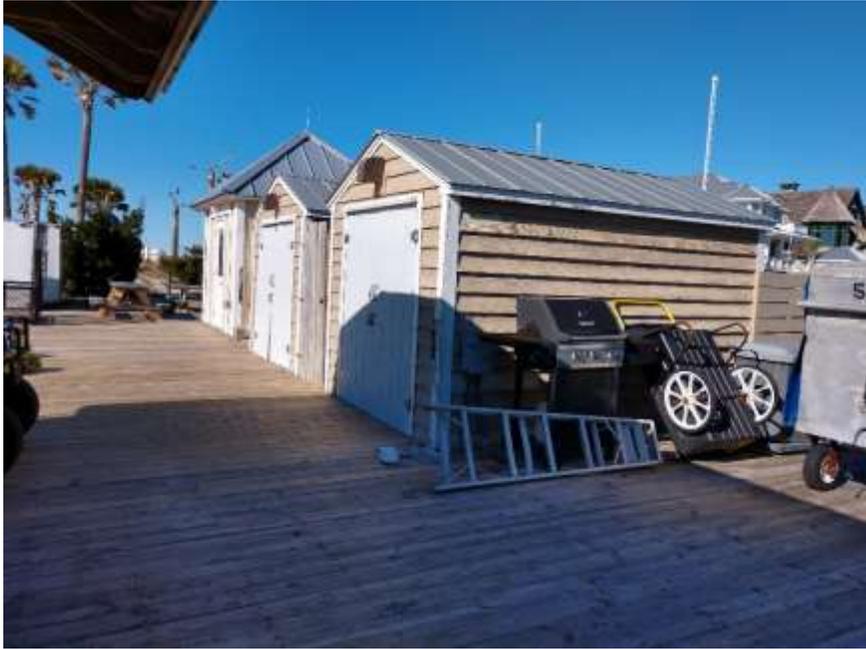
Date: 1/9/2019
		Photographer: Claudia Irvin
7	<b>Location / Orientation</b>	View looking west from ferry landing.
	<b>Remarks</b>	Three storage buildings used for a break room, a lost and found, and storage of a portable generator.

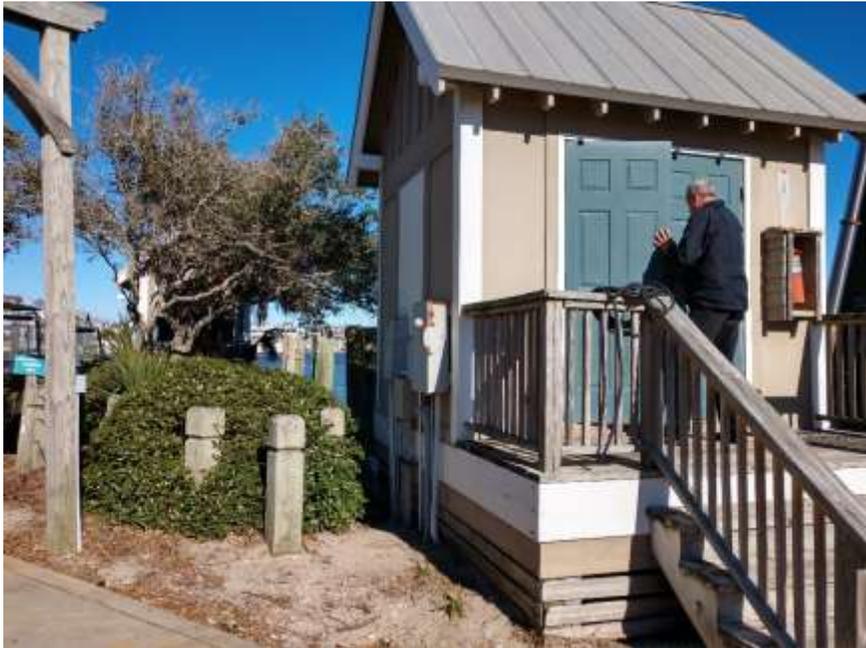
Date: 1/9/2019
		Photographer: Claudia Irvin
8	<b>Location / Orientation</b>	View looking north at barge landing.
	<b>Remarks</b>	Building housing the hydraulic pumps for the barge landing.

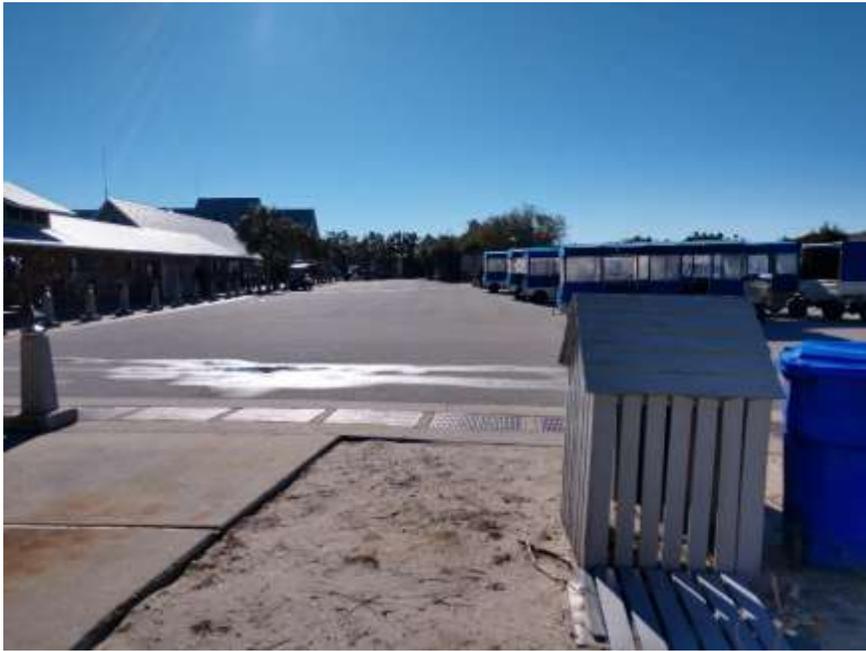
Date: 1/9/2019
		Photographer: Claudia Irvin
9	<b>Location / Orientation</b>	View looking south from the north end of the subject property.
	<b>Remarks</b>	View of tram parking area near passenger and contractor ferry terminal landing.

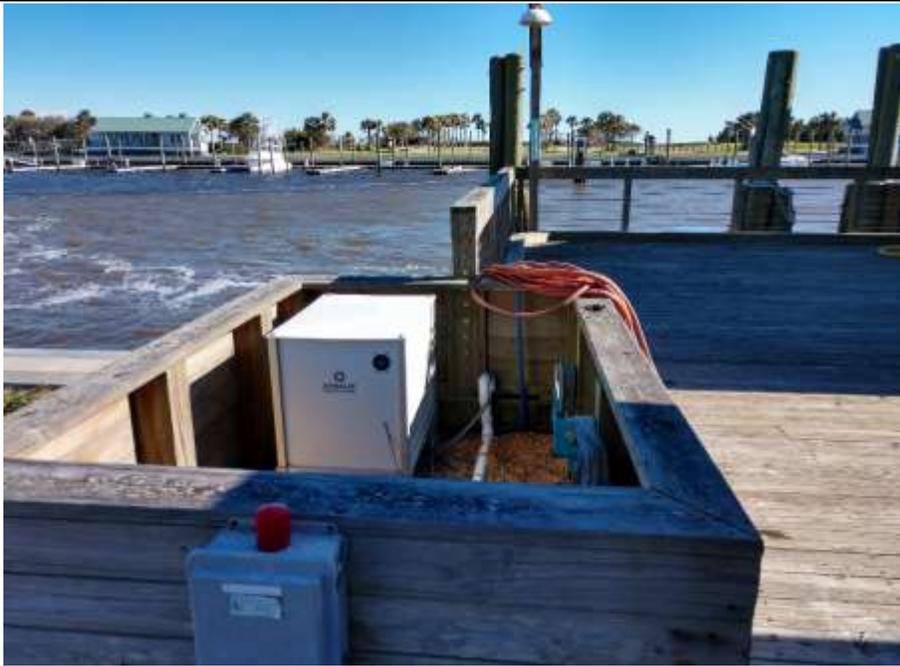
Date: 1/9/2019
		Photographer: Claudia Irvin
10	<b>Location / Orientation</b>	Looking east at ferry terminal landing.
	<b>Remarks</b>	Pump system that transfers septic from ferry to island wastewater treatment facility.

A pad mounted transformer, propane powered backup generator, propane tank, and a sewage pump station for ferry waste are present in the northeastern portion of the property. This equipment appeared to be in working condition and displayed no visible evidence of leakage or staining. Hydraulic pumps are present in the northeastern portion of the property for the barge landing operation. No evidence of petroleum spills or releases was observed around the pump building. A trash compactor and underground storage tanks are located on the adjacent property, and trash containers were observed throughout the subject property. No visible evidence of staining or releases of petroleum products or hazardous substances was observed among the waste and waste receptacles.

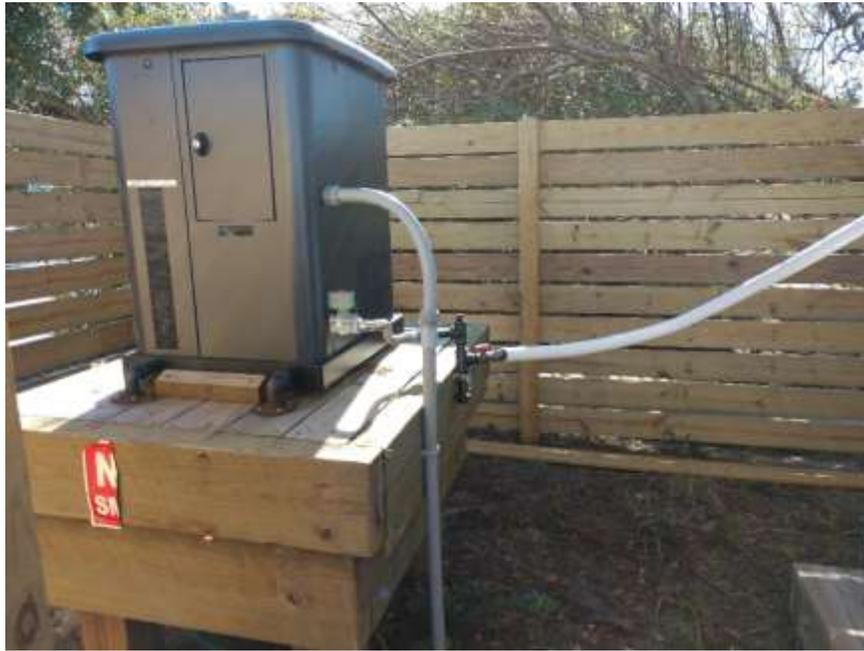
<b>11</b>	<b>Location / Orientation</b>	Inside fenced area on north west side of subject property.	Date: 1/9/2019
	<b>Remarks</b>	Propane tank and generator for backup power for ticket booth.

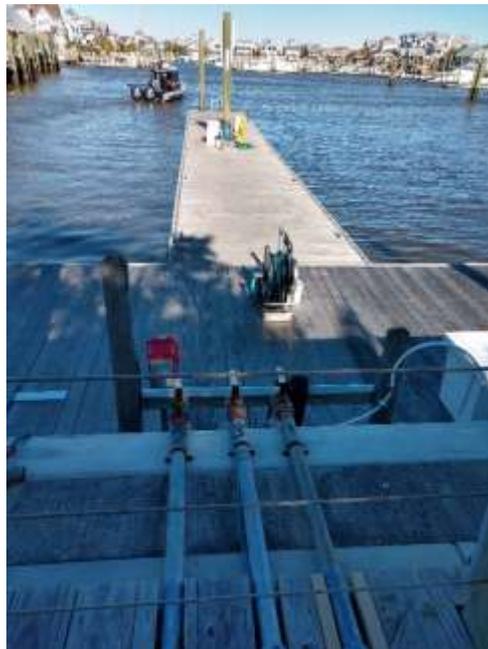
<b>12</b>	<b>Location / Orientation</b>	Looking north from Harbormaster facility.	Date: 1/9/2019
	<b>Remarks</b>	Dock for fueling private boats.

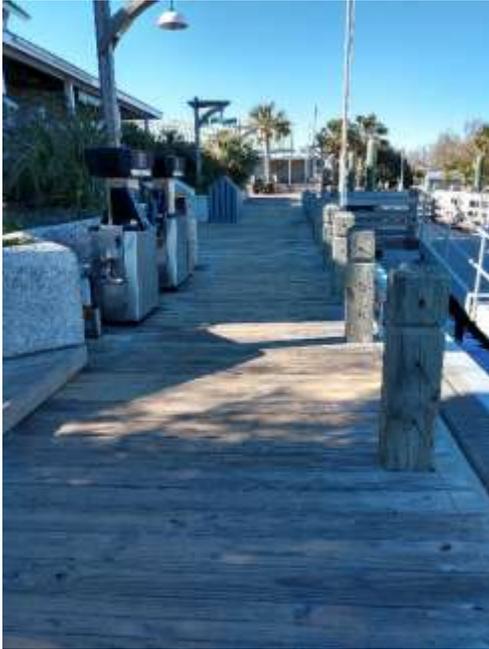
<b>13</b>	<b>Location / Orientation</b>	Looking west along the Harbormaster facility.
	<b>Remarks</b>	Dispensers for marina fueling of private vessels.

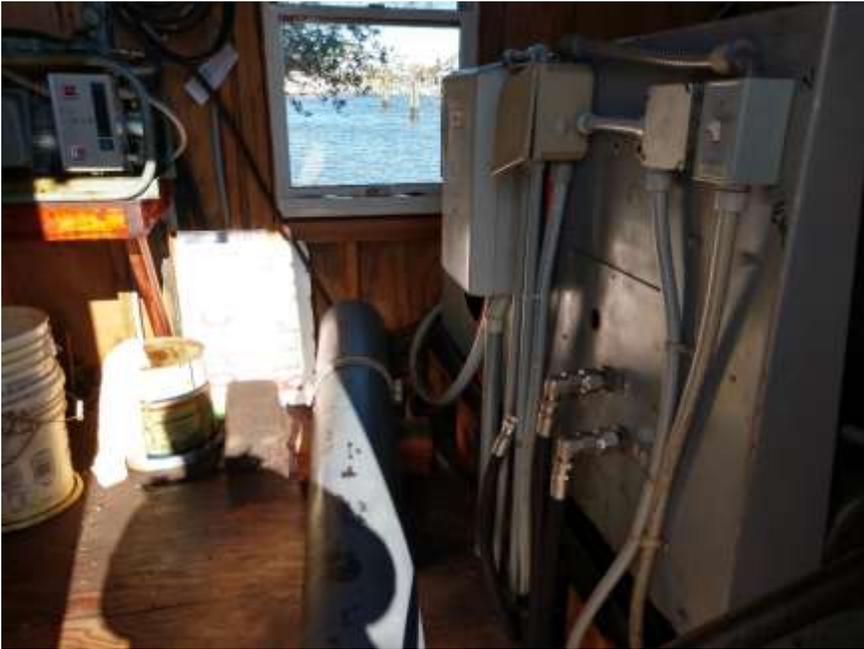
<b>14</b>	<b>Location / Orientation</b>	Interior of hydraulics building.
	<b>Remarks</b>	Pumps for barge hydraulics.
