# Bald Head Island, N.C. Beach Monitoring Program

## Monitoring Report No. 19 (May 2020 to May 2021)

**Prepared for:**  
Village of Bald Head Island

**Prepared by:**  
Olsen Associates, Inc.  
2618 Herschel Street  
Jacksonville, FL 32204  
(904) 387-6114  
(Fax) 384-7368  
olsen-associates.com  
C-1468

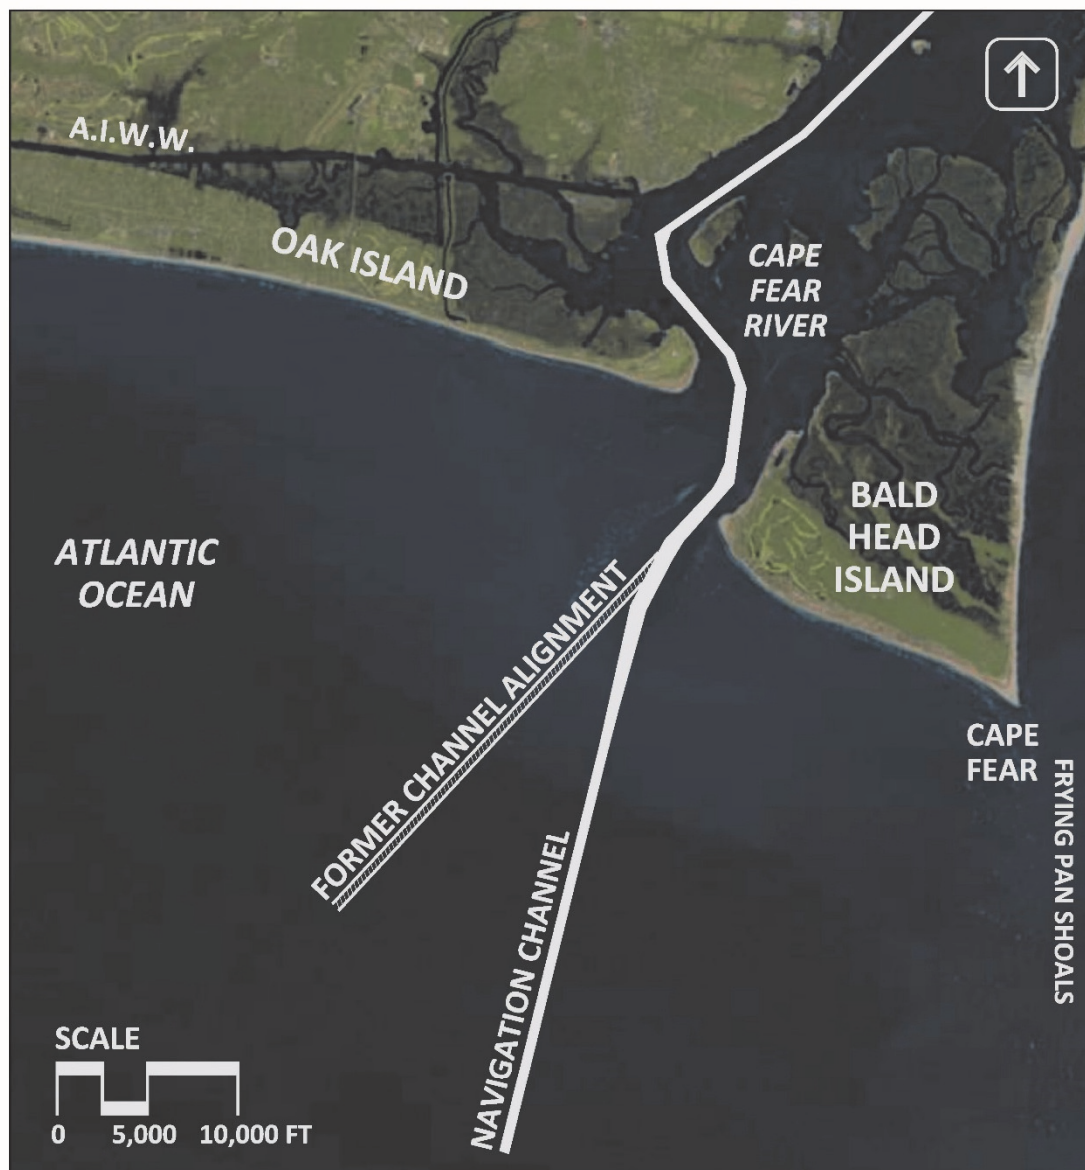
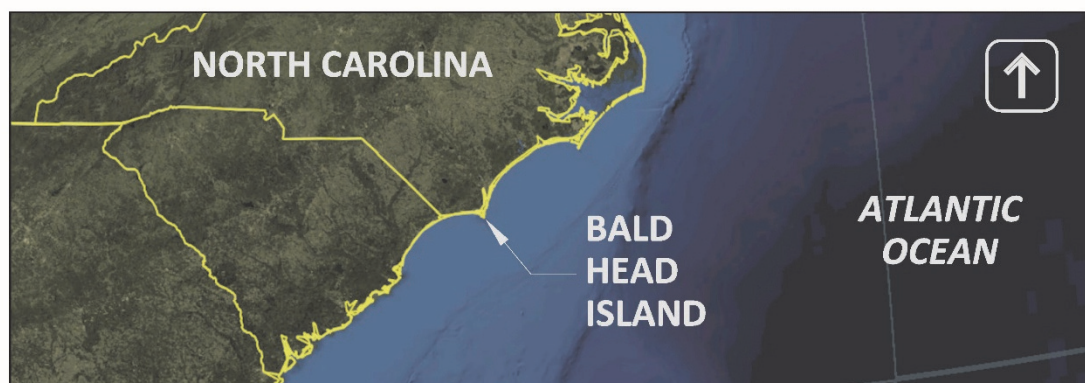
**Figure 1.1:** Location of Bald Head Island, N.C. and Federal Navigation Channel.

Bald Head Island is located in Brunswick County, North Carolina at approximately 33°51' N, 78°00' W (**Figure 1.1**). It is roughly 25 miles south of the City of Wilmington and 32 miles east of the South Carolina/North Carolina state line. It is the southernmost of the coastal barrier islands which form the Smith Island complex at the mouth of the Cape Fear River. The southeastern tip of the island is Cape Fear (also referred to as Cape Fear Point) from which Frying Pan Shoals extend seaward over 20 miles to the southeast.

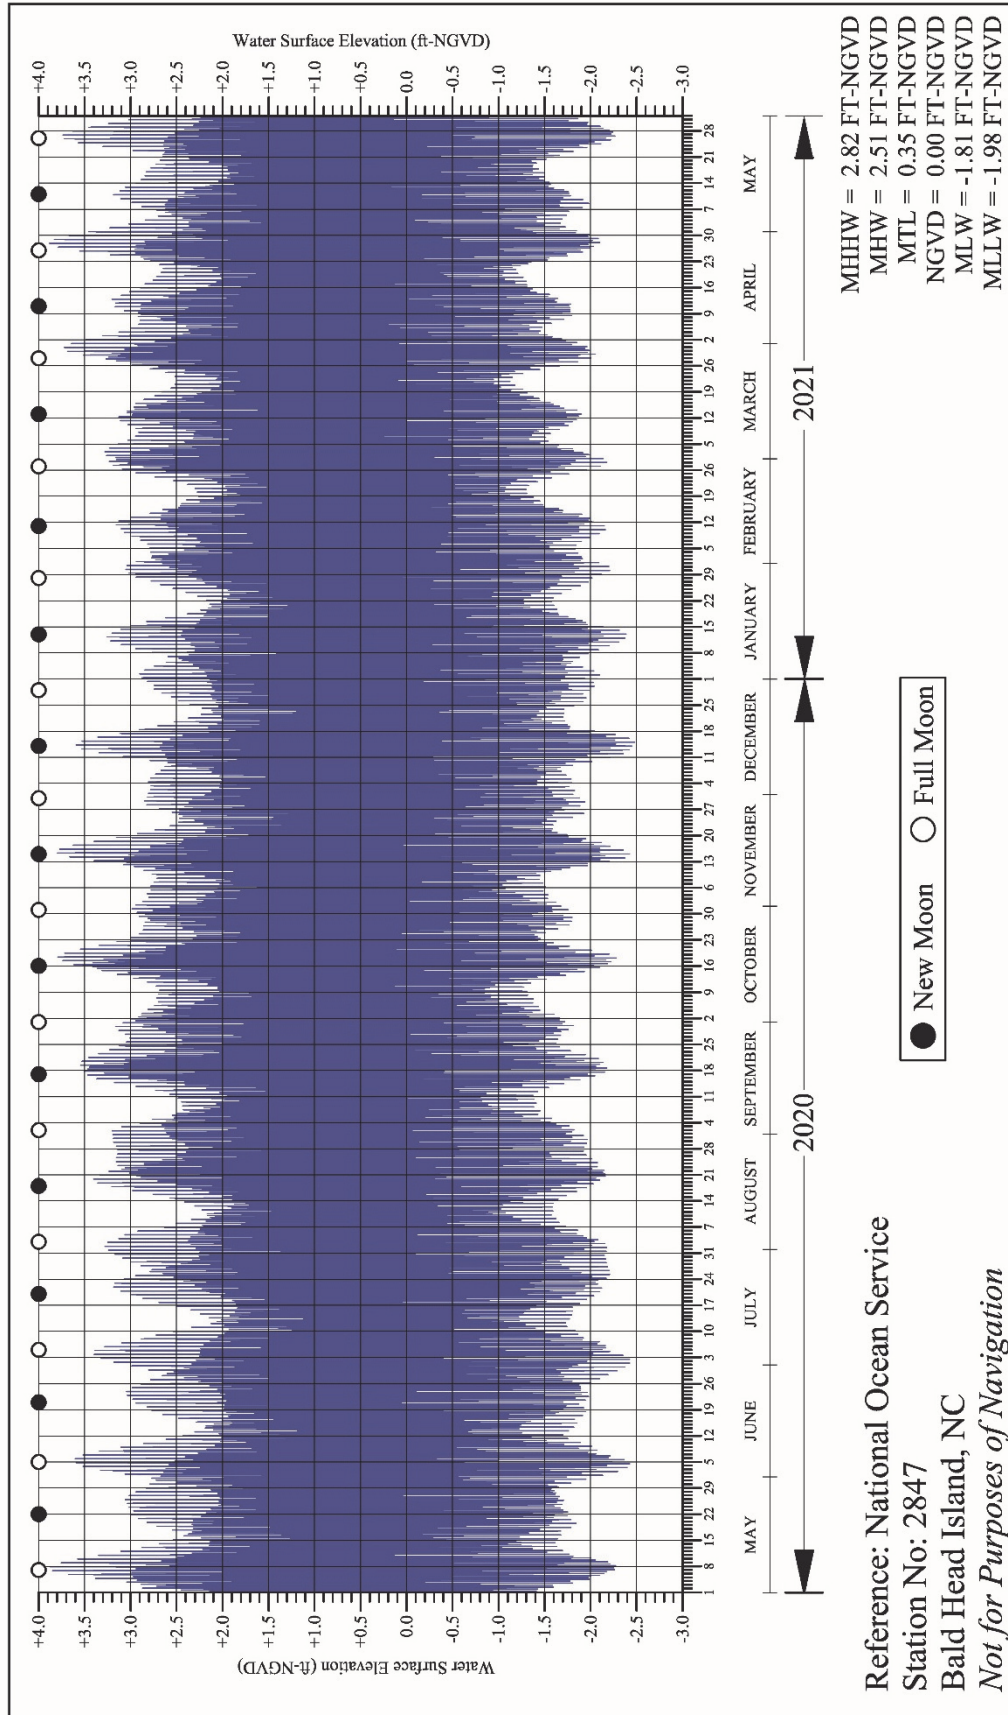
**Figure 1.2:** May 2020 through May 2021 predicted astronomical tides, Bald Head Island, North Carolina.

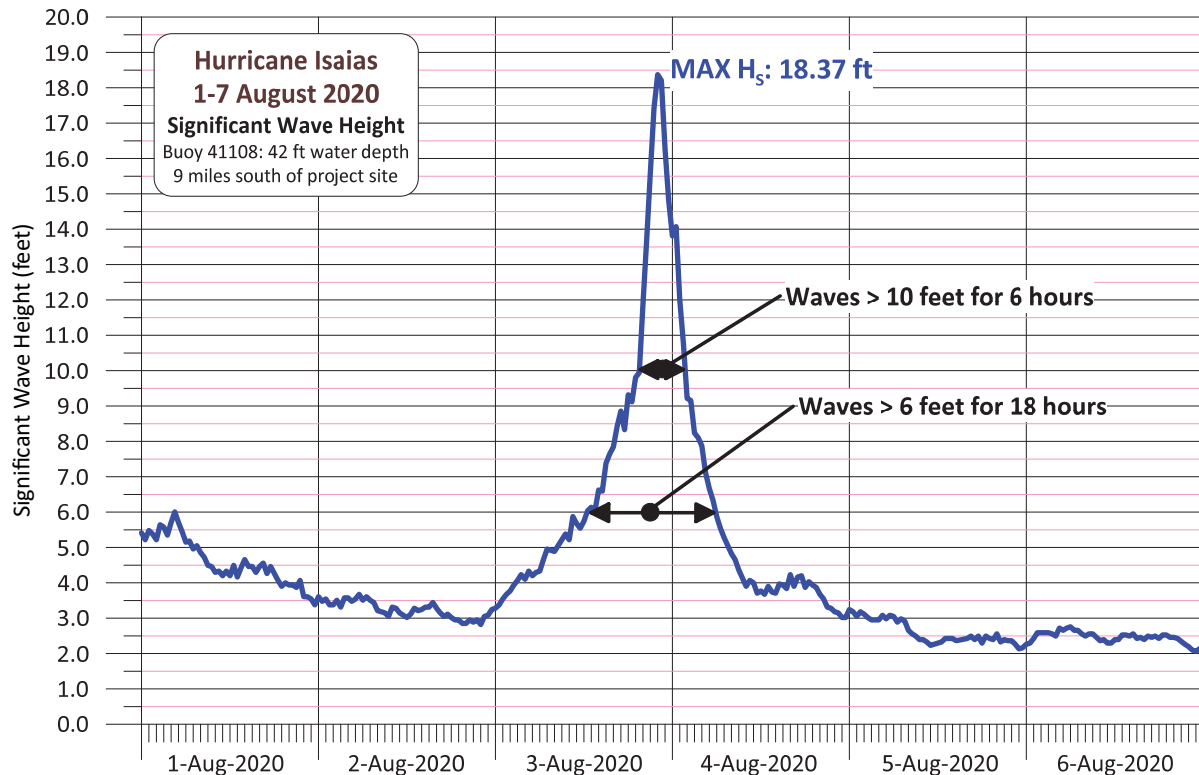
**Figure 1.5:** Time series of significant wave heights measured at NOAA Buoy 41108 as Hurricane Isaias moved by Bald Head Island, NC. The buoy is located approximately 9 miles south of Bald Head Island in 42 feet of water.

**Figure 1.5** depicts the time series measured at the buoy during the passage of Hurricane Isaias. While the buoy is located offshore in unprotected waters, the wave conditions measured can generally be related to nearshore conditions along the monitored area. Additionally, some fraction of the waves measured at the buoy are directed offshore. All wave statistics mentioned in this section will be from measurements at Buoy 41108.

During Hurricane Isaias, significant wave heights peaked at 18.37 ft on the evening of August 3<sup>rd</sup>, as the storm's center was approximately 40 miles east of the wave buoy. The dominant wave period peaked at about 12.5 seconds during this time. It is noted that these measurements reflect the significant wave height, or the average of the highest 1/3<sup>rd</sup> of waves passing the buoy during a 20 minute sampling period. There are waves that passed during the storm that were larger in height – some waves may have been as much as twice as high. Large waves persisted along the coast for a significant duration of time with significant wave heights greater than 10 feet lasting for 6 hours and waves greater than 6 feet for 18 hours. For comparison, during Hurricane Dorian (September 2019), wave heights greater than 10 feet lasted for about 20 hours and waves greater than 6 feet for 46 hours.

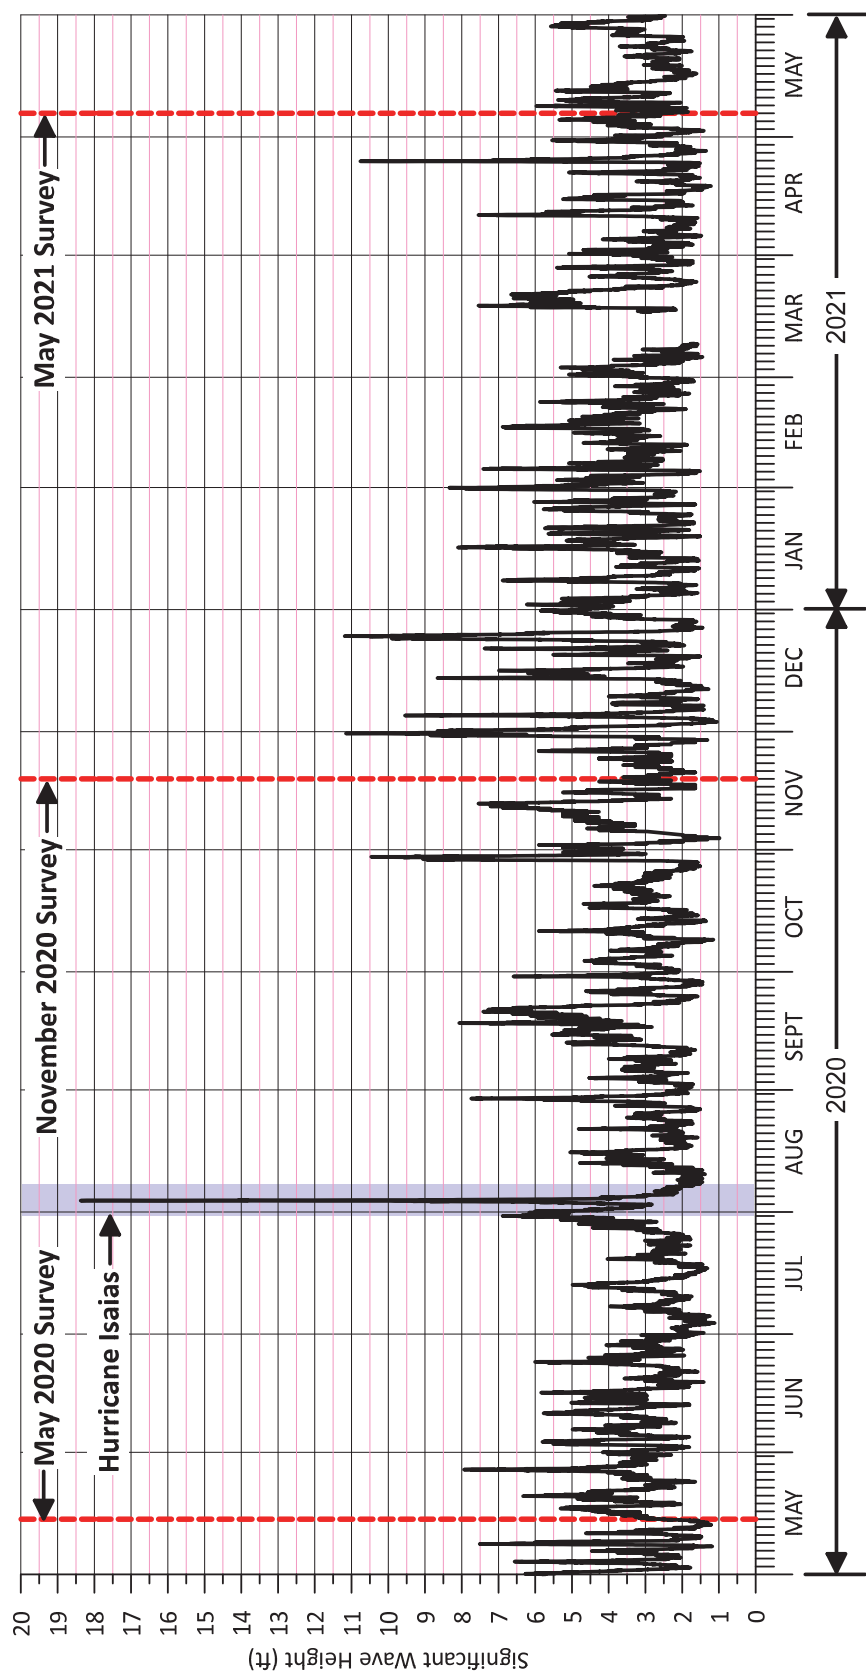
**Figure 1.6:** Significant wave heights recorded by NOAA Buoy 41108 during the 2020-21 monitoring period (Wilmington Harbor, NC).

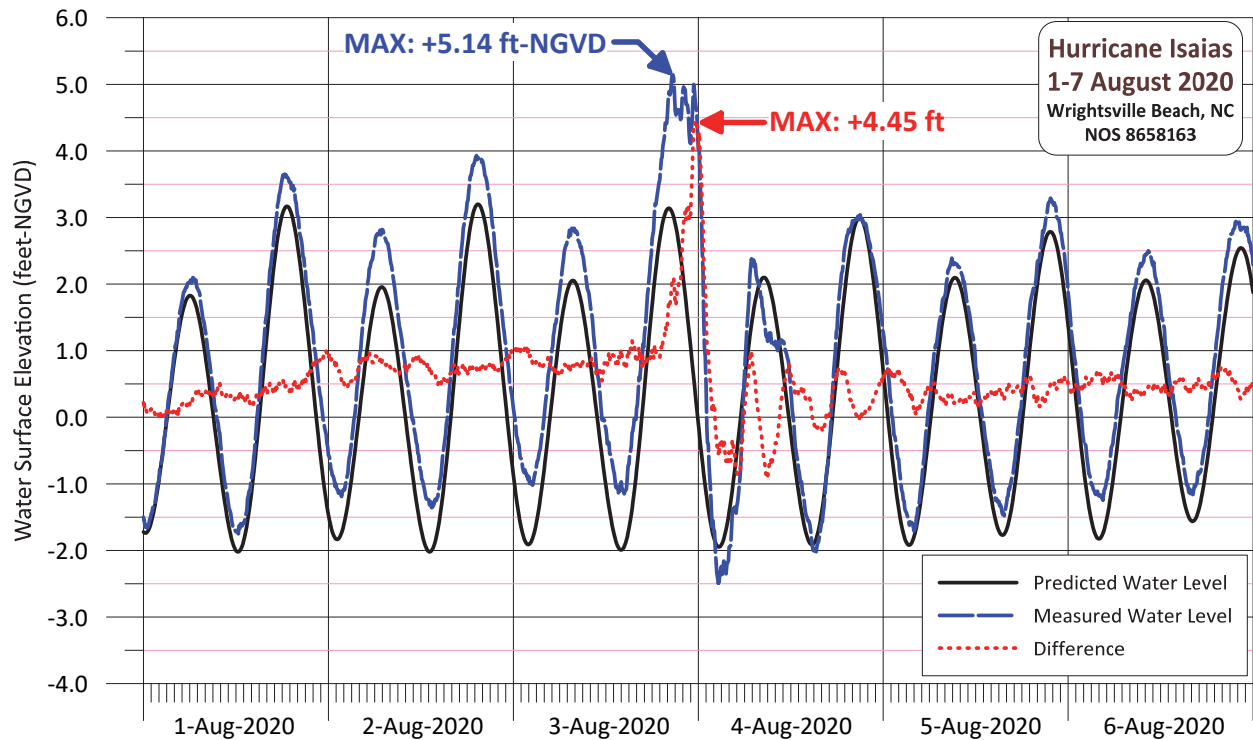
**Figure 1.7:** Time series of water levels measured at the Wrightsville Beach NOAA tide gage (NOS 8658163) located along the open Atlantic Coast, as Hurricane Isaias approached Brunswick County, NC.

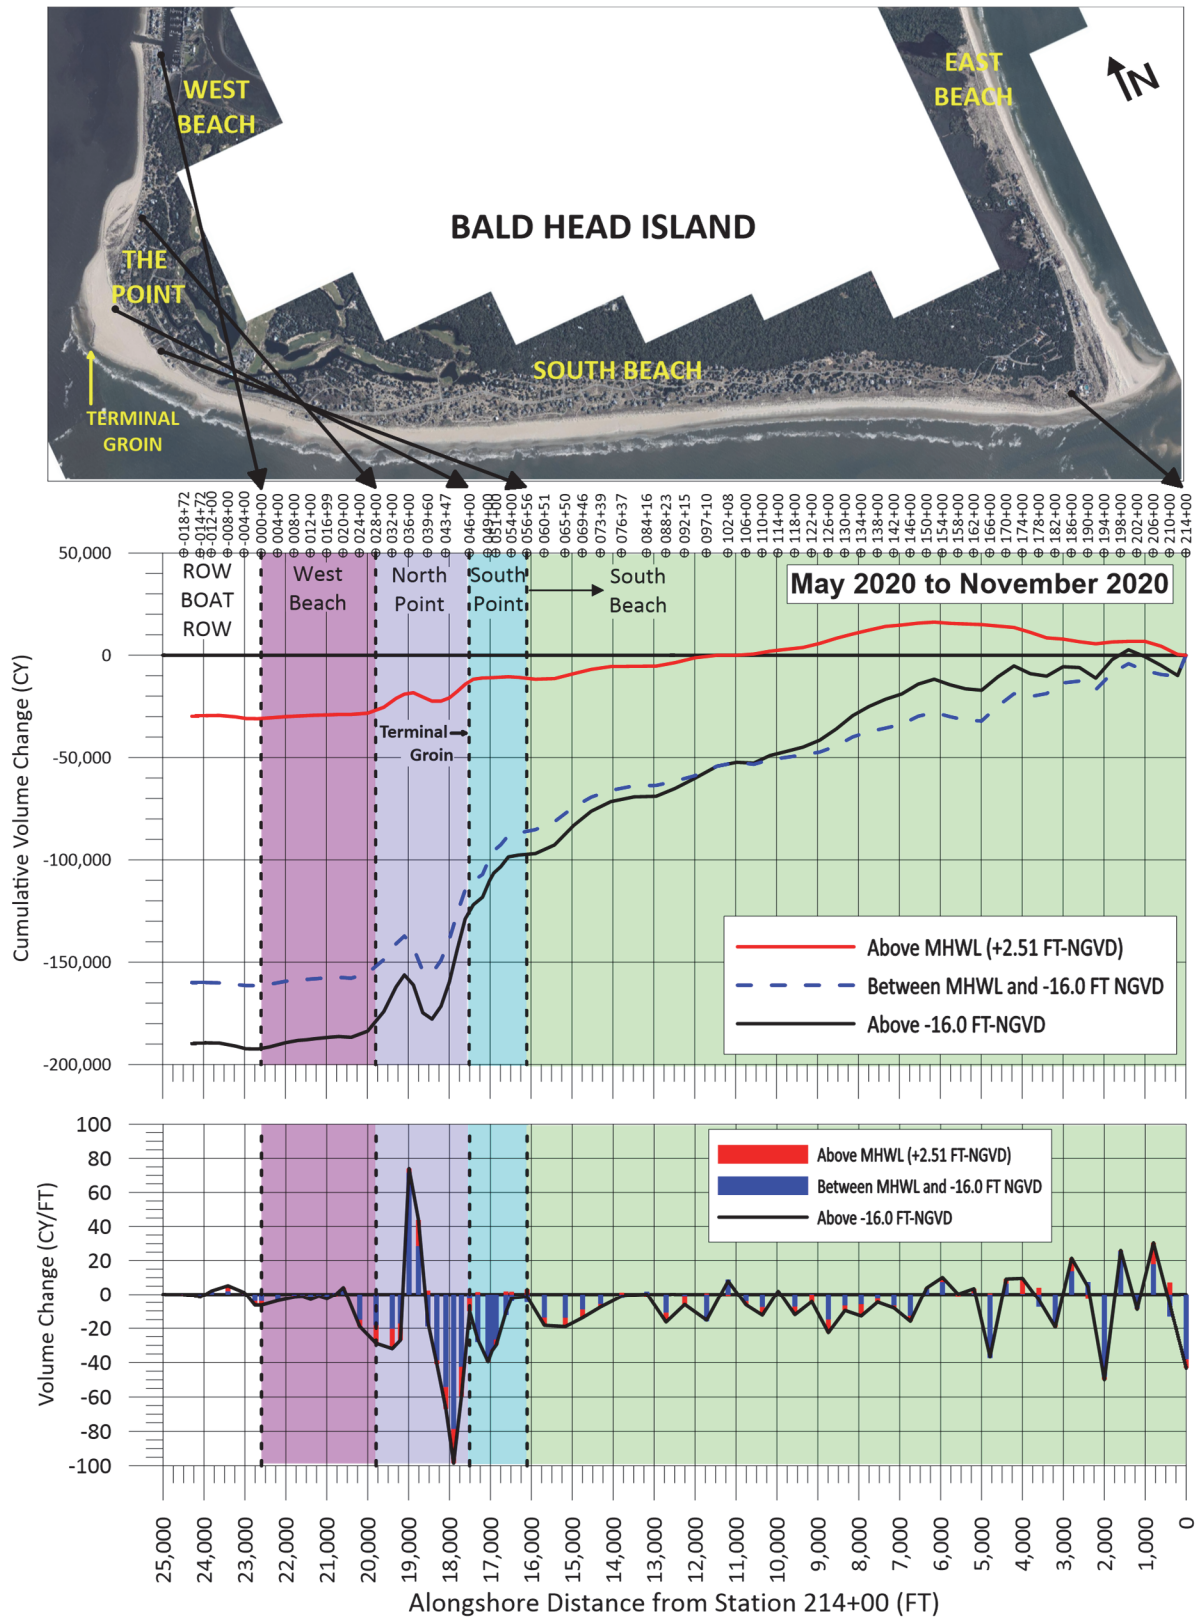
**Figure 3.1:** Volume change along the Bald Head Island shoreline between May 2020 and November 2020.

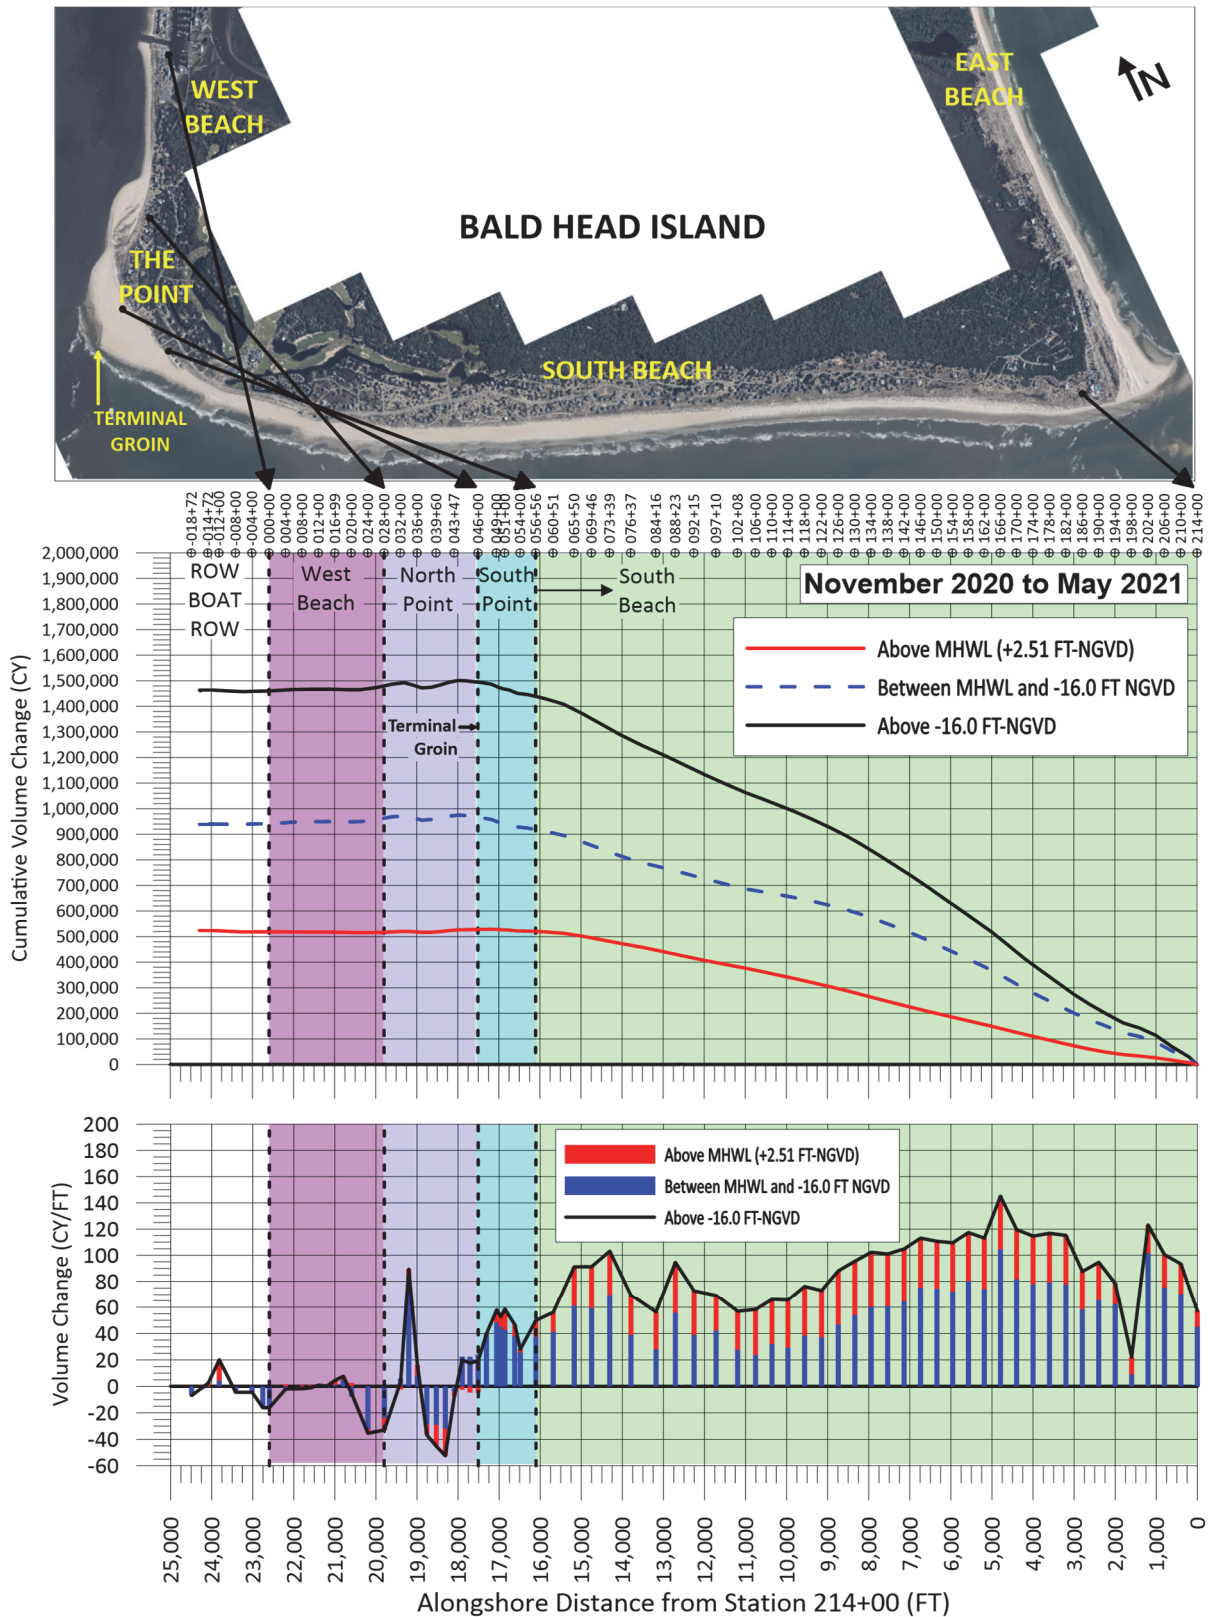
**Figure 3.2:** Volume change along the Bald Head Island shoreline between November 2020 and May 2021.

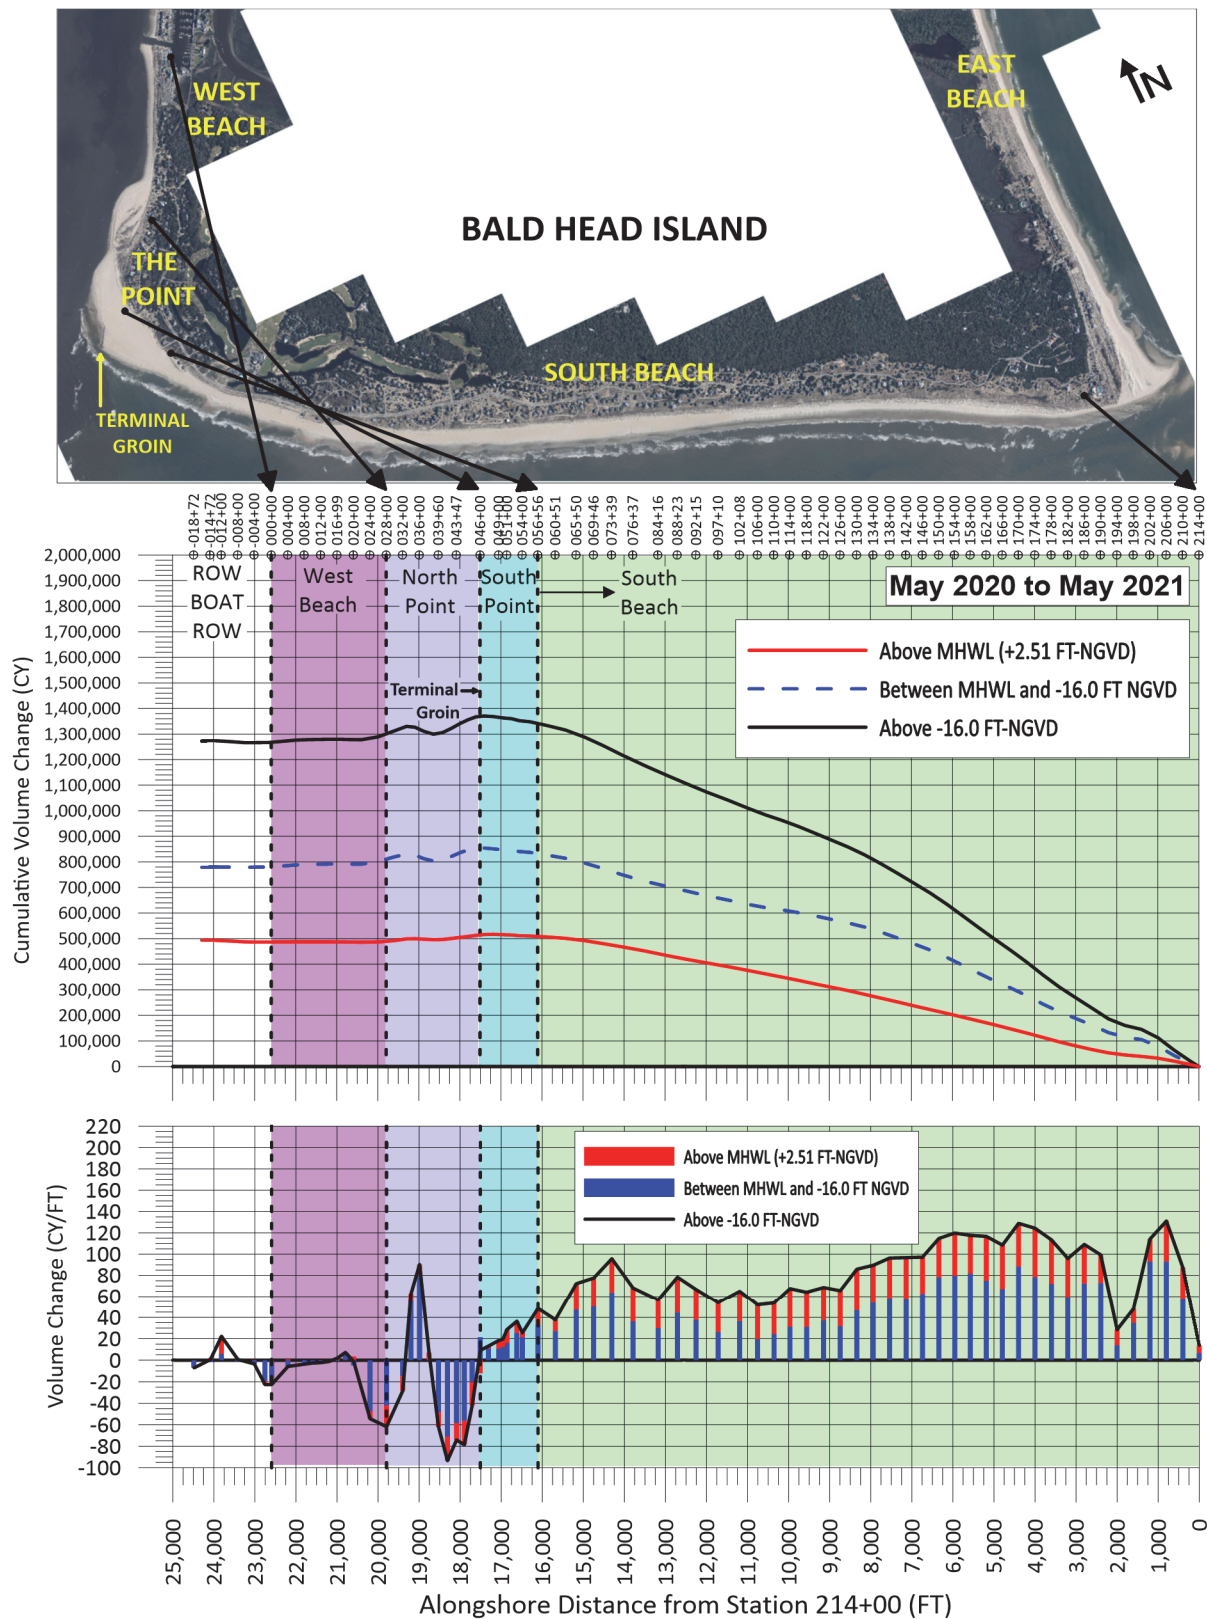
**Figure 3.3:** Volume change along the Bald Head Island shoreline between May 2020 and May 2021 (Year 20).

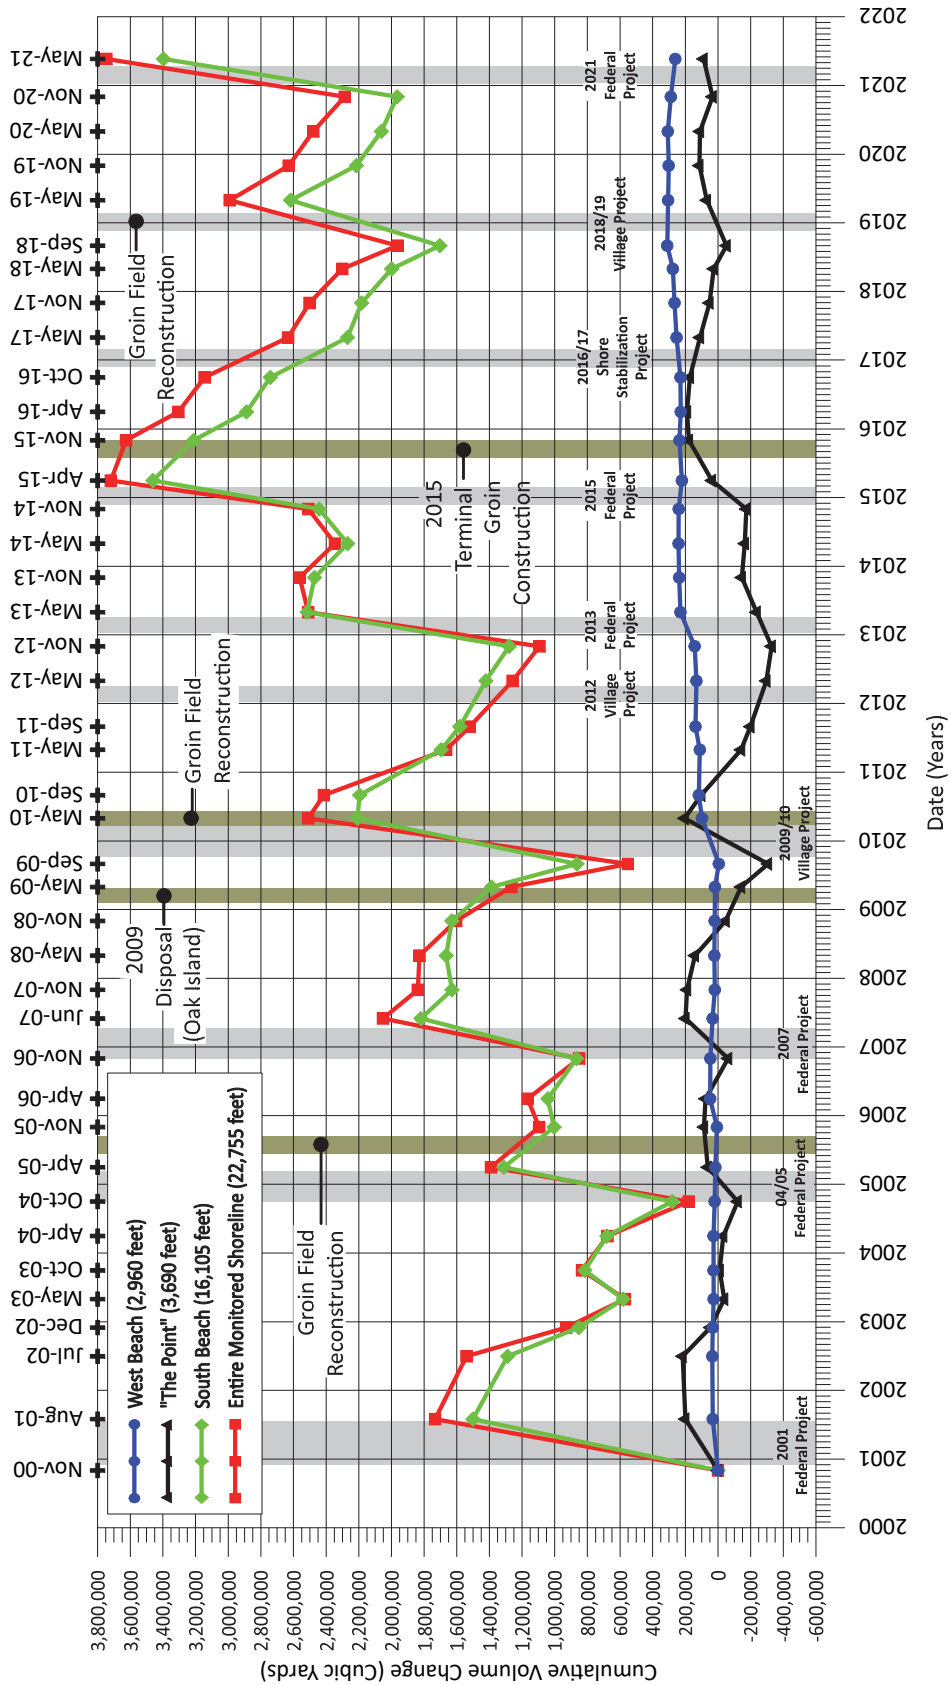
**Figure 3.6:** Cumulative volume change (above -16 ft-NGVD) relative to November 2000 conditions.

For purposes of tracking gross sand placement performance, **Figure 3.6** plots a time history of cumulative volume change relative to November 2000 conditions. **Figure 3.7** presents net volumetric change (alongshore above -16 ft NGVD) for the maximum period of comparison to date (*i.e.* November 2000 and May 2020). In both figures the effects of direct sand placement over time are included. As with other similar analyses over the last decade, East Beach, Cape Fear and Row Boat Row are *excluded* from this analysis.

The classic “saw-tooth” effects of episodic sand placement, as reflected in **Figure 3.6**, are indicative of the periodic infusion of sand along South Beach at Bald Head Island associated with the placement of sand during initial construction of the channel deepening project, five (5) subsequent beach disposal operations pursuant to the WHSMP, the proactive beach renourishment project constructed by the Village in 2009/10 and to a smaller degree the emergency fill of 2012. The Village 1.85 Mcy fill was constructed with the knowledge gained through monitoring that certain irreparable large-scale impacts to Bald Head Island would predictably occur as a direct result of the proposed diversion of channel maintenance material in 2009 to Oak Island. *Note – a similar diversion of Federal sand occurred in the summer of 2018.* As a result of the 2018 federal sand disposal at Oak Island, the Village constructed a 1.1 Mcy interim beach fill at South Beach in the fall/winter of 2018/19. The most recent federal beach disposal project was performed in the early months of 2021 (Jan – April) along South Beach on Bald Head Island.

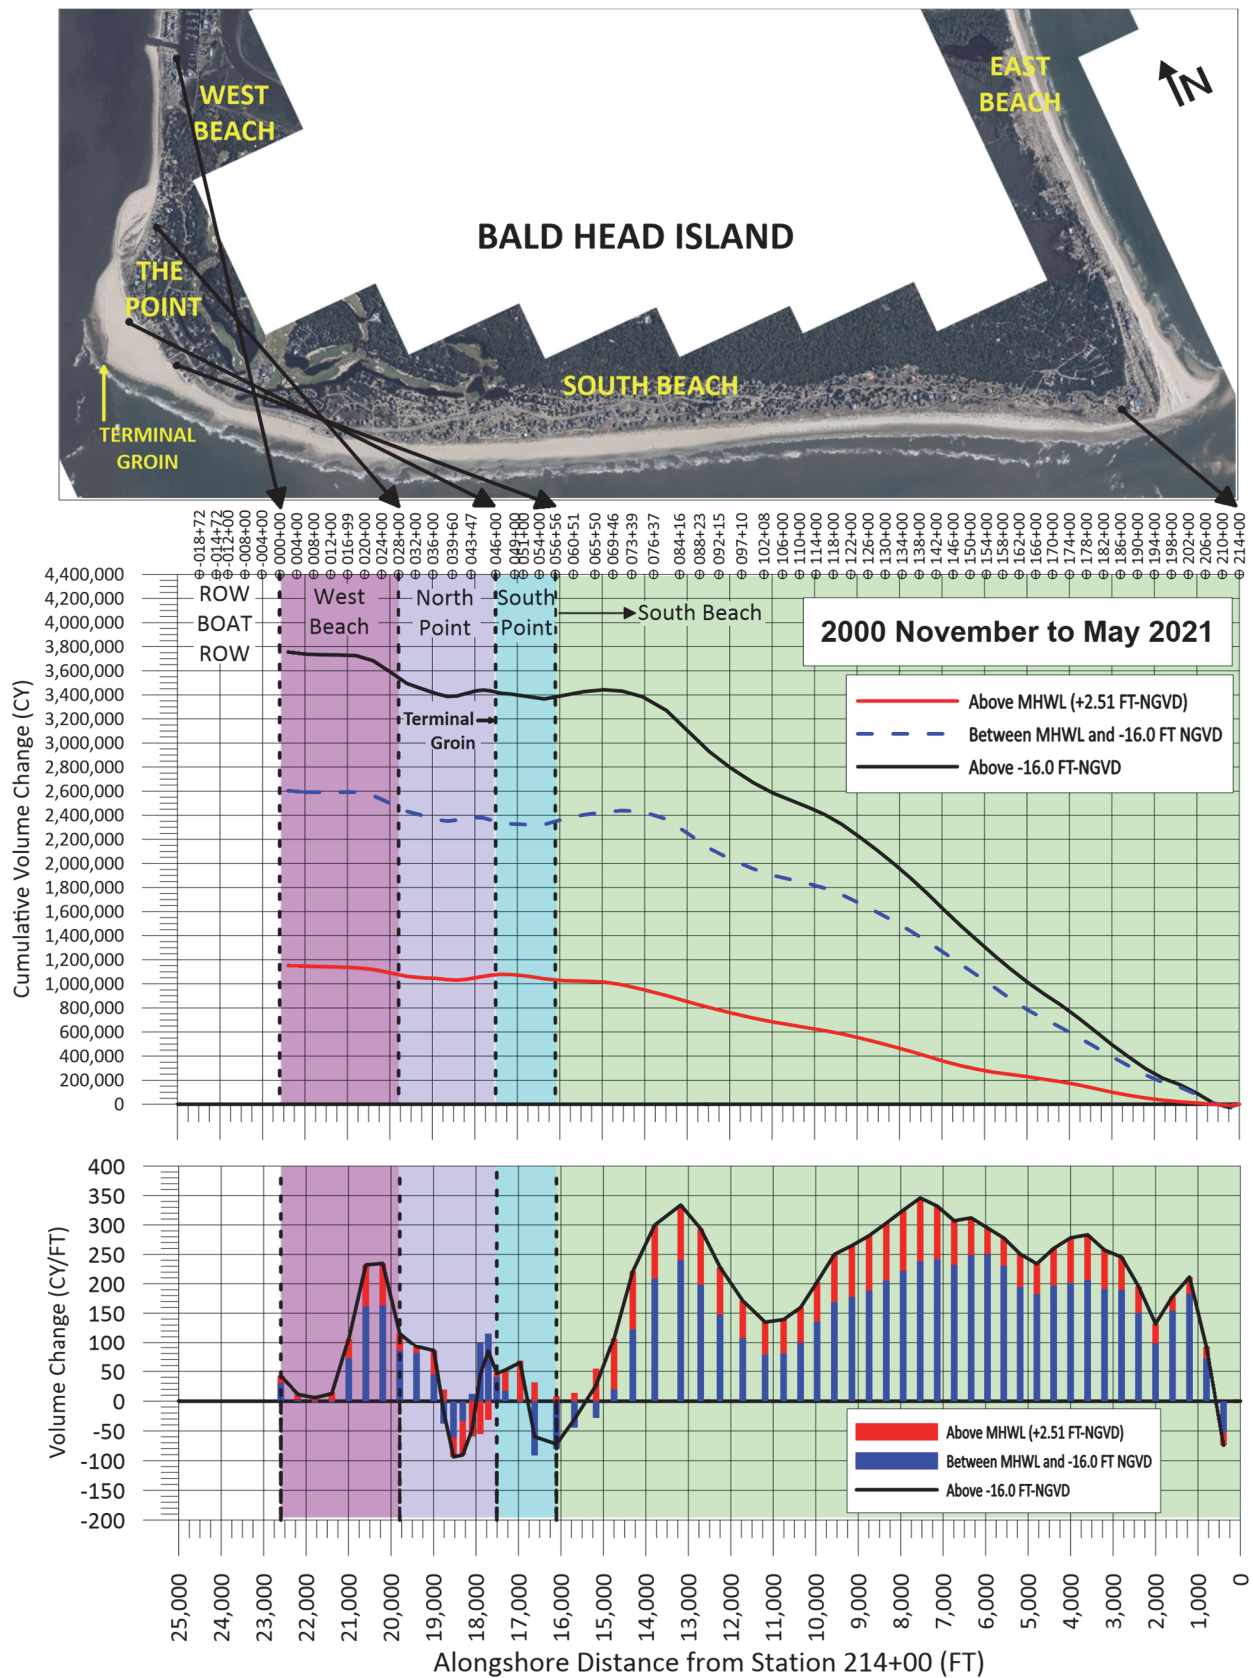
**Figure 3.7:** Volume change along the Bald Head Island shoreline between November 2000 and May 2021.

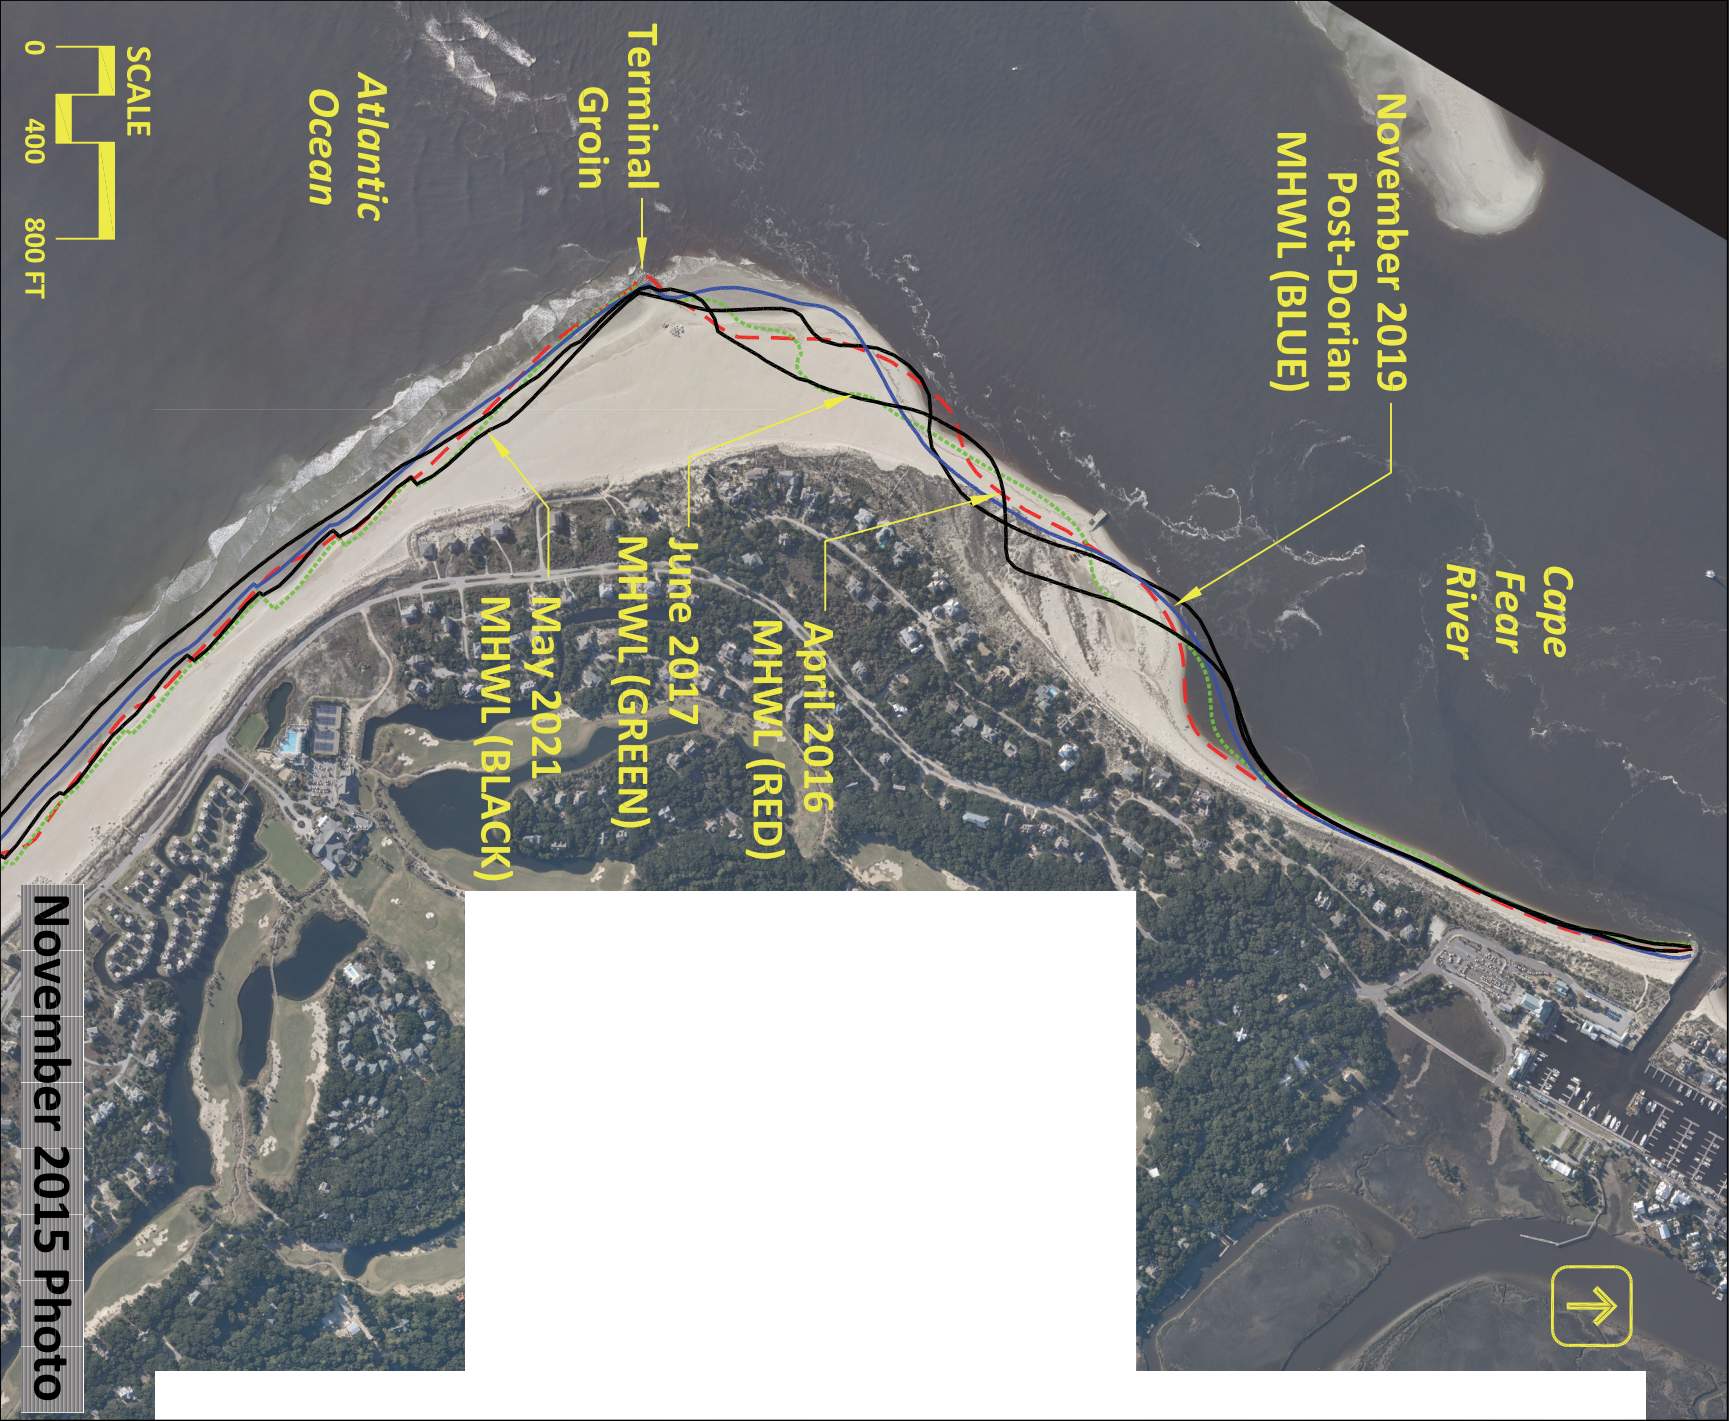
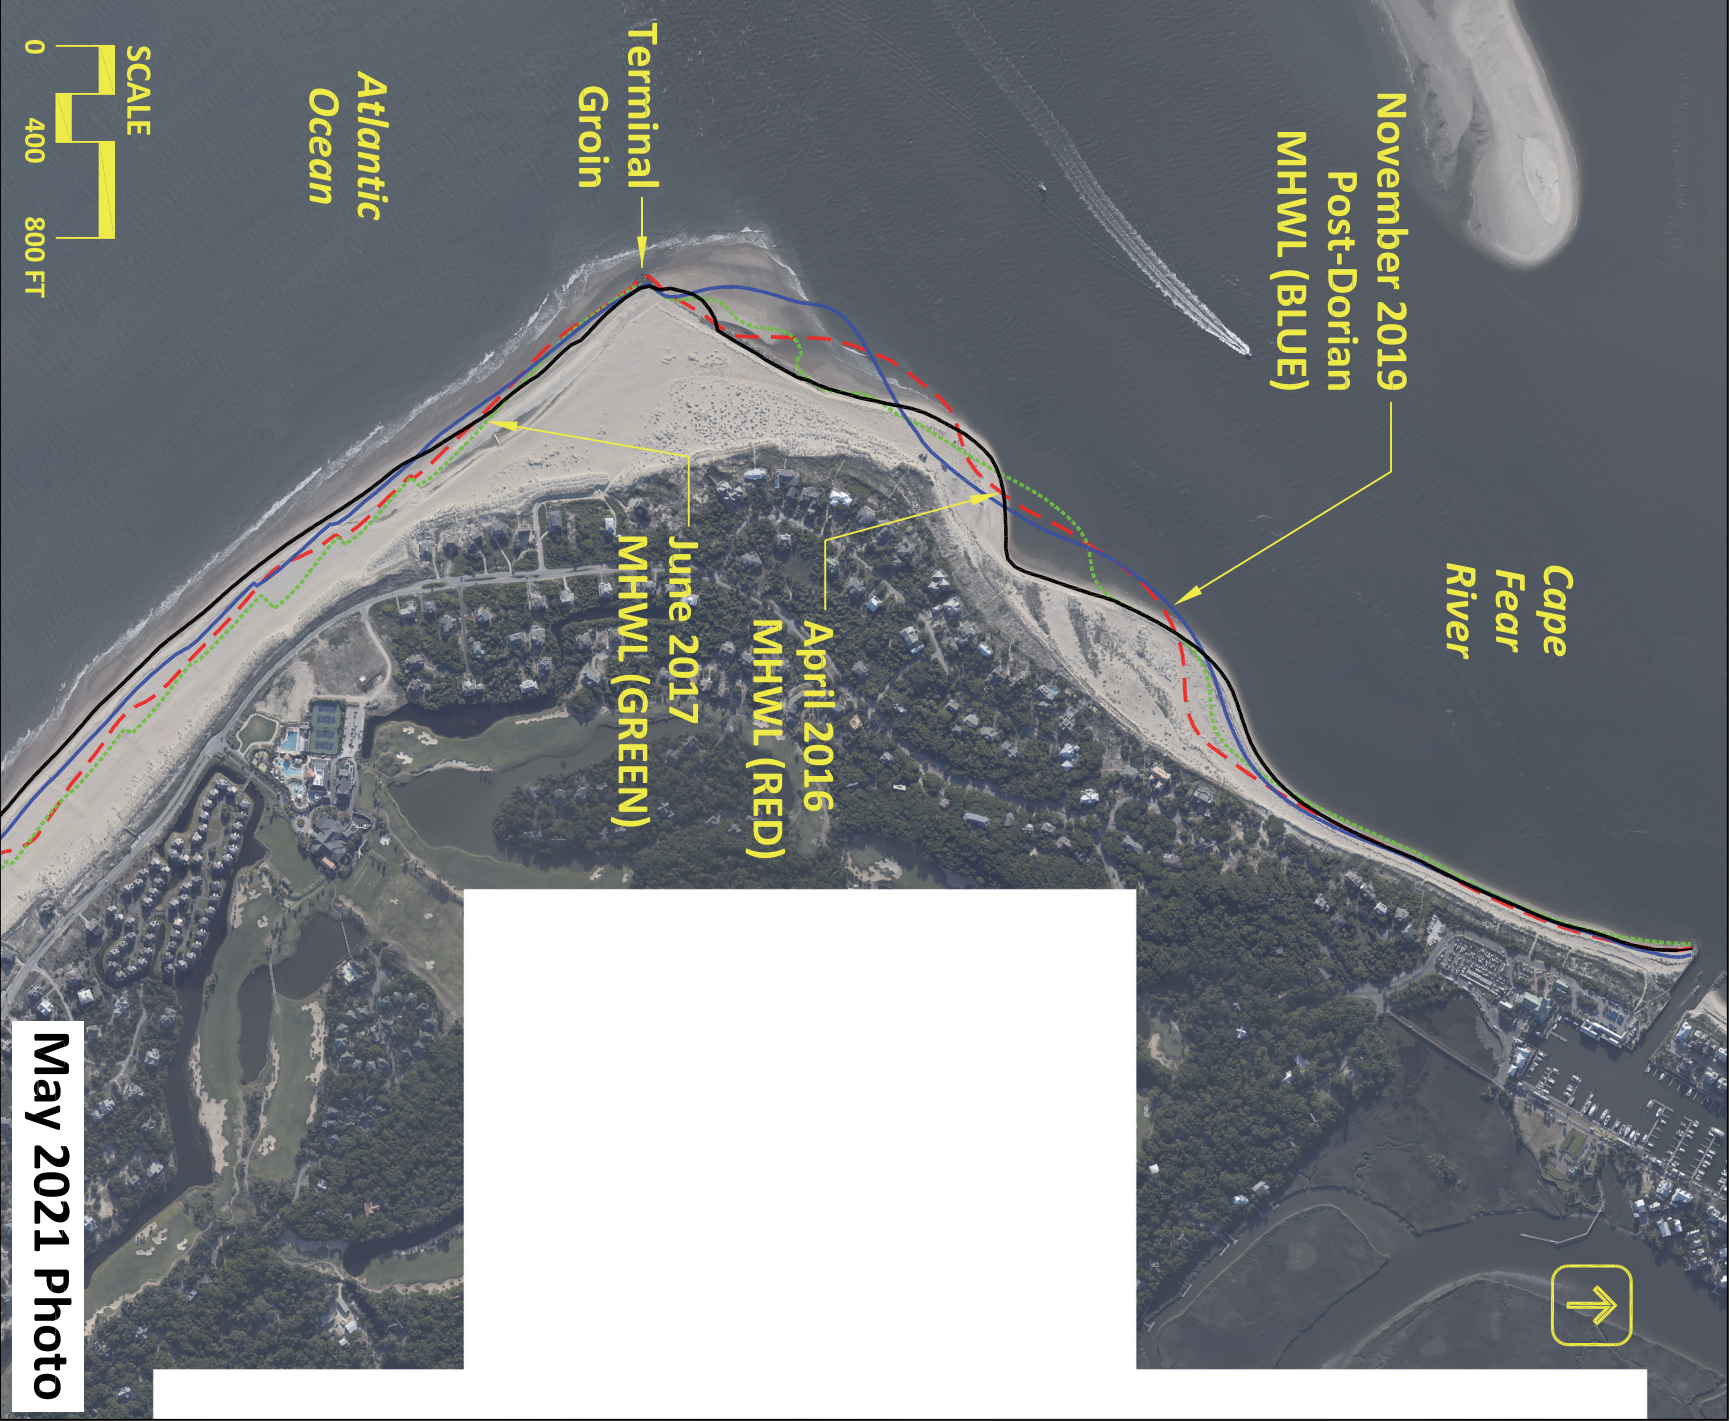
**Figure 3.8:**  
MHWL positions in the vicinity of the  
terminal groin Bald Head Island, NC

As part of the permit required monitoring for the terminal groin project completed in late 2015, the MHWL was surveyed in December 2015 (post-construction), April 2016 (5 months post-construction), June 2017 (19 months post-construction), May 2018 (30 months post-construction), September 2018 (post-Florence), May 2019 (post-fill), November 2019 (post-Dorian), May 2020, November 2020 and May 2021. The selected surveys are plotted in **Figure 3.8**. The purpose of the surveys is to be able to intercompare and assess both updrift fillet conditions and the location of the downdrift shoreline fronting the Cape Fear River. Through May 2021, terminal groin project performance – based upon monitoring – has been both as intended and as predicted.
