# Bald Head Island, N.C. Beach Monitoring Program

## Monitoring Report No. 19 (May 2020 to May 2021)

**Prepared for:**  
Village of Bald Head Island

**Prepared by:**  
Olsen Associates, Inc.  
2618 Herschel Street  
Jacksonville, FL 32204  
(904) 387-6114  
(Fax) 384-7368  
olsen-associates.com  
C-1468

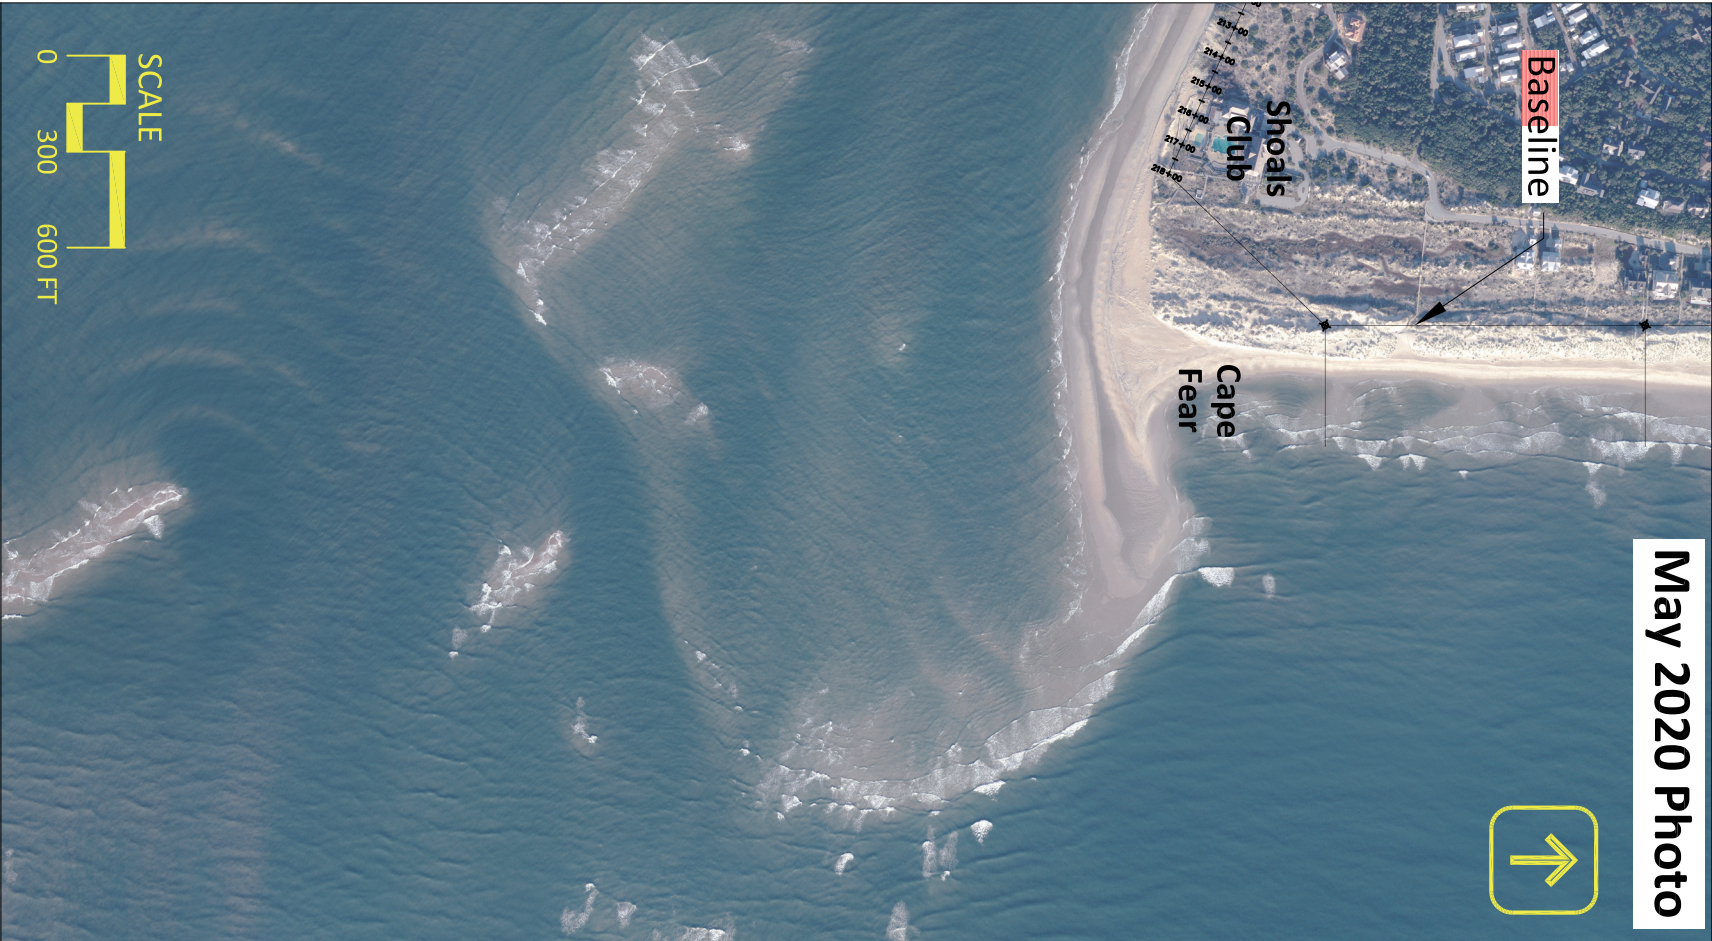
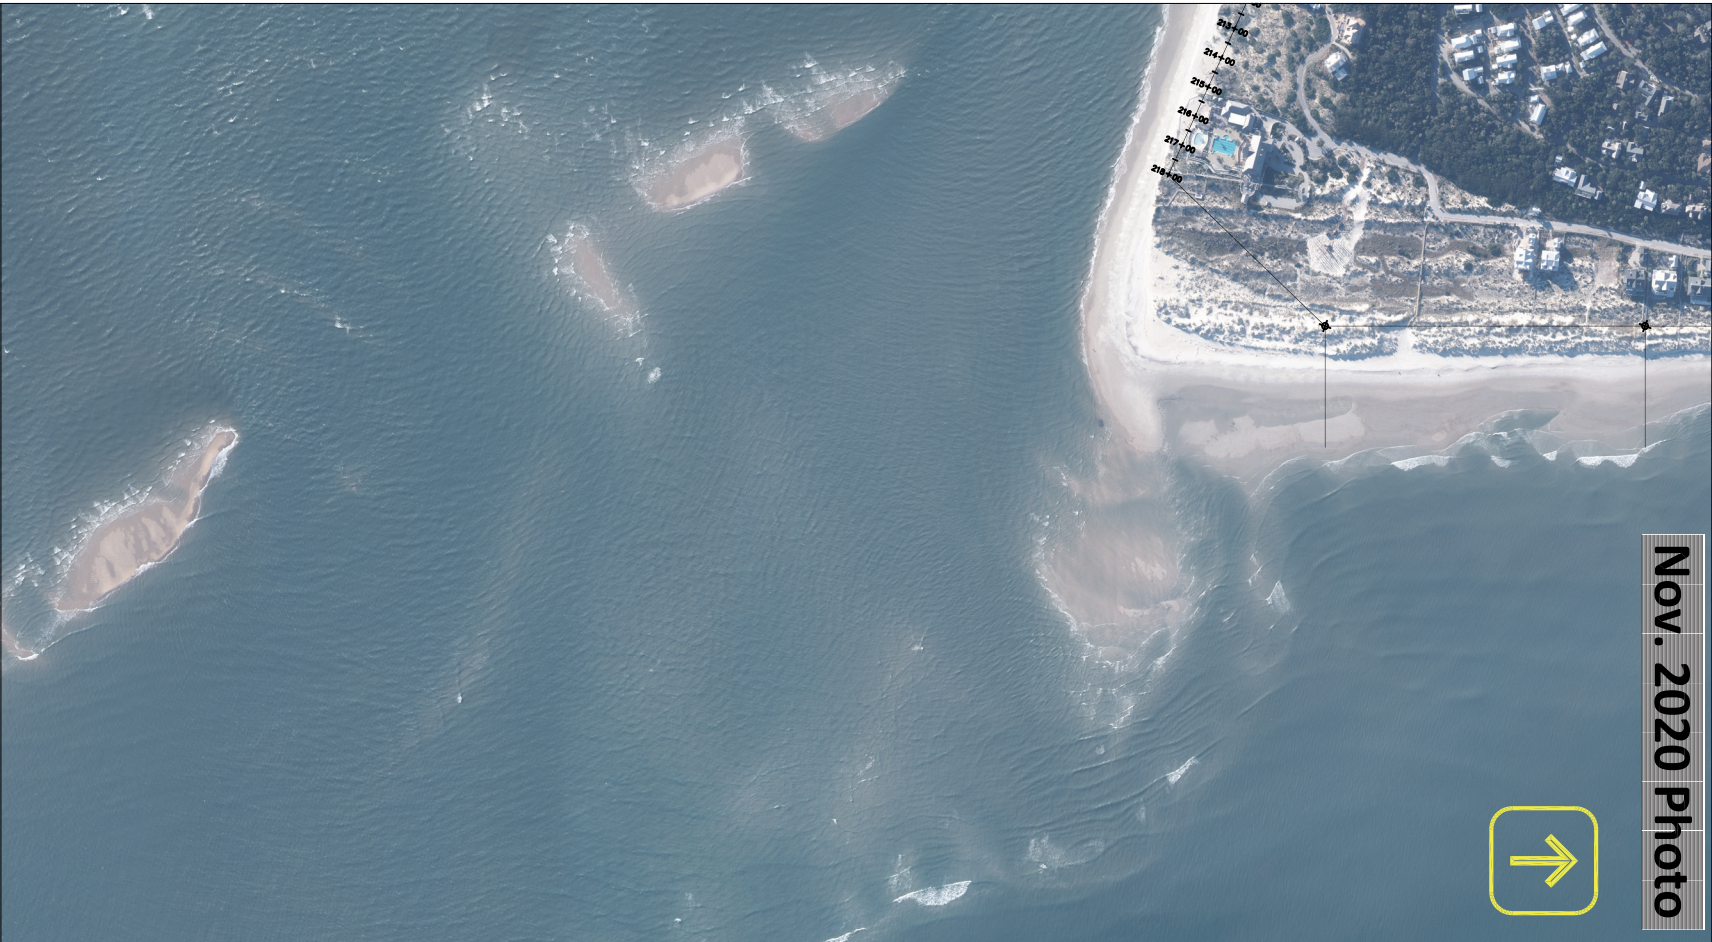
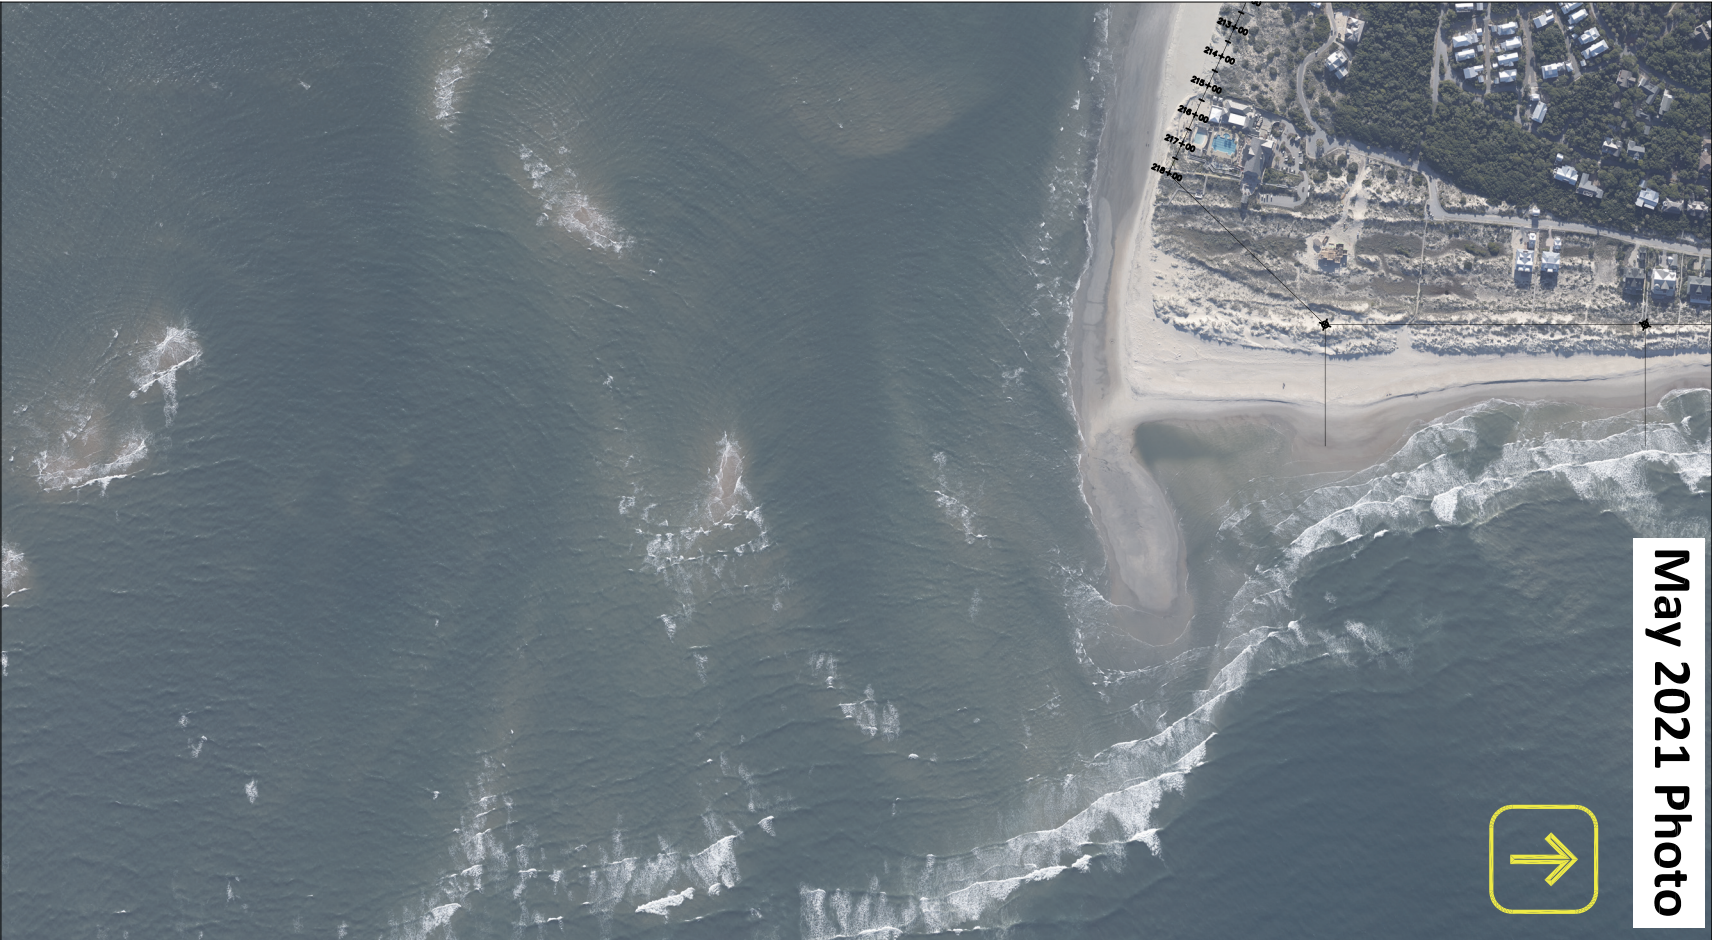
As demonstrated by the survey and photographic data (**Figure 3.9**), it can be reasonably assumed that the condition of East Beach at any one time is, has been and will continue to be highly influenced by the configuration of the depositional spit and shoals associated with the “Cape Fear Point”. Of further interest are the variations in spit size and orientation over the 12 years (2008-2021) which are depicted by **Figure 3.10**. In its simplest sense, the Cape Fear spit is a highly dynamic feature which is influenced by sand supply originating from both the west (along South Beach) and the north (along East Beach). The Point is also highly susceptible to storm waves originating from *both* the west (Atlantic Ocean) and the east (Onslow Bay) and resultant tidal channels which episodically break through and subsequently influence localized patterns of sand deposition (or erosion).

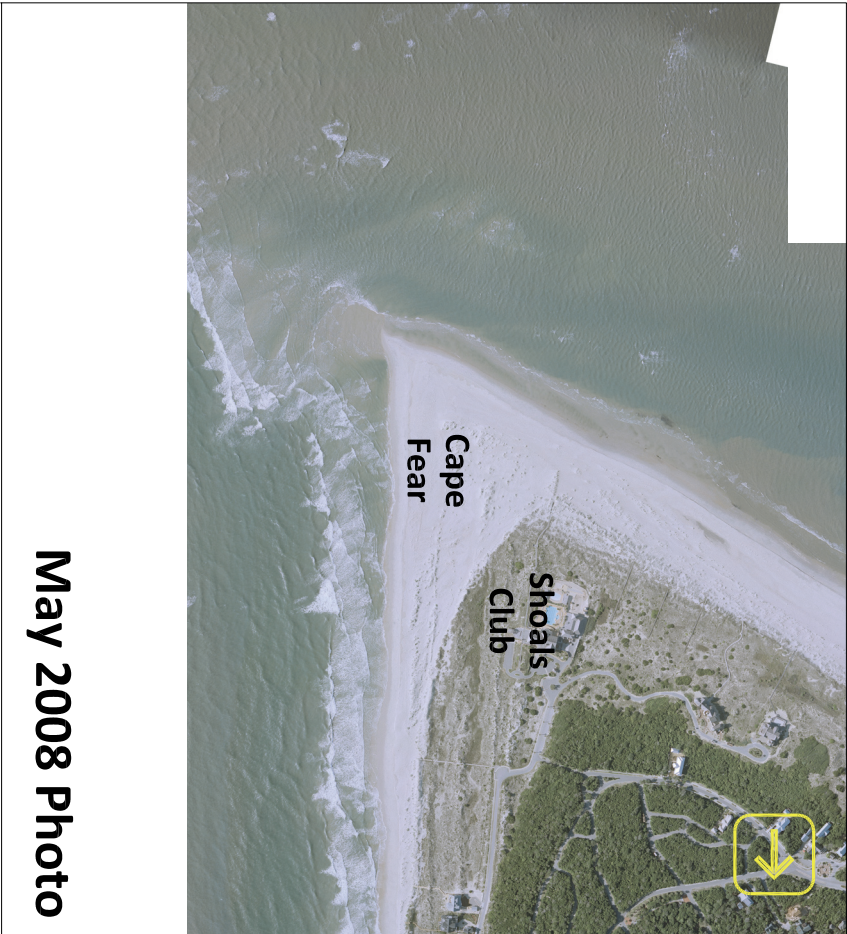
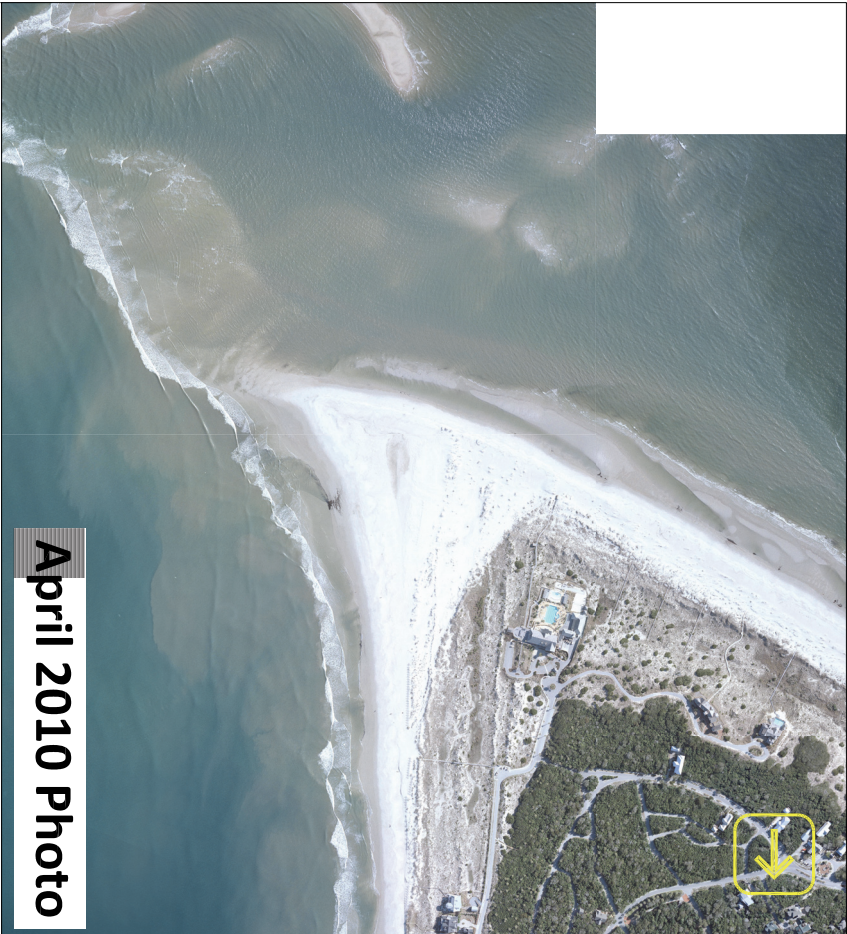
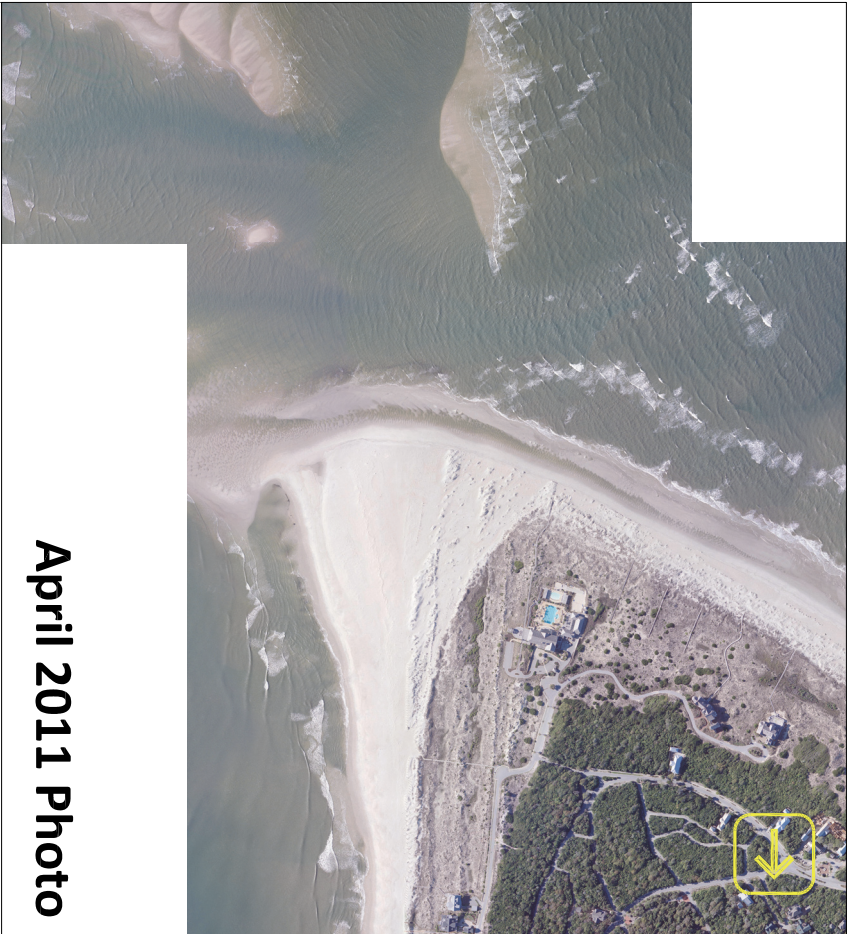
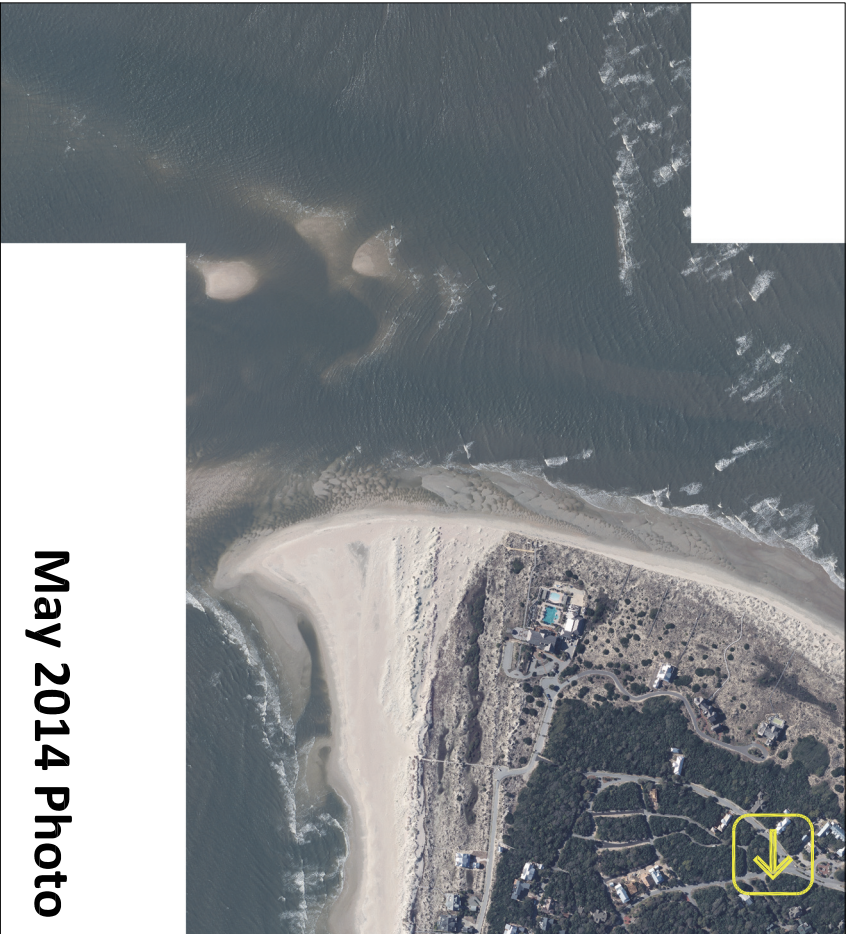
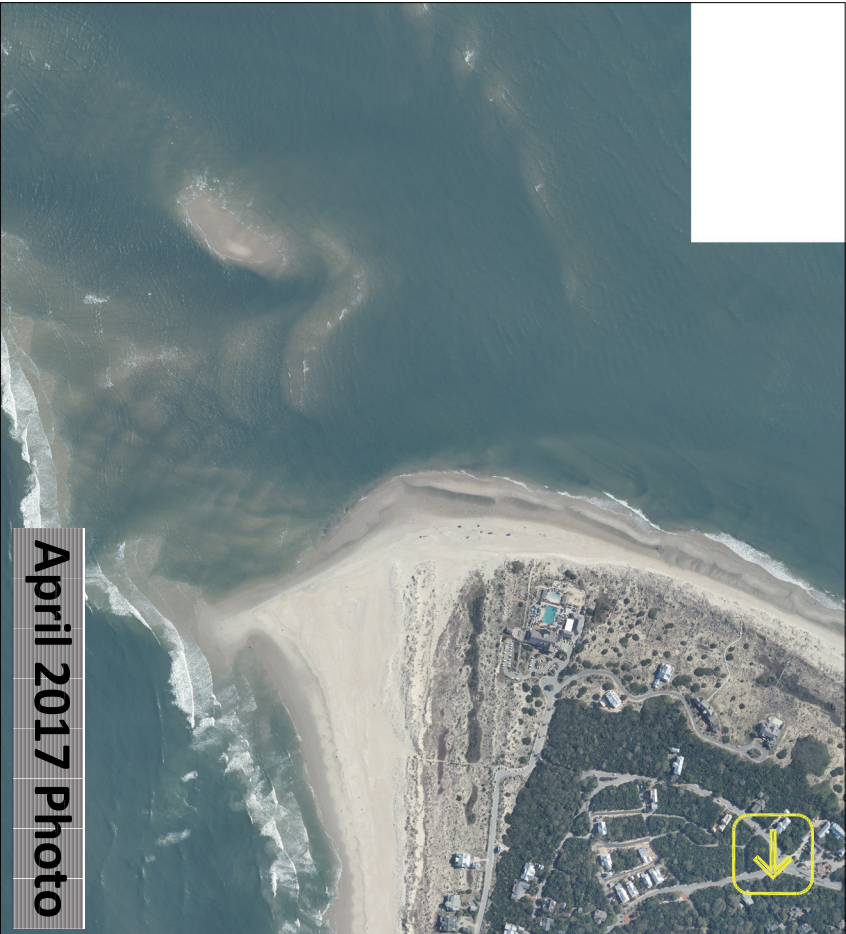
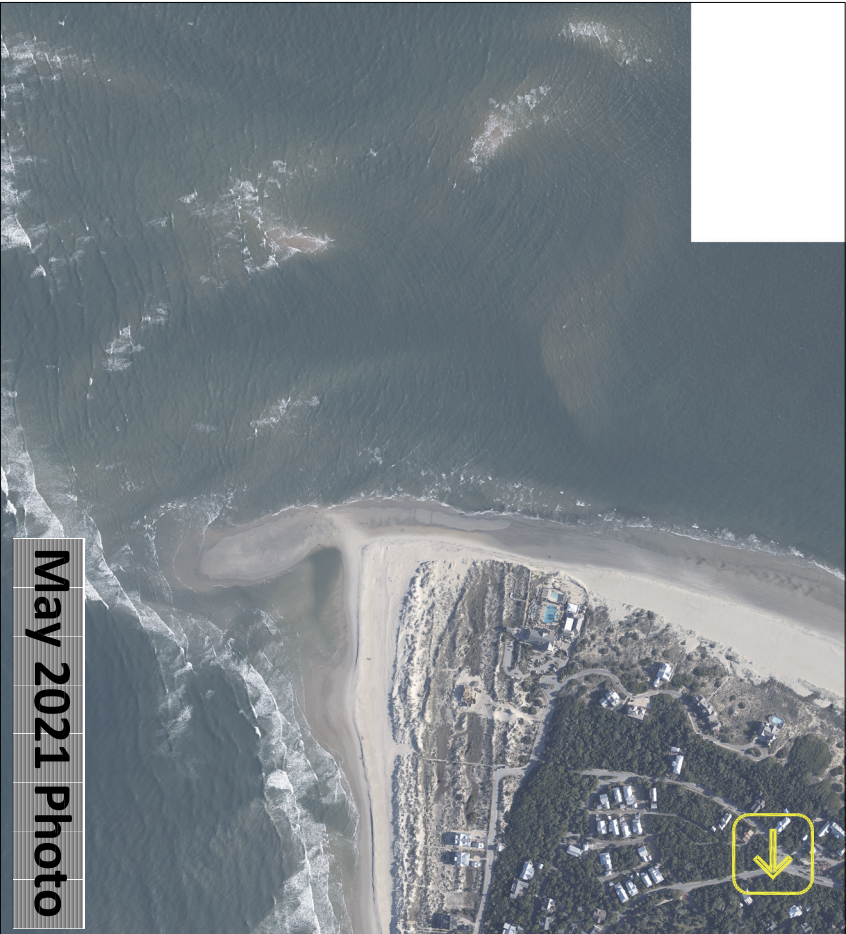
Although the near-term locations of the Cape Fear spit have been beneficial to East Beach properties, it has typically caused significant shoreline and dune recession seaward of the South Beach Shoals Club facility. That section of shorefront is monitored via beach profiles B-54 and B-55 (Sta. 214+00 and 218+00). The Shoals Club lies approximately mid-way between these two survey stations. May 2021 shoreline conditions (post-beach disposal) are visually shown by **Figure B-9 (Appendix B – May 2021 Aerial Photography – page B-10)**. Between November 2014 and May 2020, the MHWL at B-54 had receded by about -208 ft which equates to a rate of -38 ft/yr. At B-55, over the same period of time, the MHWL had receded -130 ft, or about -24 ft/yr. In contrast, **Figure B.9** qualitatively shows improved beach conditions at the two (2) profiles lines noted above due to the most recent federal beach disposal project completed in April 2021. For example, at B-54 the effective MHWL was extended seaward approximately 75 ft between November 2020 and May 2021. At B-55, the MHWL was moved seaward approximately 40 ft. Neither of these conditions represents an “equilibrated” beach profile and is subject therefore to change. Another influencing factor will be whether beach fill placed westward of the Shoals Club facility will eventually move eastward toward Cape Fear, thereby reversing erosional trends experienced over the last two decades, subsequent to the 2001 federal disposal project which benefited the entirety of the South Beach shoreline.

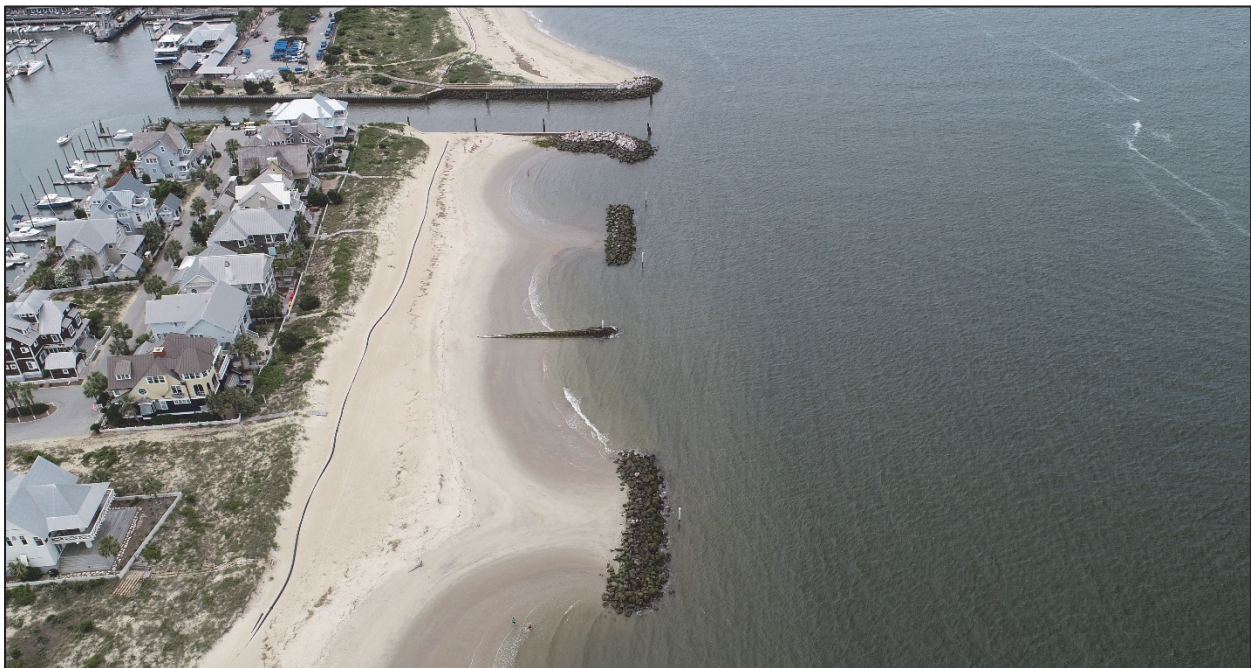
**Figure 3.11:** Southward looking view of the Row-Boat-Row shoreline detached breakwaters (June 2021 photo).

In early 2017, after completion of a 26,000 cy beach fill placed by Marcol Dredging along the Row Boat Row shoreline, two detached rock breakwaters were constructed by Intra Coastal Marine Construction. Final acceptance of the project occurred in July 2017. Subsequently, the shorefront within the influence of the two shore parallel structures has equilibrated into a series of discrete crenulate features between tombolos which extend from the center of each breakwater in a landward direction (**Figure 3.11**).
