# Village of Bald Head Island, NC

**April 5, 2022**

## **Coastal Sustainability Shoreline Management Program & Terminal Groin**

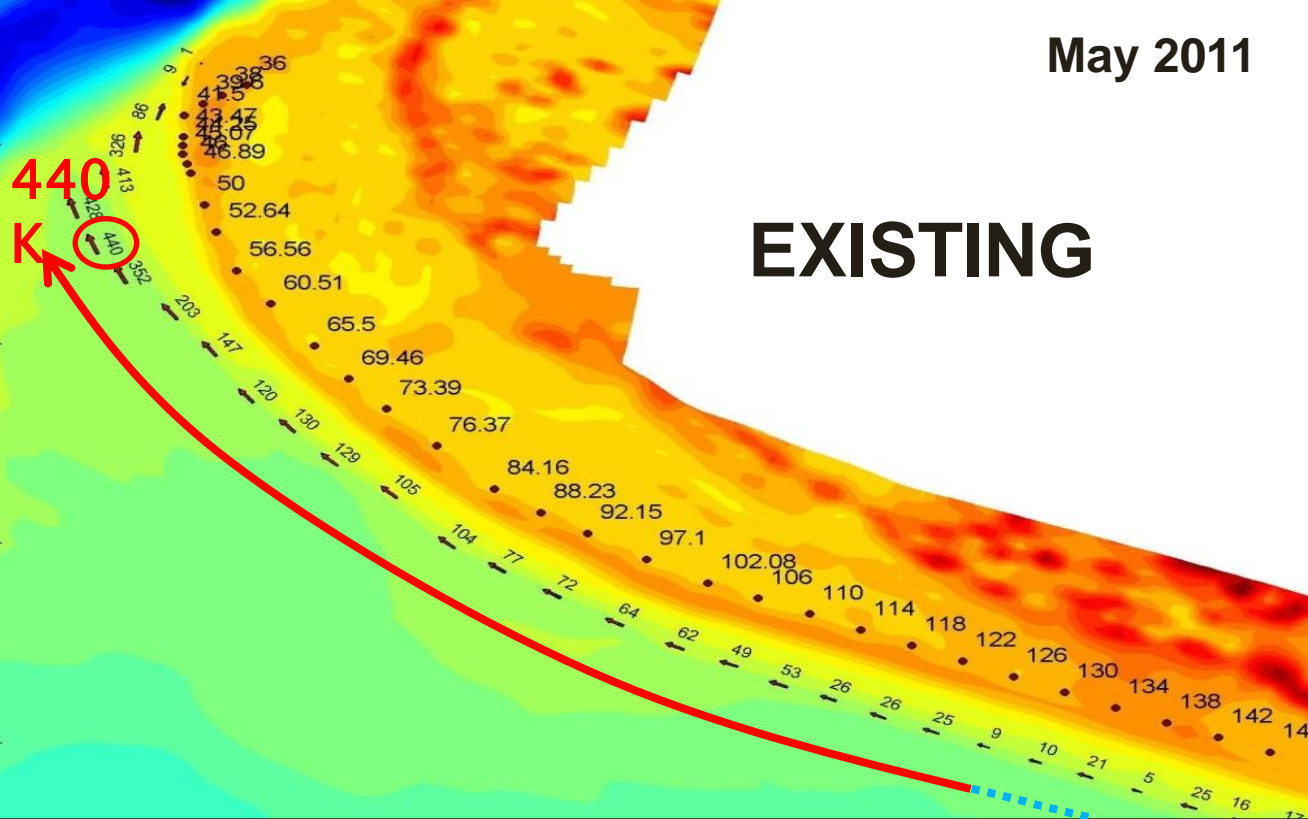
# Sediment Transport Potential (cy/yr)

**EXISTING**

**Accretional  
Fillet**

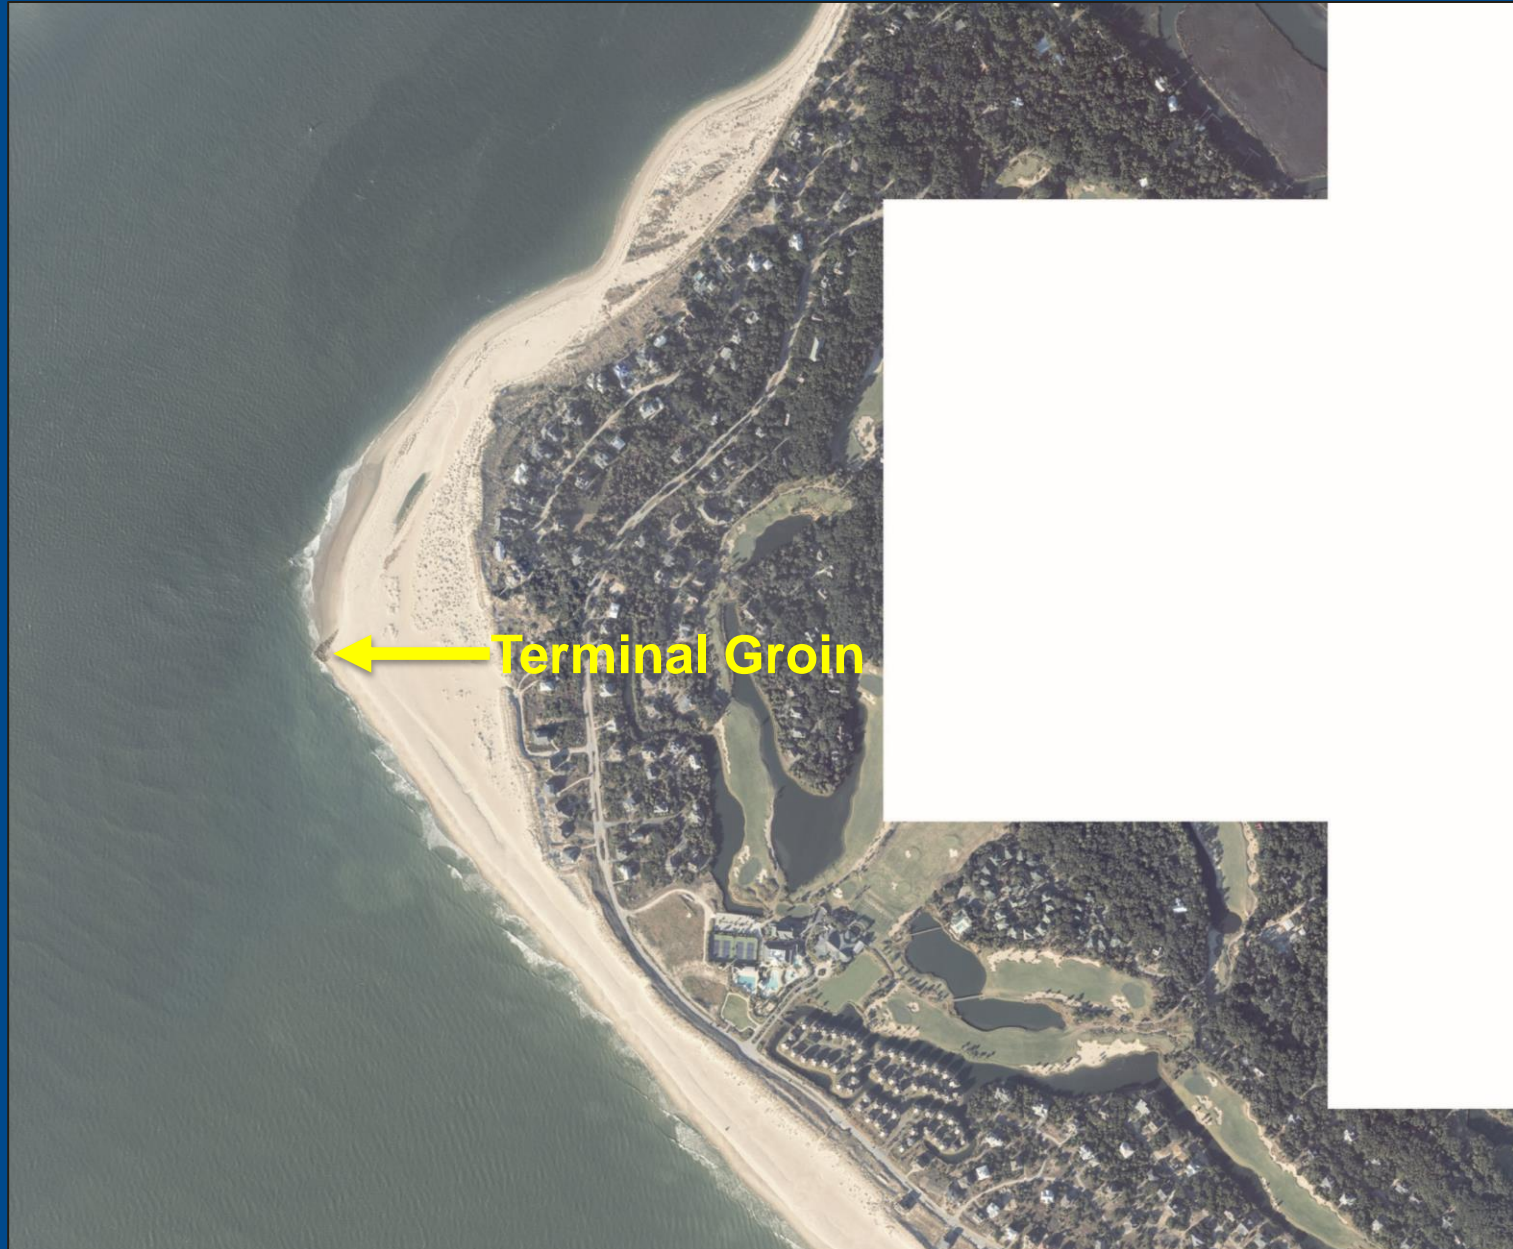
# EXISTING CONDITIONS (NOV. 2021)

**ATLANTIC OCEAN**

**● END OF STRUCTURE (1,300 FT)**

**CAPE  
FEAR  
RIVER**

**TIE BACK (DUNE)  
(STA 0+00)**
