Bald Head Island, N.C. Beach Monitoring Program

Monitoring Report No. 21 (May 2022 to May 2023)

Prepared for:
Village of Bald Head Island

Prepared by:
Olsen Associates, Inc.
2618 Herschel Street
Jacksonville, FL 32204
(904) 387-6114
(Fax) 384-7368
olsen-associates.com
C-1468

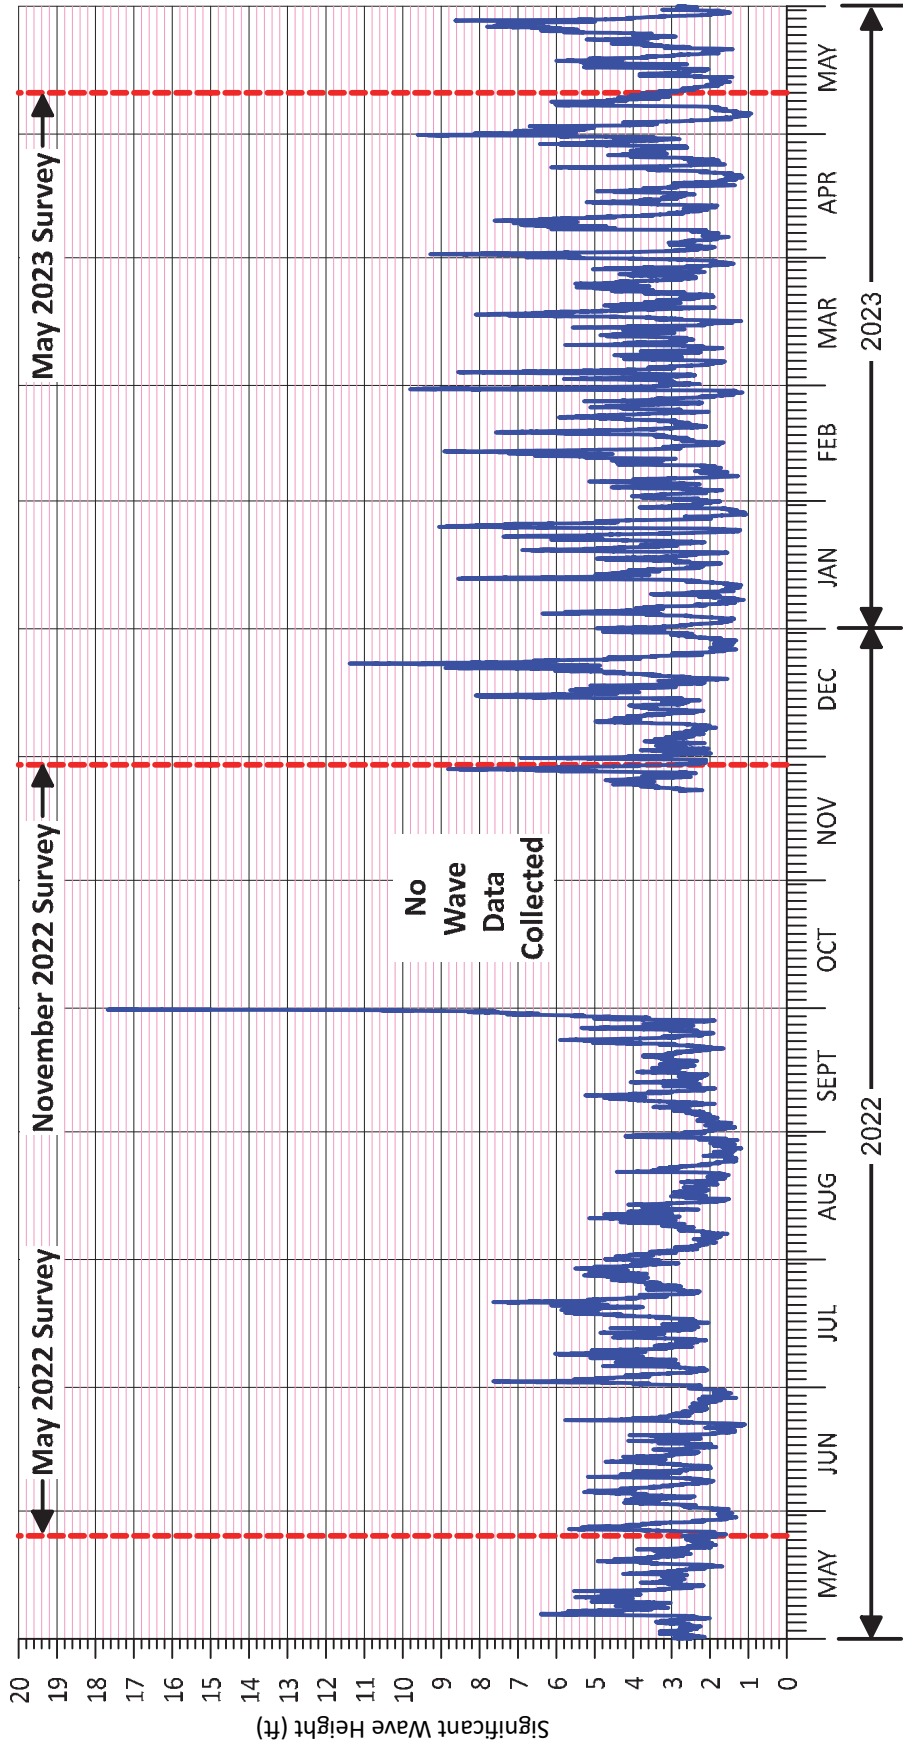
Figure 1.6: Significant wave heights recorded by NOAA Buoy 41108 during the 2022-23 monitoring period (Wilmington Harbor, NC).

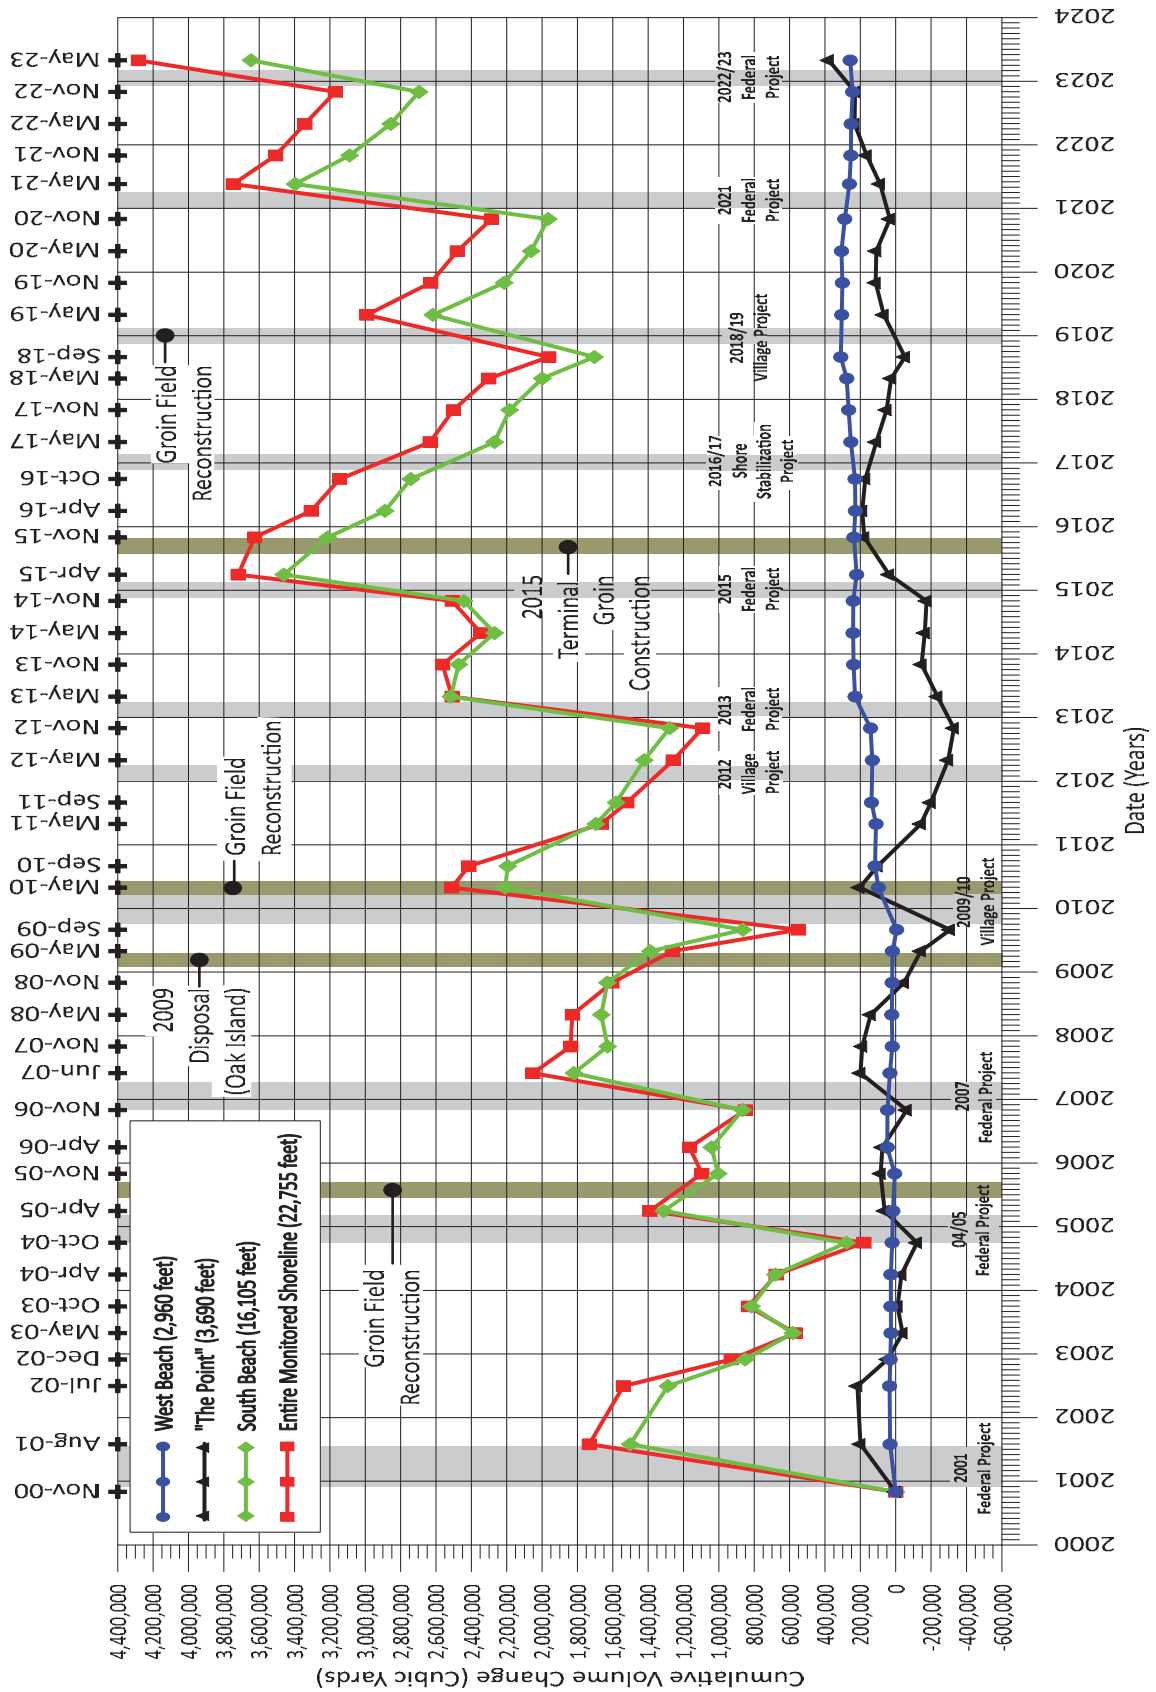
For purposes of tracking gross sand placement performance, **Figure 3.6** plots a time history of cumulative volume change relative to November 2000 conditions. **Figure 3.7** presents net volumetric change (alongshore above -16 ft NGVD) for the maximum period of comparison to date (*i.e.* November 2000 and May 2023). In both Figures the effects of direct South Beach sand placement over time are included. As with other similar analyses over the last decade, East Beach, Cape Fear and Row Boat Row are *excluded* from this analysis.

The classic “saw-tooth” effects of episodic sand placement (and subsequent sand losses over time), as reflected in **Figure 3.6**, are indicative of the periodic infusion of sand along South Beach at Bald Head Island associated with the placement of sand during initial construction of the channel deepening project, six (6) subsequent beach disposal operations pursuant to the WHSMP, the proactive beach renourishment project constructed by the Village in 2009/10 and to a smaller degree the emergency fill of 2012. The Village 1.85 Mcy fill was constructed with the knowledge gained through monitoring that certain irreparable large-scale impacts to Bald Head Island would predictably occur as a direct result of the proposed diversion of channel maintenance material in 2009 to Oak Island. *Note – a similar diversion of Federal maintenance sand occurred in the summer of 2018.* As a result of the 2018 federal sand disposal at Oak Island, the Village constructed a 1.1 Mcy interim beach fill at South Beach in the fall/winter of 2018/19. The most recent federal beach disposal project was completed in March 2023 along South Beach on Bald Head Island. Over the following 2 months, mol the fill berm had just begun to equilibrate. Similarly, a portion of that sand placed can be found as an accretional spit located immediately westward of the terminal groin. The episodic formation of that depositional feature was intended “by design” in order to maintain a sand supply to West Beach – subsequent to terminal groin construction.

Figure 3.6: Cumulative volume change (above -16 ft-NGVD) relative to November 2000 conditions.

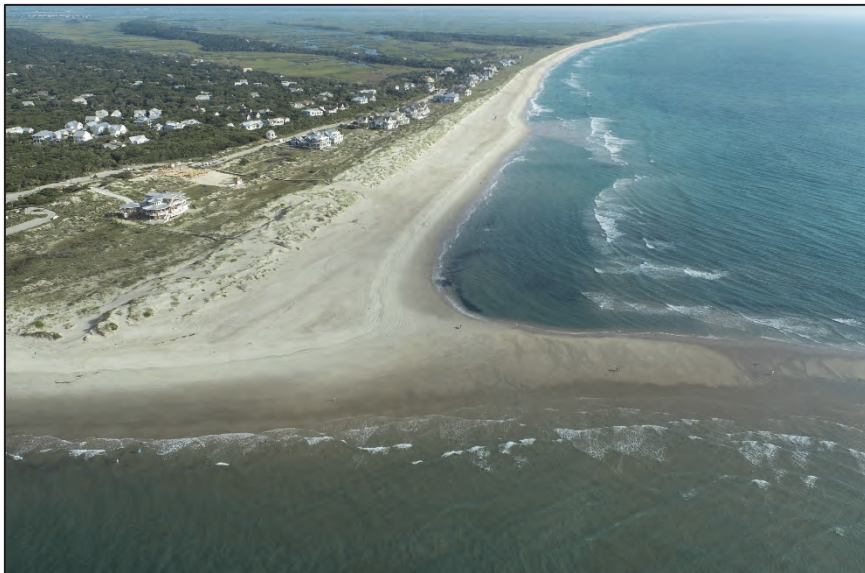
Figure 3.9:
Northward looking view
of East Beach from Cape
Fear. (July 2023 Photo).

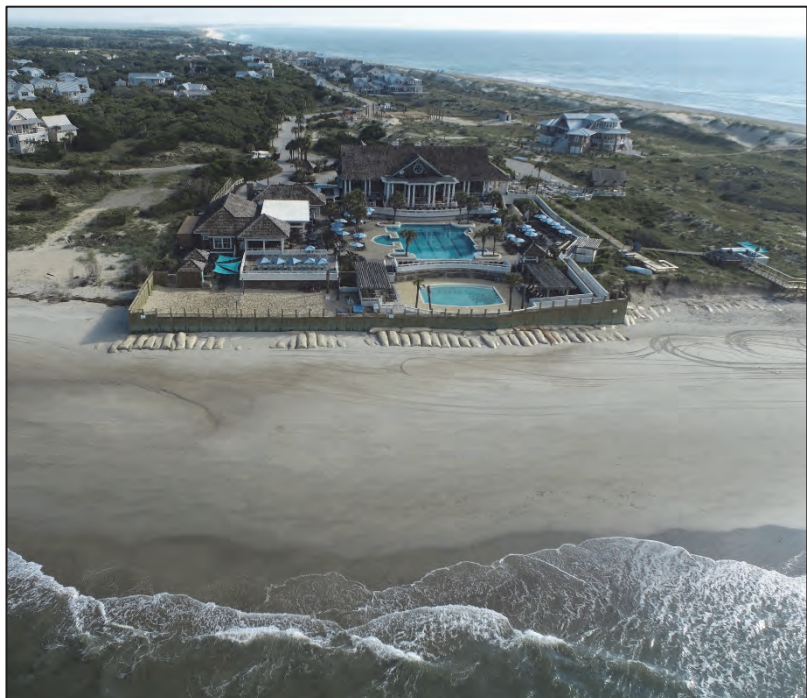
Figure 3.11:
View of the South Beach
Shoals Club facility.
(July 2023 Photo).

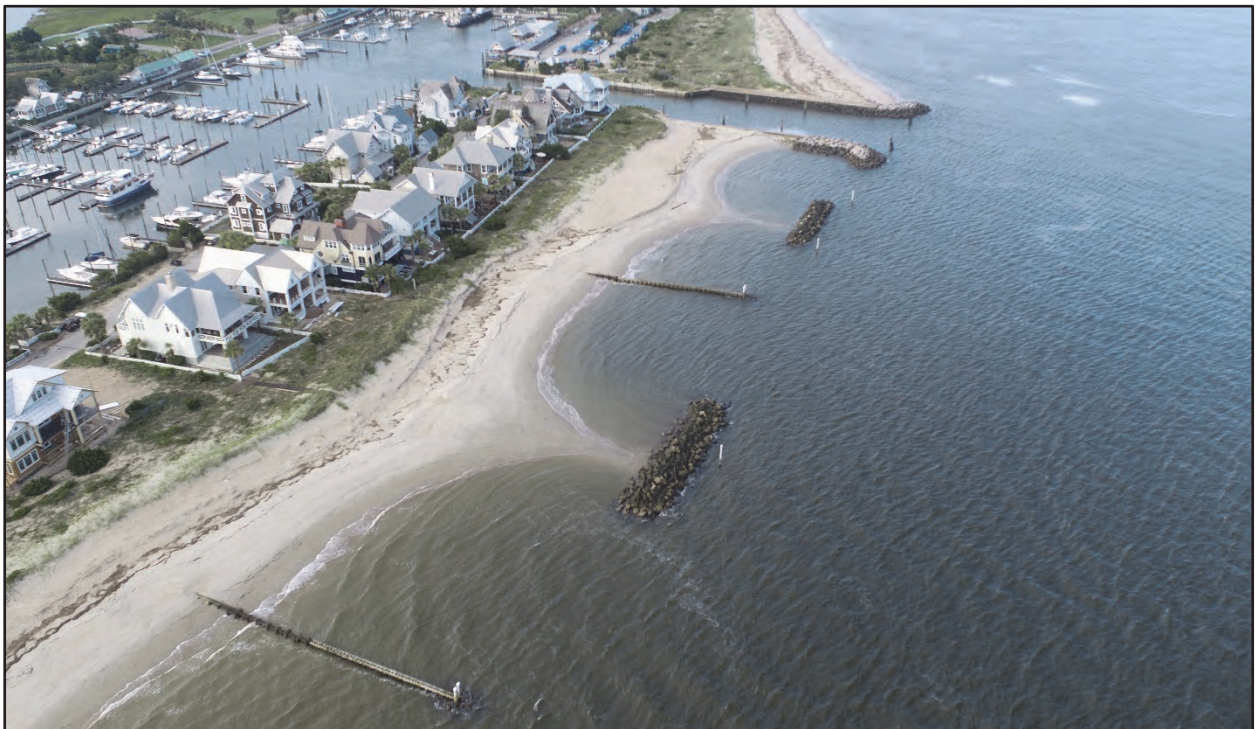
In early 2017, after completion of a 26,000 cy beach fill placed by Marcol Dredging along the Row Boat Row shoreline, two detached rock breakwaters were constructed by Intra Coastal Marine Construction. Final acceptance of the project occurred in July 2017. Subsequently, the shorefront within the influence of the two shore parallel structures has equilibrated into a series of discrete crenulate features between tombolos which extend from the center of each breakwater in a landward direction (**Figure 3.13**).

Figure 3.13: Southward looking view of the Row-Boat-Row shoreline detached breakwaters (July 2023 photo).
