SHOALS CLUB EROSION STUDY

BALD HEAD ISLAND, NORTH CAROLINA

SEPTEMBER 2023

PREPARED BY
COASTAL PROTECTION ENGINEERING OF NORTH CAROLINA, INC.
ENGINEERING LICENSE CERTIFICATE #: C-2331

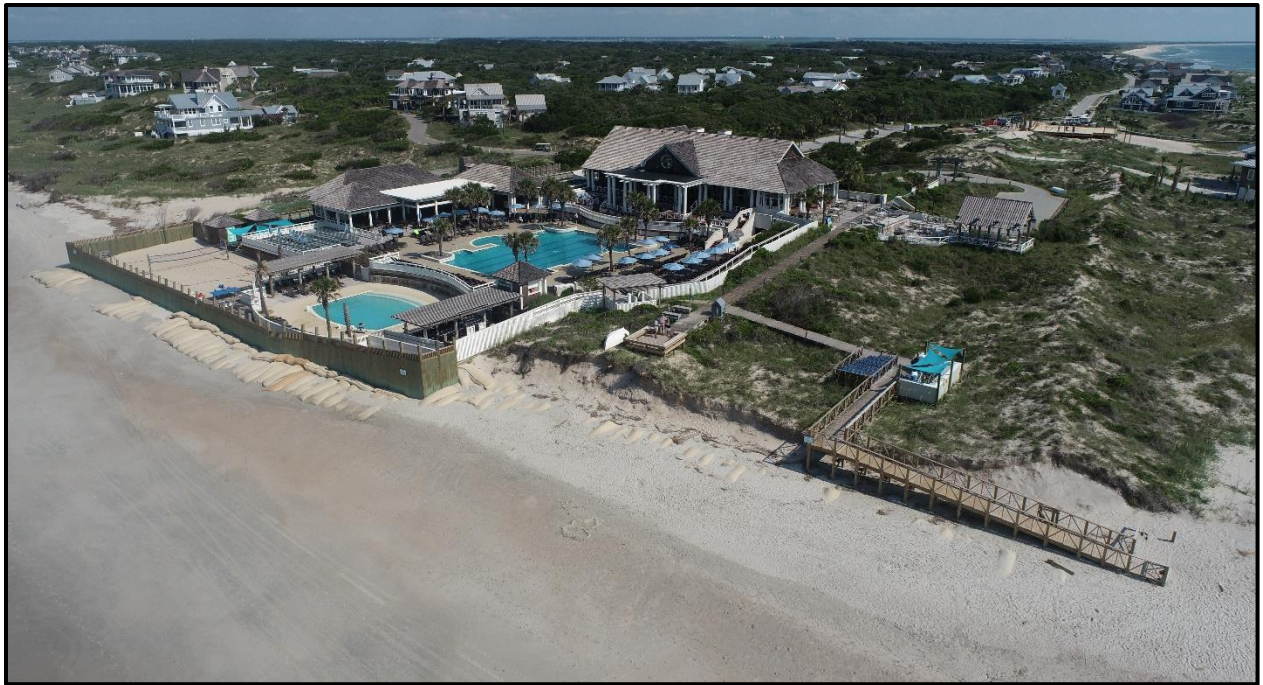
Figure 4: Sandbag revetment placed in front of the Club in June 2022. Photo from July 2023.

Despite the addition of millions of cubic yards of sand to South Beach over the years, recent erosion experienced along the southeastern end of the island prompted the Club to install a sandbag revetment in June 2022 to prevent impacts to the Club infrastructure (see **Figure 4**).

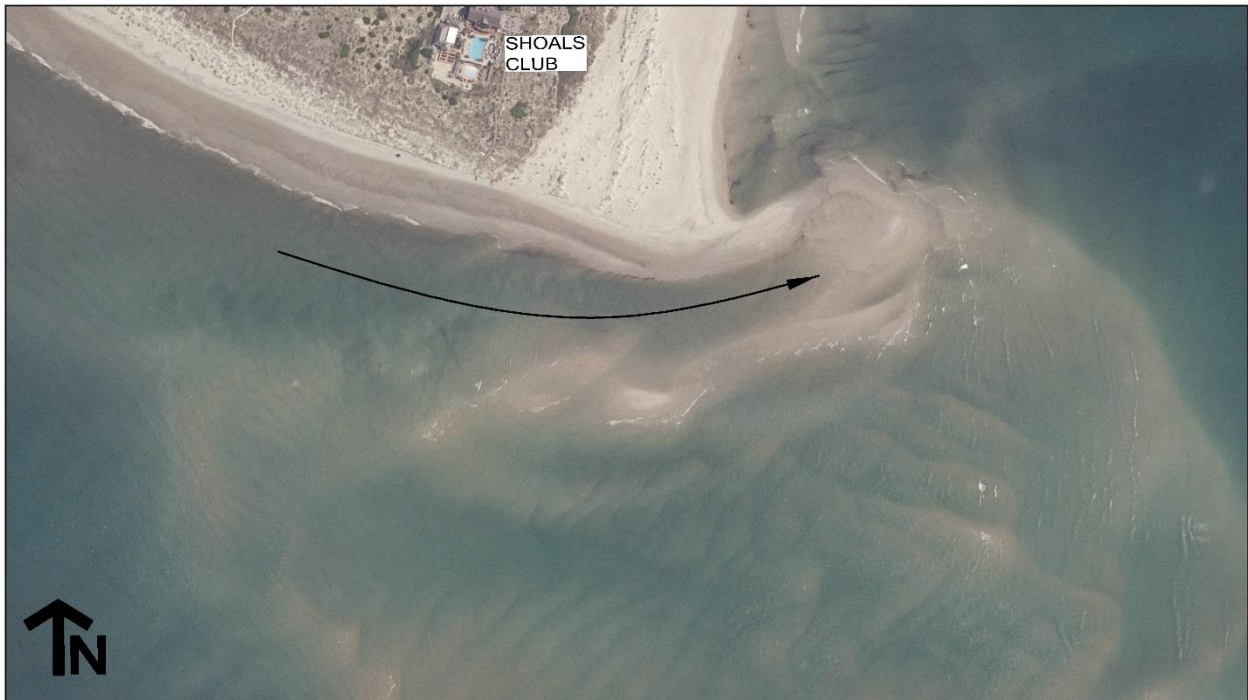
Figure 9: Example "overwash" fan at the Cape Fear point from May 2014 aerial.

Along the waterline on South Beach, an alongshore current appeared to flow to the east as suggested by the sub-aqueous “overwash” fans at the terminus of the Cape Fear point. This is especially clear in the photos after May 2007 in **Appendix B.2** (zoomed in scale). These fans are most evident in the 2014, 2018, and 2020 aerials. **Figure 9** illustrates an example of the evidence of an alongshore current and sandbar overwash from the May 2014 aerial image. These strong currents likely increase easterly sediment transport along the beach fronting the Club, resulting in shoreline retreat, as well as prevent the southward progradation of the point. Similar features can be observed in the aerials as a result of strong alongshore currents flowing to the south along East Beach.

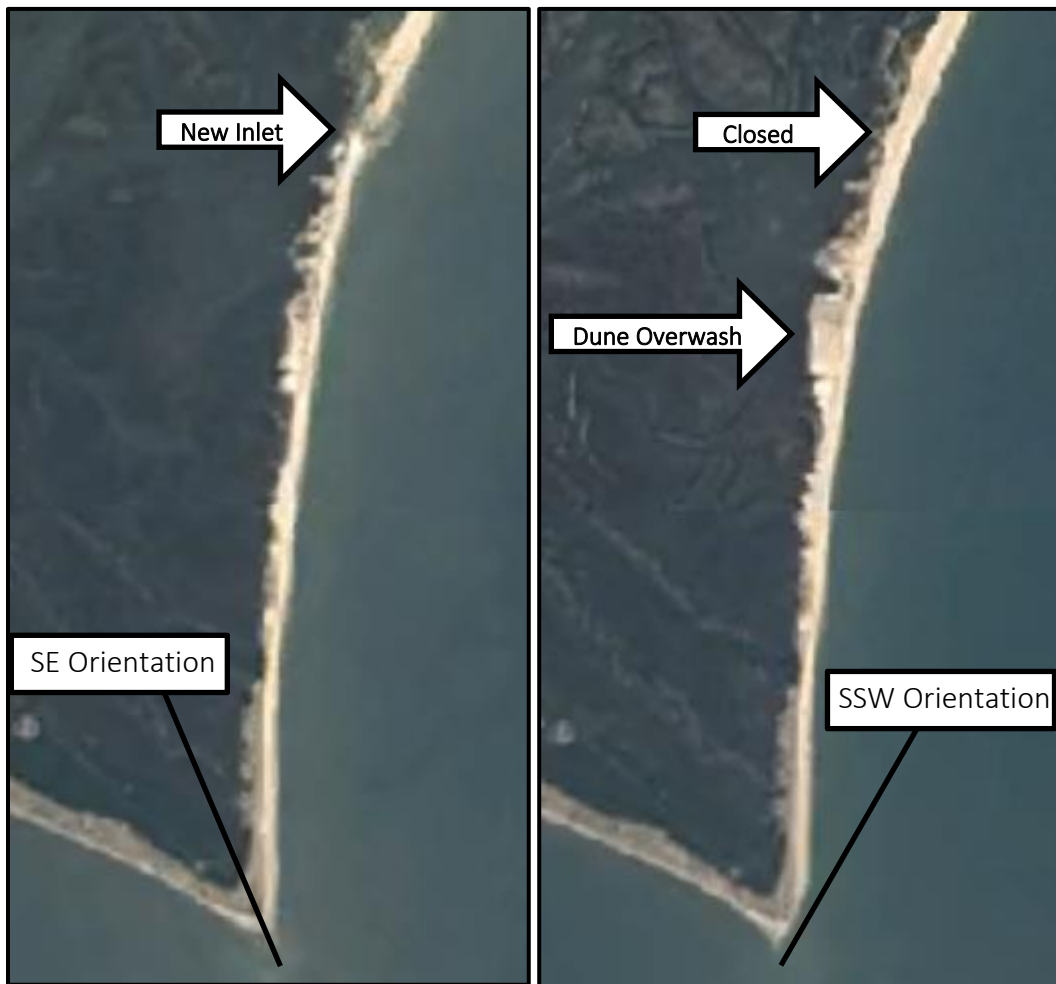
Figure 10: Google Engine timelapse imagery illustrating BHI in 1998 (left) and 1999 (right), pre- and post-Hurricane Floyd.

Lastly, changes in coastal conditions were additionally investigated using Google Earth Engine’s Timelapse feature. This webpage provided an animation of annual aerial imagery from 1984 to 2022. Through comparison of the 1998 and 1999 aerals, the orientation of the Cape Fear point was observed to rotate from southeast to south-southwest, and signs of significant dune overwash can also be seen along East Beach as well as the closure of New Inlet (see **Figure 10**). These observations indicate the westerly-directed transport of sand across East Beach, the point, and likely Frying Pan Shoals. During this time period, Hurricane Floyd impacted Bald Head Island and the North Carolina coast as it made landfall near the BHI in September 1999 (NHC, 2014). Hurricanes Denis and Irene additionally produced offshore wave heights in excess of 19 ft during the same season (see **Appendix F.1**). The morphologic changes illustrated in the figure below were likely the result of these three storms. The LIDAR bathymetric map in **Figure C.2** of **Appendix C** provides another view of the reoriented Cape Fear point in October 1999, one month after Hurricane Floyd impacted the area.

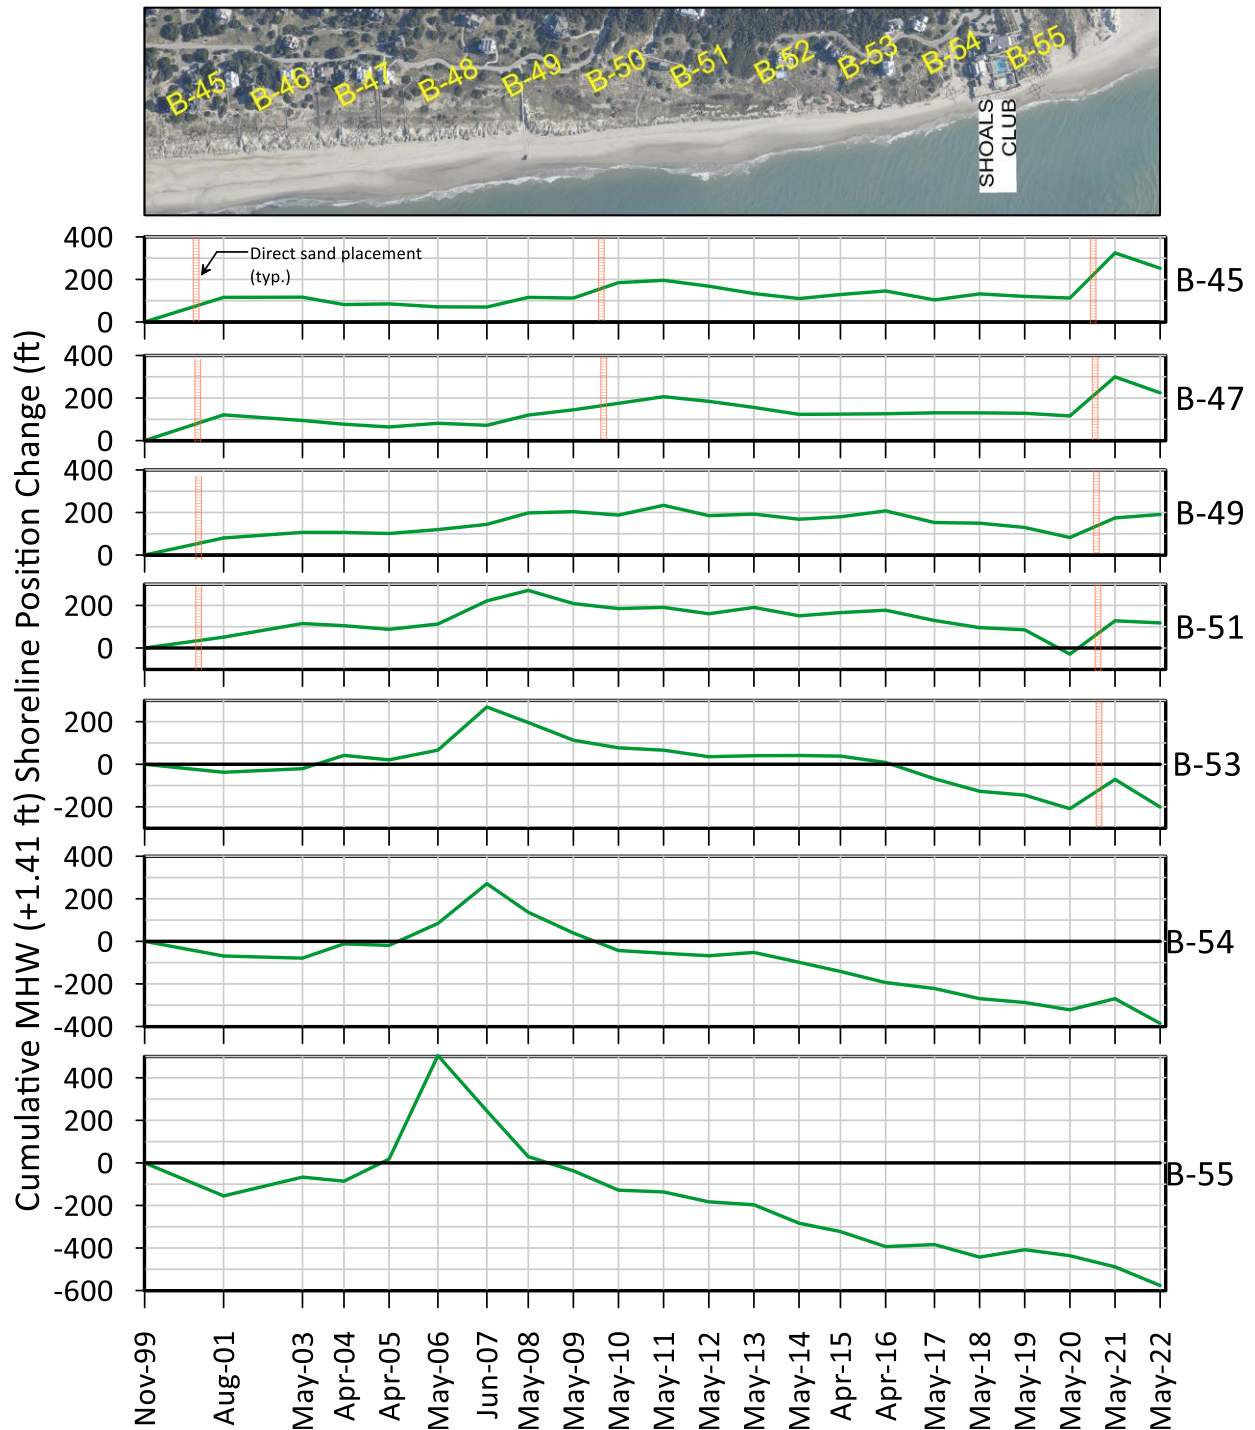
Figure 11: Cumulative MHW (+1.41 ft NAVD88) shoreline position change (ft) along South Beach stations B-45 to B-55 from November 1999 to May 2022.

The growing influence of the Cape Fear point on the MHW shoreline positions is evident in **Figure 11**. From 2005 to 2006, the point shoreline advanced significantly to the south, which caused an updrift, seaward advancement of the shoreline in front of the Club at station B-55 of around 500 ft. By June 2007, this advance continued further updrift to stations B-54 and B-53, which measured advances of approximately 250 ft. The MHW line at station B-51 advanced nearly 200 ft from May 2006 to May 2008; however, the advance at this station may be the result of both the updrift accretion wave as well as a renourishment project in 2007 located 3,000 to 4,000 ft to the west. The significant MHW shoreline advance at these stations was followed by steady shoreline retreat until the most recent survey in May 2022. From May 2008 to May 2022, the MHW shoreline at station B-55 steadily retreated an average of approximately -43 ft/yr.

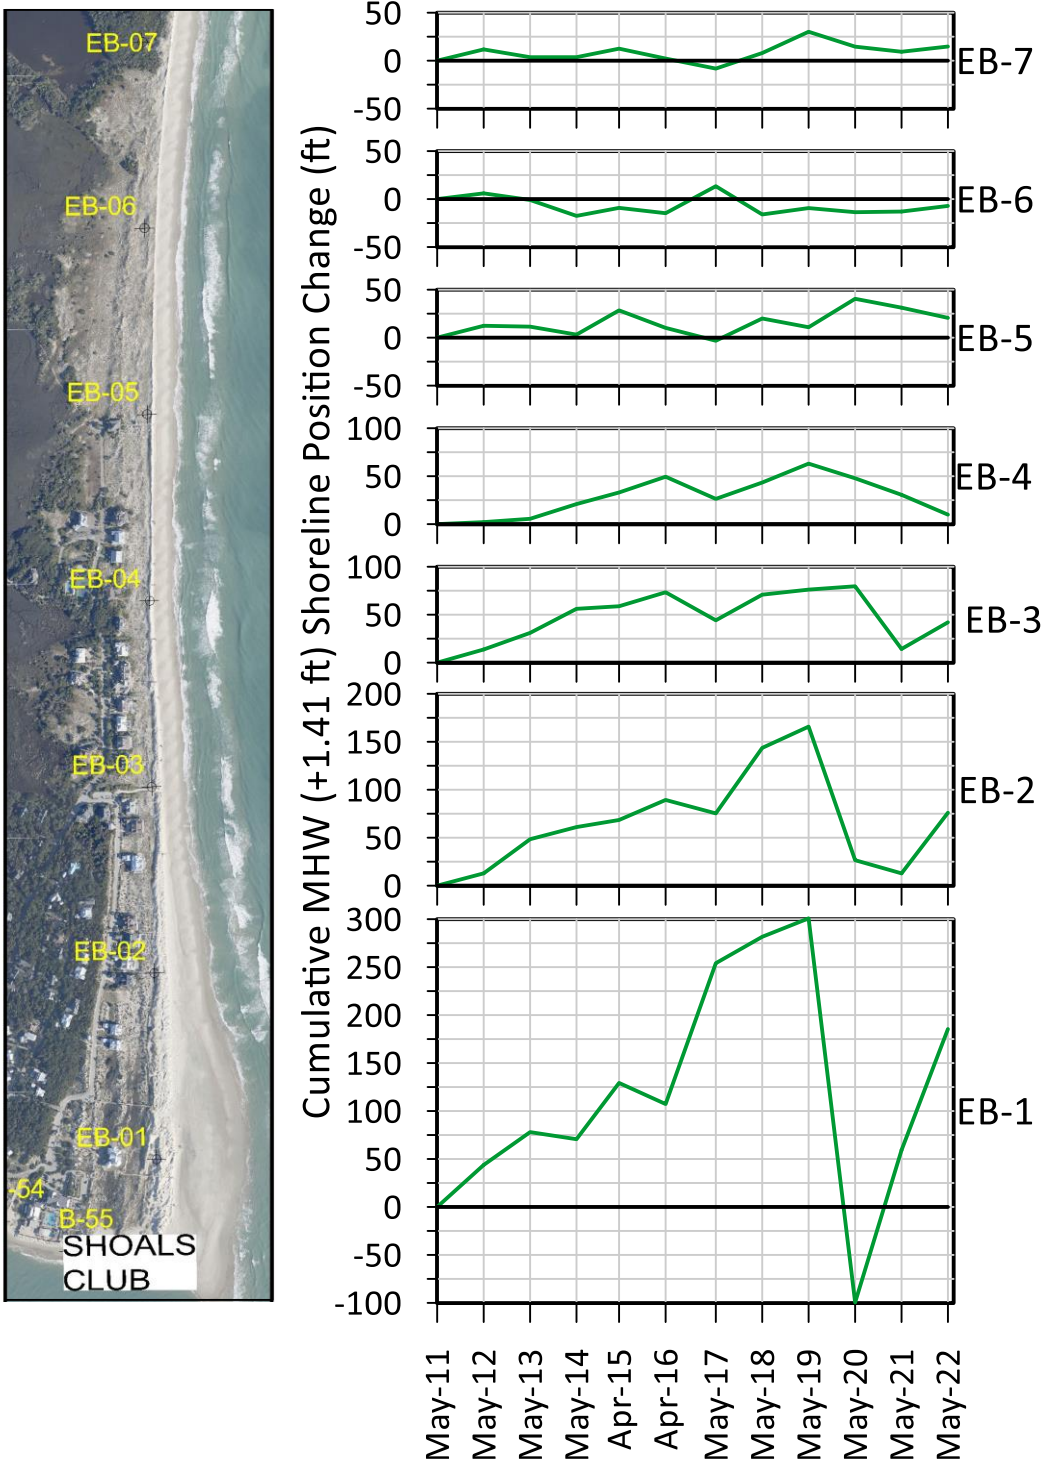
Figure 12: Cumulative MHW (+1.41 ft NAVD88) shoreline position change (ft) along East Beach stations EB-1 to EB-7 from May 2011 to May 2022.

Figure 12 depicts the cumulative MHW shoreline position changes along East Beach from May 2011 to May 2022. During this time period, the overall shoreline advancement rates increased from north to south, averaging +1.5 ft/yr at station EB-7 to +18.5 ft/yr at station EB-1. Similar to South Beach, the position changes fluctuate drastically with increasing proximity to the Cape Fear point. From station EB-7 to EB-5, the shoreline positions were largely stable to slightly advancing. From station EB-4 to EB-1, the MHW shorelines steadily advanced from May 2011 to May 2019. From 2019 to 2020, the figure reveals a substantial retreat event occurred at stations EB-1 and EB-2 of -400 ft and -140 ft, respectively. This occurrence was likely related to the passing of Hurricane Dorian in September 2019. Thereafter, a south to north “wave” of shoreline recovery (advance) appeared to occur at station EB-1 and two years later at stations EB-2 and EB-3.

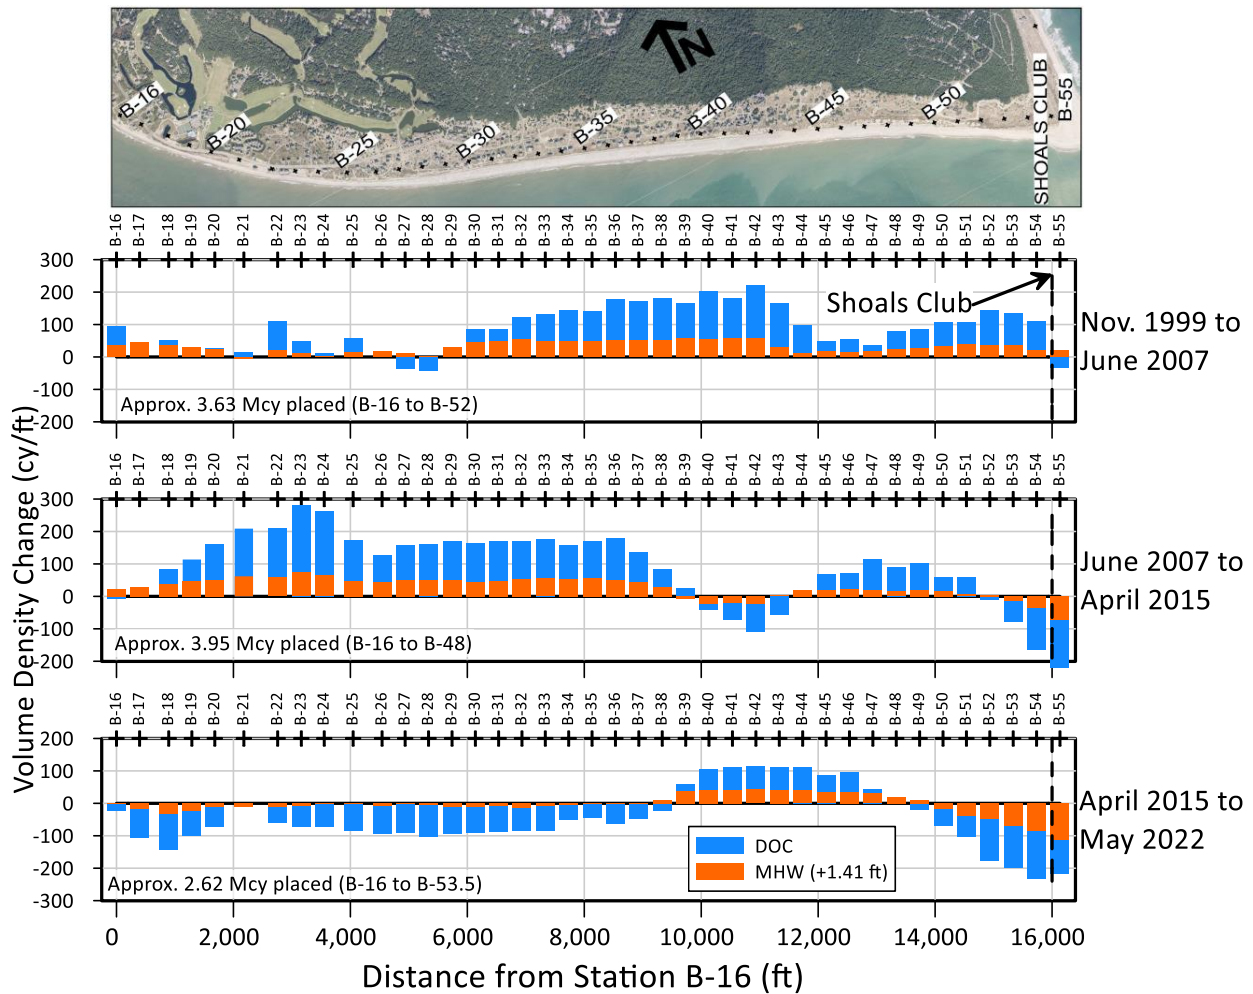
Figure 14: Volume density changes along South Beach from during three different time periods above MHW (+1.41 ft NAVD88) and the depth of closure (DOC).

erosion along the eastern end of South Beach moved westward (updrift) from the point. Most notably, the beach profile adjacent to the Club (B-55) eroded approximately -112 cy/ft above MHW and -216 cy/ft above the DOC during the seven-year period from 2015 to 2022.

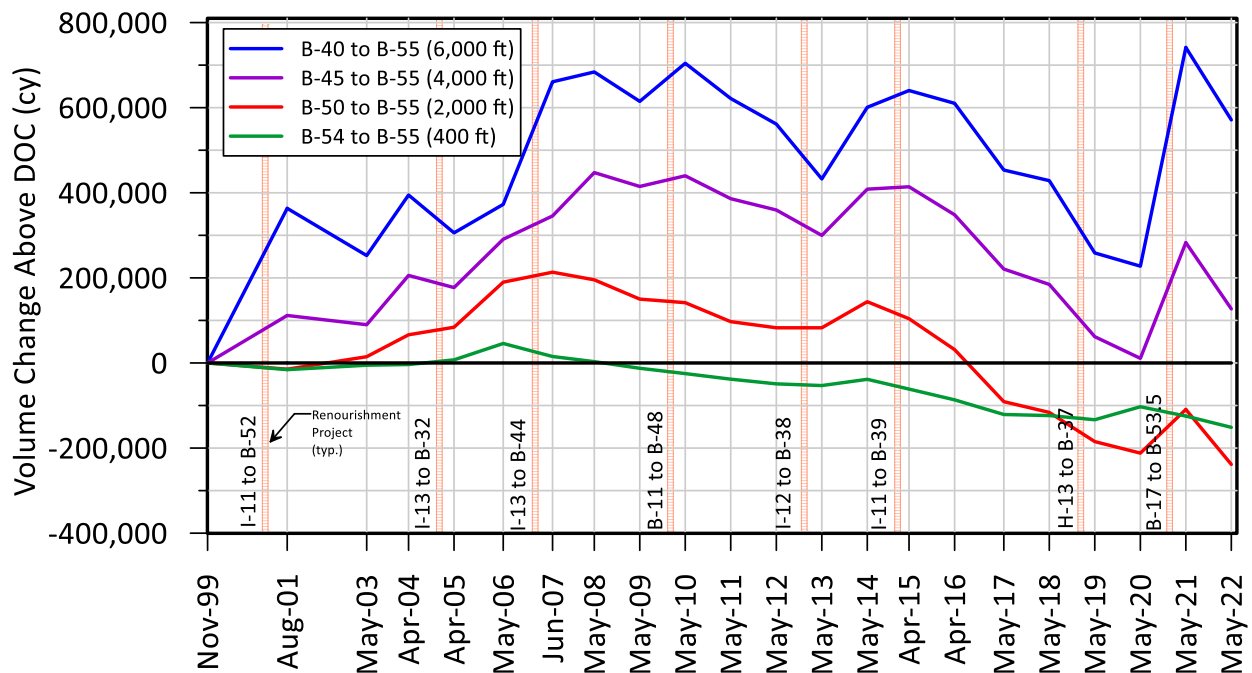
Figure 15: Cumulative volume change above the DOC datum along various sections of South Beach from 1999 to 2022. The beach profile stations beginning with I and H are located along West Beach, outside of the study area in this report.

Volume changes were also calculated using the average-end area method utilizing the volume densities previously described and the distances between adjacent beach profile stations. **Figure 15** presents the cumulative volume changes above the DOC line along different lengths of beach west of the Club from 1999 to 2022. The various lines represent different lengths of beach, as listed in the legend; therefore, they should not be directly compared. The orange vertical lines signify the placement of beach fill along the shorelines named next to the vertical lines. Note that fill was not necessarily placed within each analyzed segment of beach during the renourishment projects. For example, the second renourishment event that occurred in 2005 did not place fill in any of the analyzed beach segments.

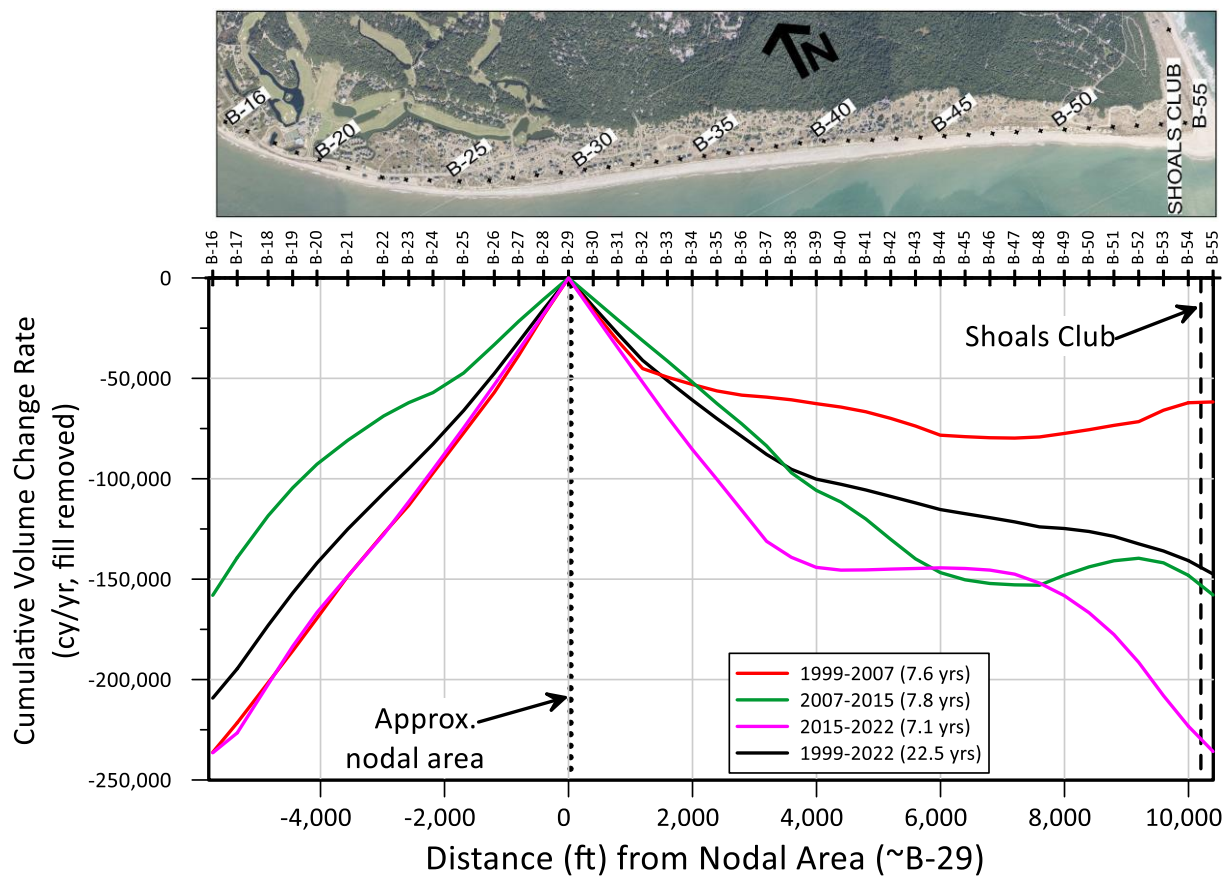
Figure 18: Cumulative volume changes rates above the depth of closure with beach fill volumes removed for various time periods from 1999 to 2022 along South Beach, relative to the nodal area.

Figure 18 presents the annualized, cumulative volume change rates above the DOC along South Beach during four periods of interest between 1999 to 2022. The calculated volume changes were adjusted to remove the effects of placed sand due to a renourishment project, when necessary. Volume changes during each time period were summed cumulatively beginning at the approximate nodal area identified in Olsen (1989), where the net sediment transport diverges. This area is marked with the vertical dashed line at station B-29 in **Figure 18**. The cumulative addition of volume changes facilitates discerning spatial trends in erosion and accretion in the figure. Between the nodal area and the Club, erosion is evidenced by a negative slope (directed down and to the right), accretion by a positive slope (directed up and to the right), and a stable shoreline is horizontal.

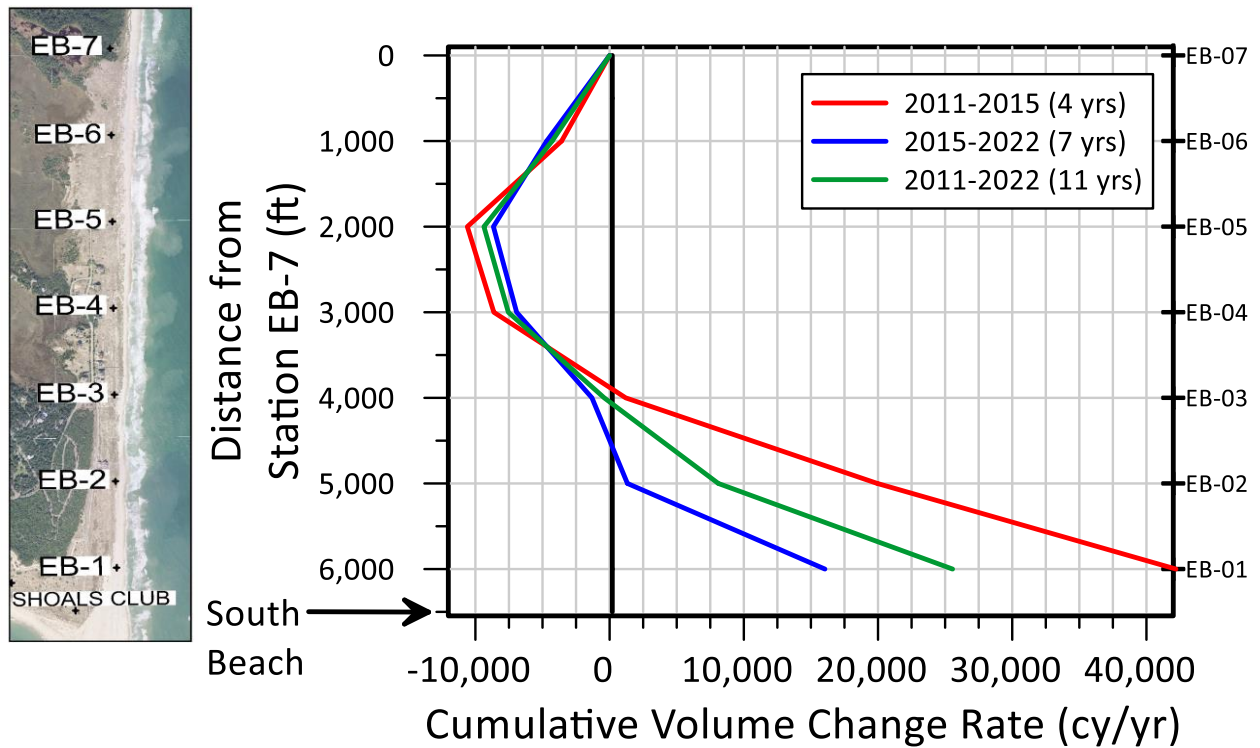
Figure 19: Cumulative volume changes rates above the depth of closure for various time periods from 2011 to 2022 along East Beach.

A similar analysis was conducted along East Beach with the available survey data from May 2011 to May 2022. Volumes were summed from north to south beginning at EB-7. There were no beach renourishment projects along East Beach during this time period, so volume changes were not adjusted. **Figure 19** presents the annualized cumulative volume change rates along East Beach during the four-year period from May 2011 to April 2015, the seven-year period from April 2015 to May 2022, and the overall 11-year period from May 2011 to May 2022.

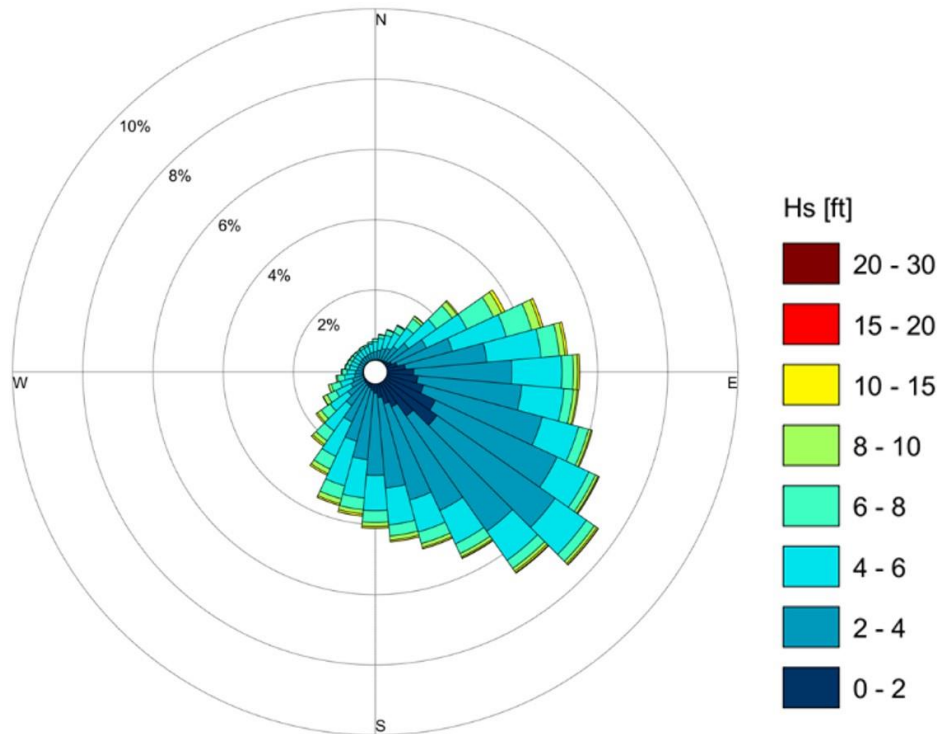
Figure 21: Directional wave statistics from WIS Station 63320 from January 1980 to December 2021.

feet in height most frequently came from the east-northeast and are most likely associated with winter season nor'easters. The greatest wave heights originated from the south and southeast, which are primarily associated with tropical storms and hurricanes.

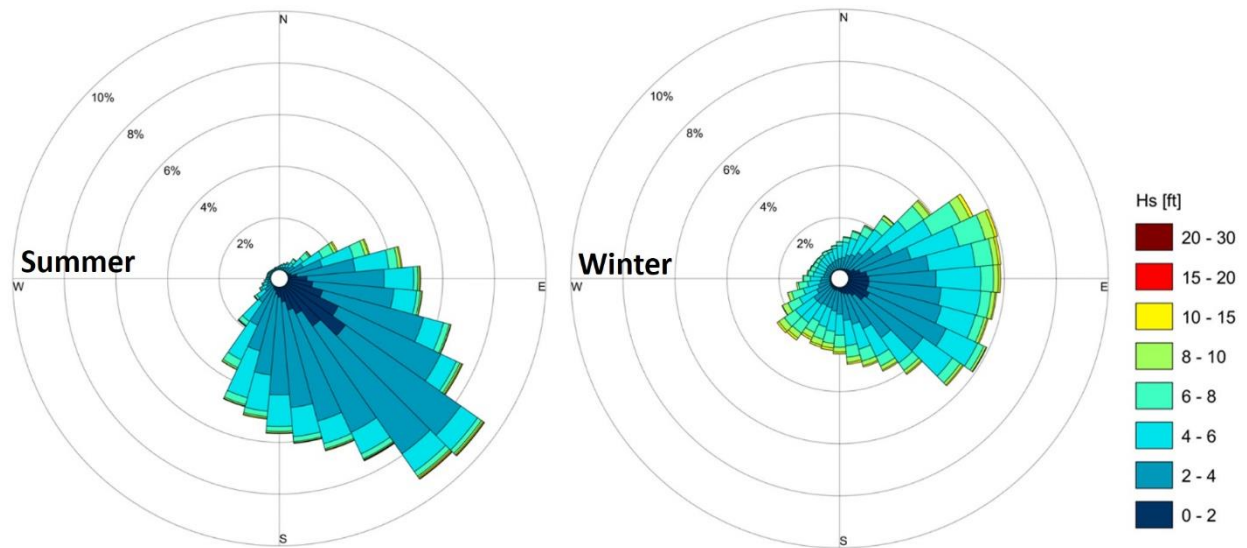
Figure 22: Directional wave statistics from WIS Station 63320 from January 1980 to December 2021 for summer (left, April through September) and winter (right, November through March).

The summer season is characterized by smaller waves arriving predominantly from the southeast direction. On average, the wave height during the summer months was 3.9 ft. Summer conditions can be episodically affected by the passage of tropical systems (i.e., hurricanes and tropical storms) originating from both the Atlantic Ocean and the Gulf of Mexico. Hurricanes and tropical storms can bring extreme winds, waves, and storm surge, which can cause significant morphological changes in coastal areas in a very short period of time. The impacts of these systems can be severe and can be influenced by the system's size, intensity, proximity, path, and forward speed in relation to an area. **Figure 23** illustrates the historic tracks of hurricanes that came within 30 miles

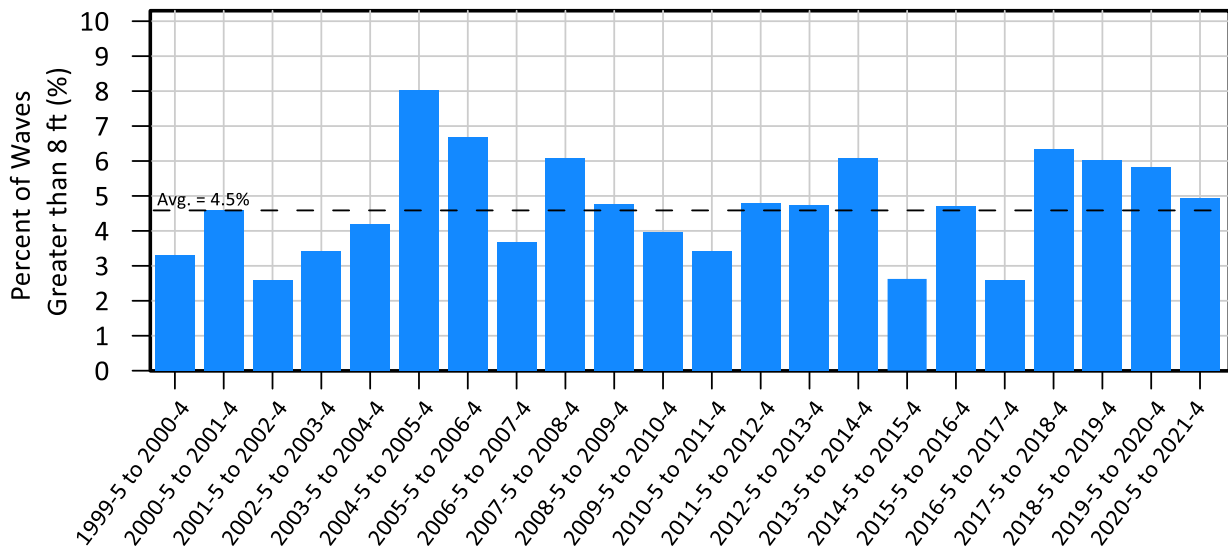
Figure 25: Percentage of waves greater than 8 ft during each monitoring year for WIS Station 63320.

The percentage of waves greater than 8 ft during each monitoring year is illustrated in **Figure 25**. These waves comprised between approximately 2.5% and 8% of all waves during the 21-year wave record, and on average, they comprised approximately 4.5%. The figure indicates that the 2-yr period from summer 2004 to summer 2006 as well as the 4-yr period from summer 2017 to summer 2021 experienced an above average frequency of wave conditions greater than 8 ft. In contrast, the 3-yr period from summer 2001 to summer 2004 was characterized by below average frequency of elevated wave conditions. During the past decade, eight of the years experienced above average frequency of elevated wave conditions. Overall, there is not a strong link between the cumulative volume change rates along South Beach in **Figure 18** and the wave climate illustrated in **Figure 24** and **Figure 25**.

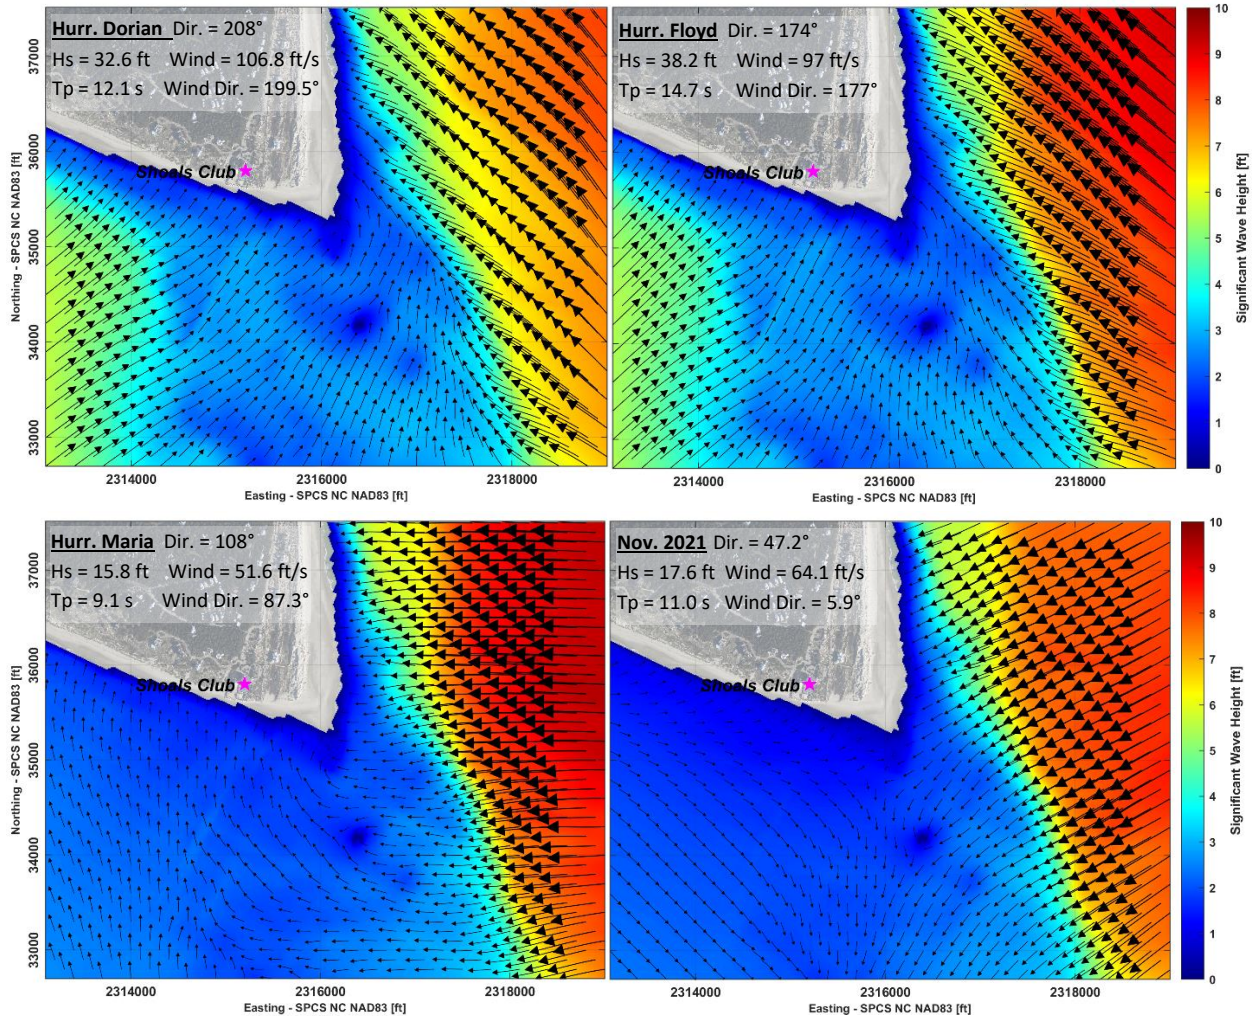
Figure 28: Wave modeling results of the four storm wave cases on the October 2022 bathymetry. The input wave parameters are listed on each panel in the upper left corner.

Similar to the average wave simulations, an alongshore gradient in wave height is visible on South and East Beach, depending on the input wave direction, with wave heights decreasing with increasing proximity to Frying Pan Shoals. This gradient is even larger in the storm wave simulations, which would result in even larger alongshore hydraulic gradients, which in turn drive stronger point-directed, alongshore currents. It is believed that these currents are responsible for the majority of the beach erosion issues that the Club has experienced during the past decade and a half.
