# Due Diligence Assessment

Produced for Bald Head Island Transportation Authority

March 5, 2019

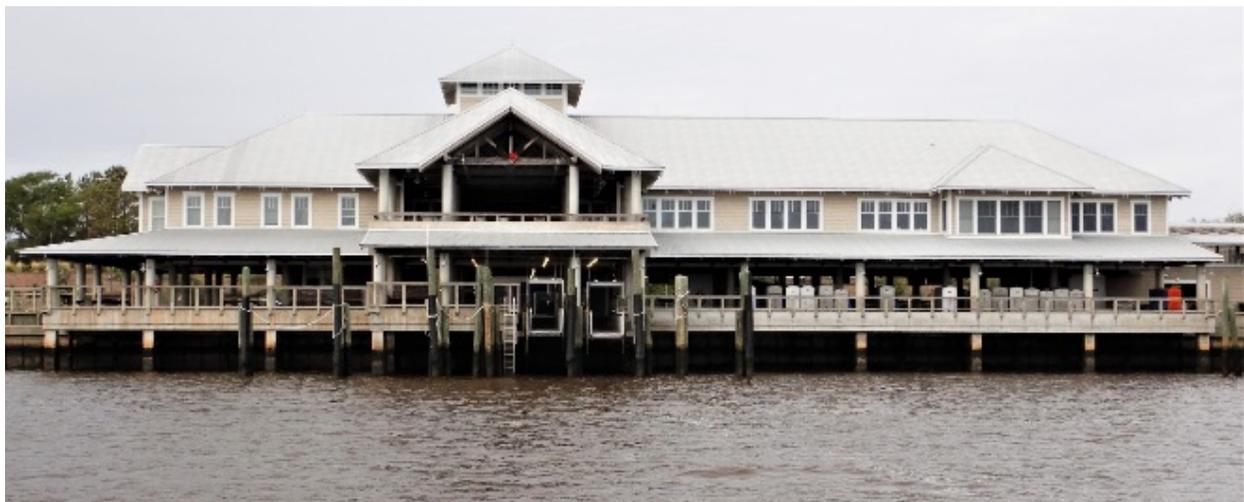
**FIGURE 2-1: DPM A-GATE PASSENGER LANDING ELEVATION VIEW (LOOKING WEST)**

Summary	
Construction	Concrete
Overall Condition	Good
Repair Priority	Low
Significant Defects	None
Recommendations	Routine Inspection & Maintenance
Recommended Repairs Estimate	\$0

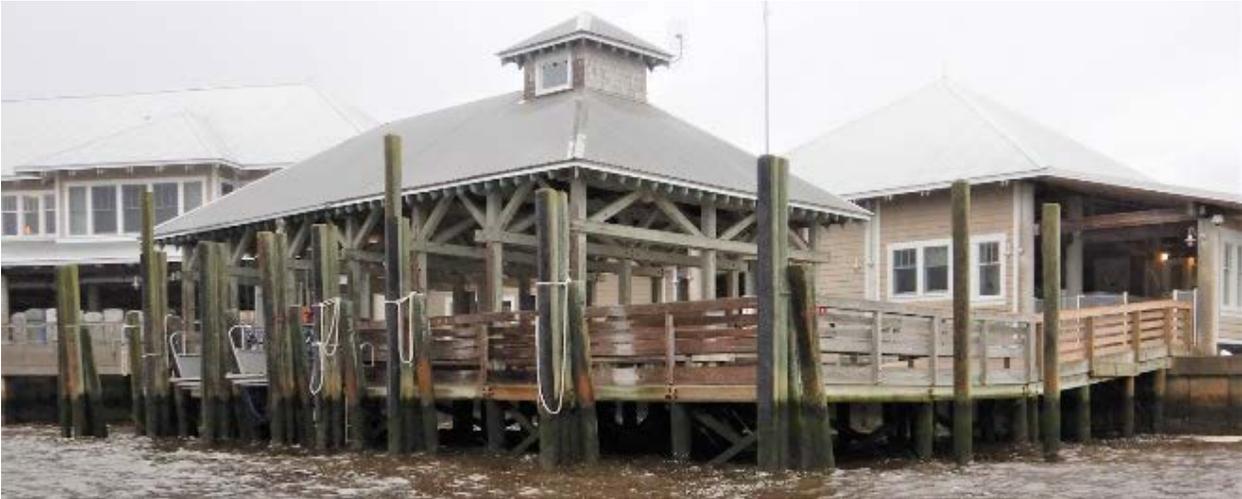
FIGURE 2-3: DPM B-GATE CONTRACTOR LANDING ELEVATION VIEW (LOOKING WEST)

Summary	
Construction	Timber
Overall Condition	Satisfactory
Repair Priority	Medium
Significant Defects	Steel tie straps are corroded/ wasted. Joist boards split 2 places
Recommendations	Repair minor timber framing defects and corroded steel tie straps.
Recommended Repairs Estimate	\$11,000

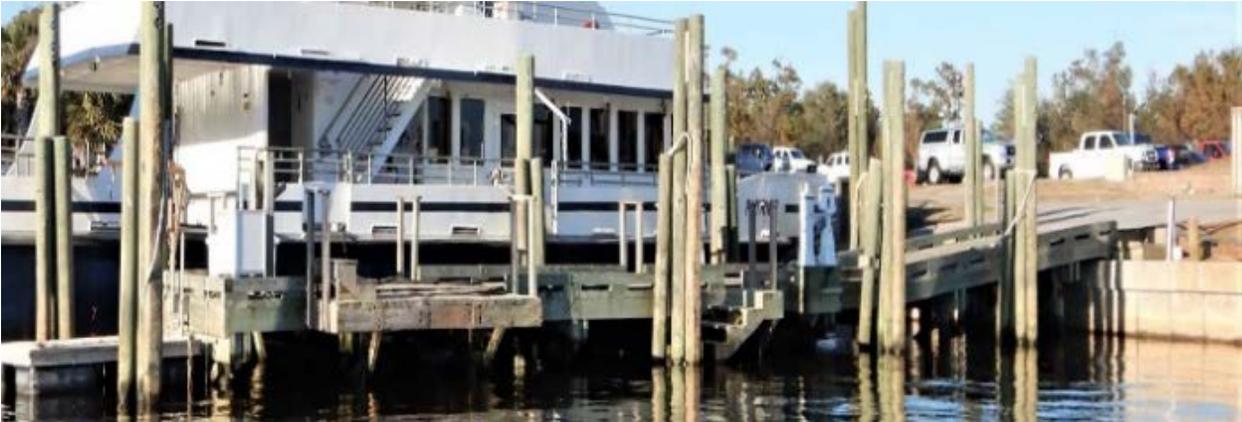
FIGURE 2-5: DPM MAINTENANCE FIXED PIER ELEVATION VIEW (LOOKING WEST)

Summary	
Construction	Timber
Overall Condition	Good
Repair Priority	Low
Significant Defects	Open bolt holes in piles.
Recommendations	Repair minor defects including bolt holes in timber piles and split bracing.
Recommended Repairs Estimate	\$1,000

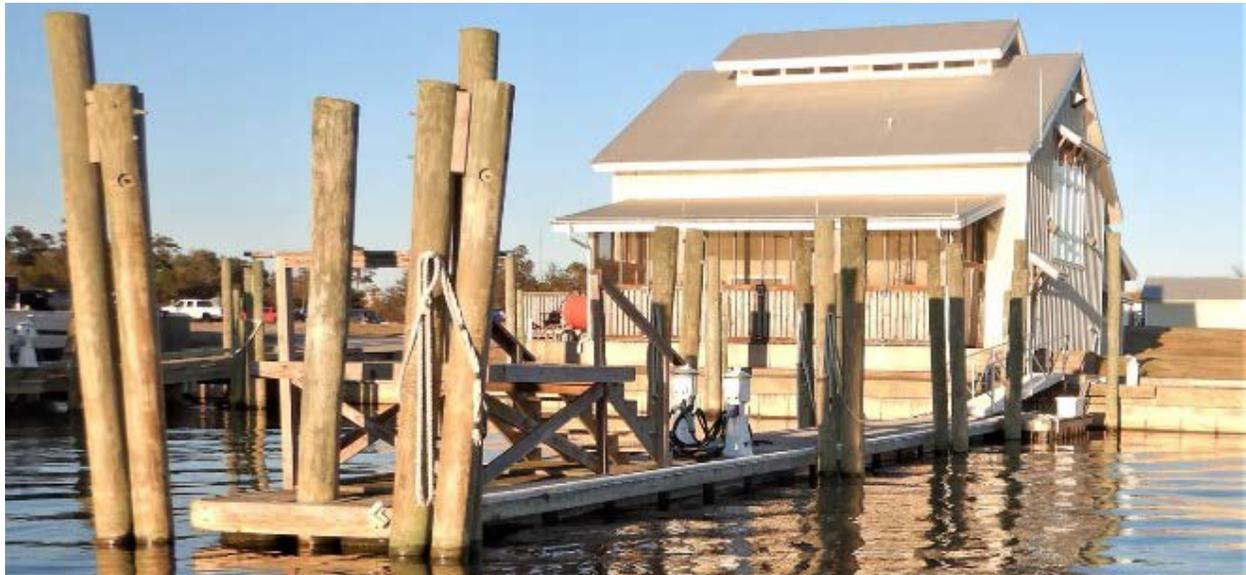
**FIGURE 2-7: DPM MAINTENANCE FINGER ELEVATION VIEW (LOOKING NORTHWEST)**

Summary	
Construction	Floats with Timber Piles
Overall Condition (Gangway Support Piles)	Satisfactory
Repair Priority	Low
Significant Defects	Gangway support pile section loss
Recommendations	Repair/replace gangway support pile
Recommended Repairs Estimate	\$10,000

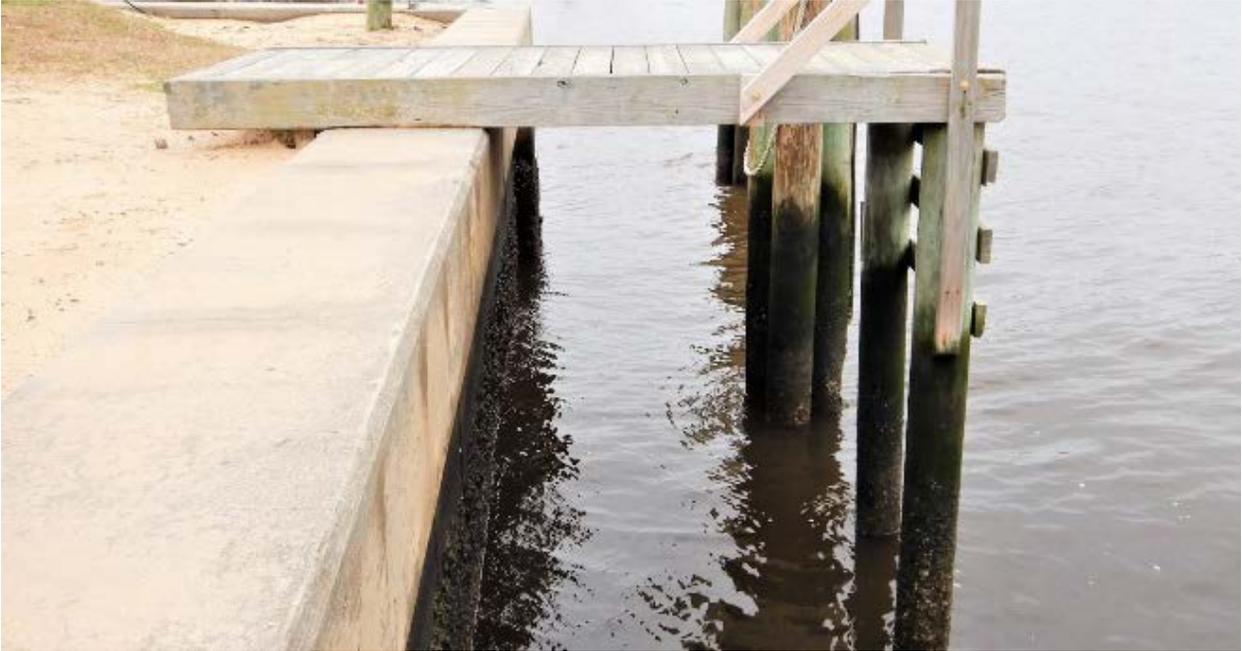
FIGURE 2-8: DPM "G" BERTHING PLATFORM ELEVATION VIEW (LOOKING SOUTH)

"G" Berthing platform is constructed of a timber deck supported by the marina bulkhead cap on the landside and a timber piles in the water. An above and below water inspection found the structure to be in good overall condition with no visible signs of damage or repairs needed.

Summary	
Construction	Timber
Overall Condition	Good
Repair Priority	Low
Significant Defects	None
Recommendations	Routine Inspection & Maintenance
Recommended Repairs Estimate	\$0

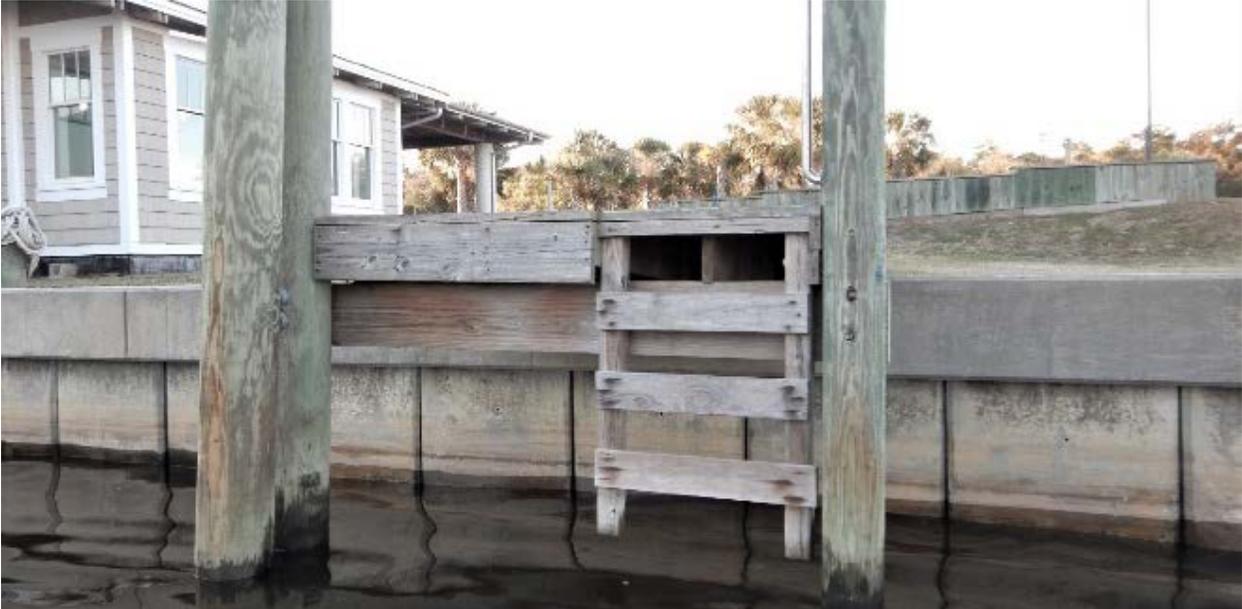
**FIGURE 2-9: DPM “H” BERTHING PLATFORM ELEVATION VIEW (LOOKING WEST)**

“H” Berthing platform is constructed of a timber deck supported by the marina bulkhead cap on the landside and a timber piles in the water. An above and below water inspection found the structure to be in good overall condition with minor abrasions (up to 3/4” deep) on the piles above water.

Summary	
Construction	Timber
Overall Condition	Good
Repair Priority	Low
Significant Defects	Minor abrasions on piles
Recommendations	Routine Inspection & Maintenance
Recommended Repairs Estimate	\$0

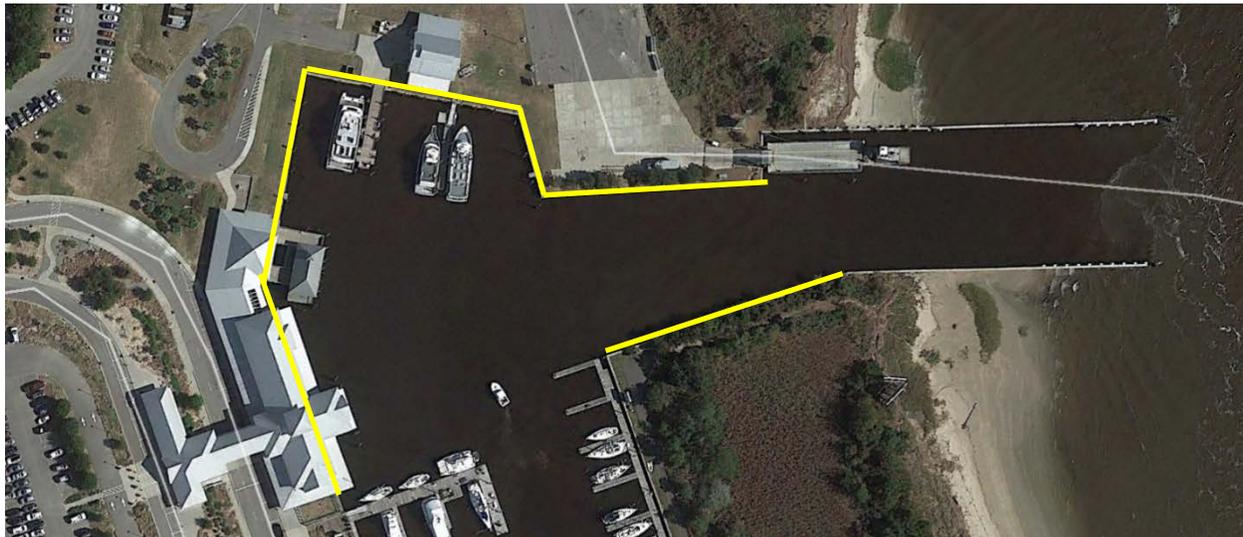
**FIGURE 2-10: DEEP POINT MARINA PLAN VIEW**

Summary	
Construction	Concrete Sheet Pile
Overall Condition	Satisfactory
Repair Priority	Medium
Significant Defects	Sinkholes behind the wall Minor spalls & cracks
Recommendations	<ol style="list-style-type: none"> <li>1. Repair/ fill sinkholes as needed</li> <li>2. Monitor the repair section adjacent to the barge ramp &amp; plan a permanent repair during the next major CAPEX cycle.</li> </ol>
Recommended Repairs Estimate	\$137,000

Ferry Terminal bulkhead wall scope limits highlighted in yellow

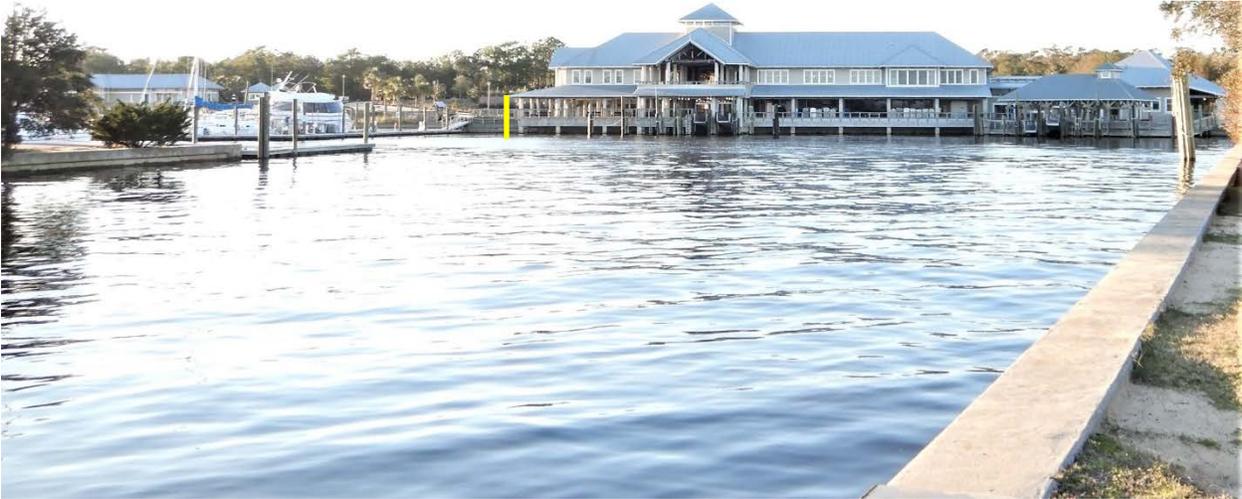
FIGURE 2-11: VIEW OF DPM (LOOKING WEST)

View of DPM bulkhead wall at marina inlet (foreground left and right) and end of scope limits between Ferry Terminal Building and A Dock (yellow, background center-left)

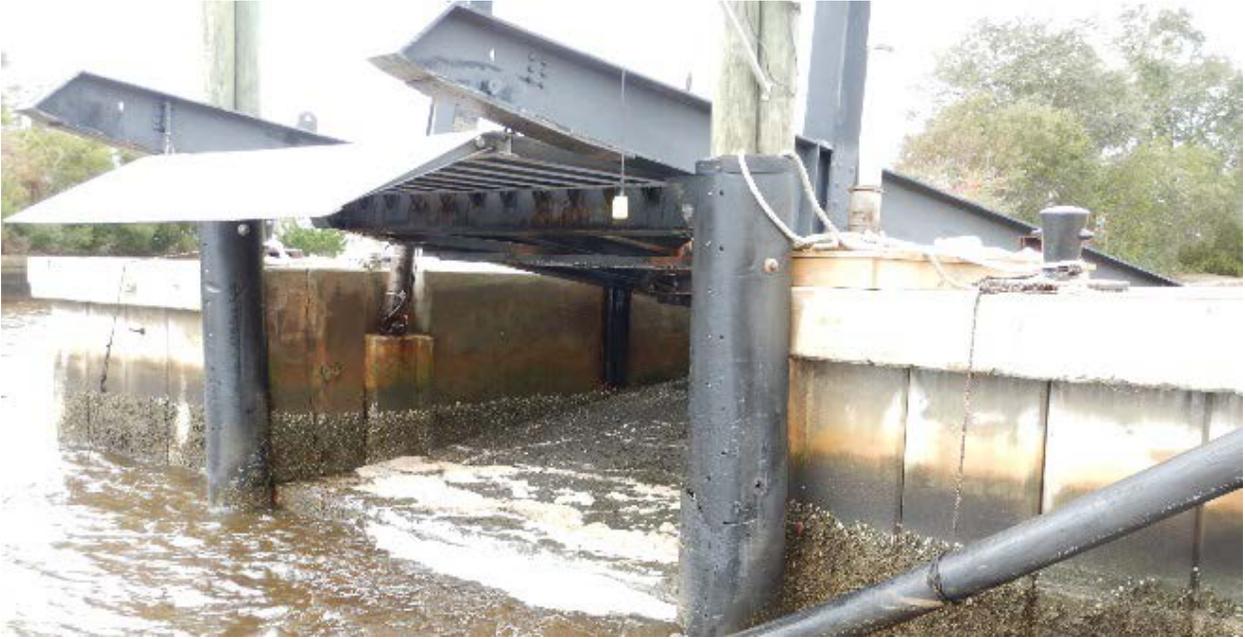
FIGURE 2-18: DPM BARGE RAMP ELEVATION VIEW (LOOKING SOUTHWEST)

Summary	
Construction	Steel Ramp with Concrete Substructure
Overall Condition	Satisfactory
Repair Priority	Medium
Significant Defects	Moderate corrosion of steel elements Crack in concrete substructure
Recommendations	<ol style="list-style-type: none"> <li>1. Monitor tension crack associated with bulkhead repair section.</li> <li>2. Monitor steel corrosion and plan refurbishment during the next major CAPEX cycle.</li> </ol>
Recommended Repairs Estimate	\$154,000

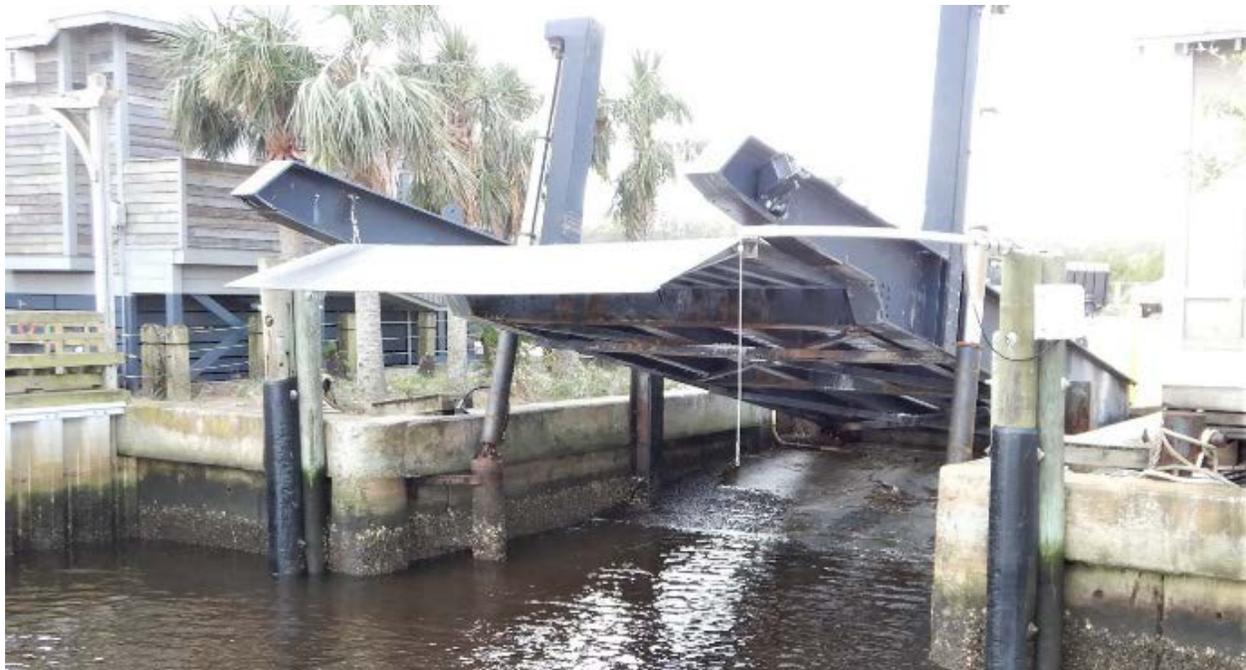
**FIGURE 2-20: BHI BARGE RAMP ELEVATION VIEW (LOOKING SOUTHEAST)**

Summary	
Construction	Steel Ramp with Concrete Substructure
Overall Condition	Satisfactory
Repair Priority	Medium
Significant Defects	Moderate corrosion of steel elements
Recommendations	Monitor steel corrosion and plan refurbishment during the next major CAPEX cycle.
Recommended Repairs Estimate	\$130,000

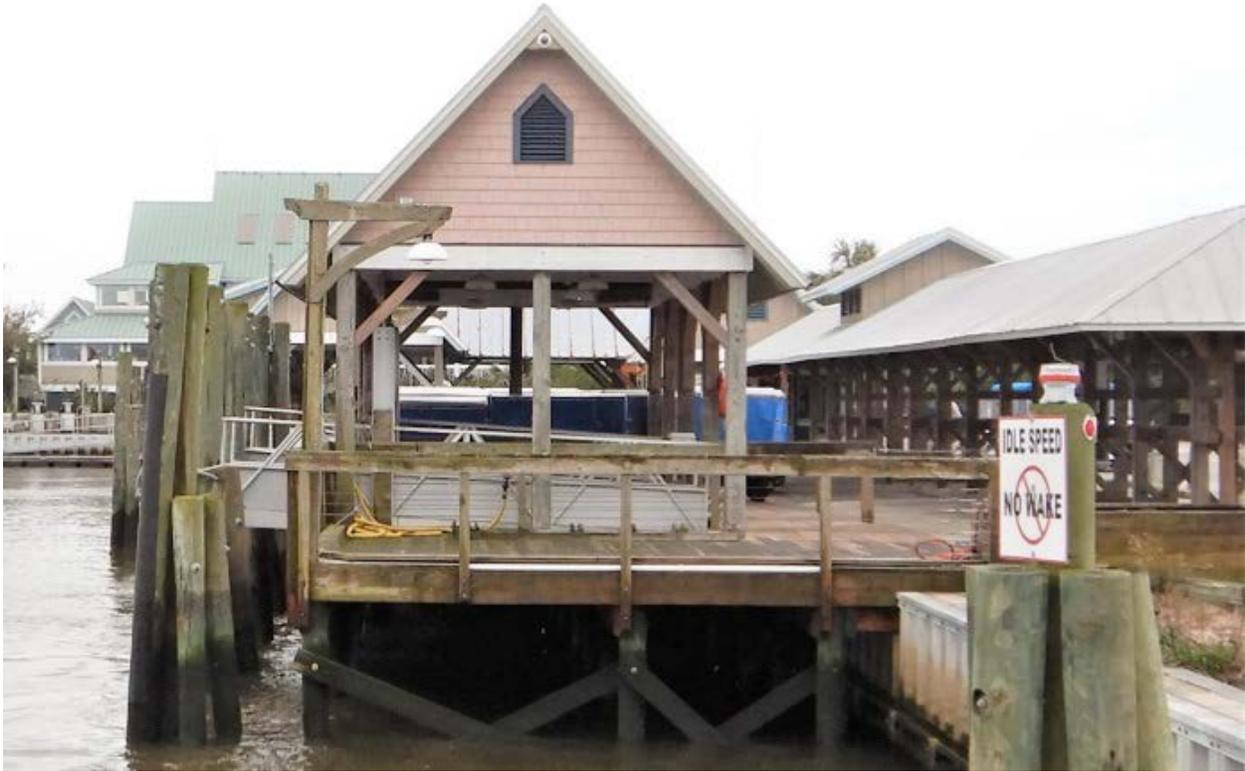
FIGURE 2-22: BHI CONTRACTOR LANDING END VIEW (LOOKING SOUTH)

Summary	
Construction	Timber
Overall Condition	Good
Repair Priority	Low
Significant Defects	Minor decay on 3 piles Open bolt holes and minor timber defects (abrasion/ check/ shake)
Recommendations	Routine Inspection & Maintenance Cover open bolt holes with epoxy
Recommended Repairs Estimate	\$10,000

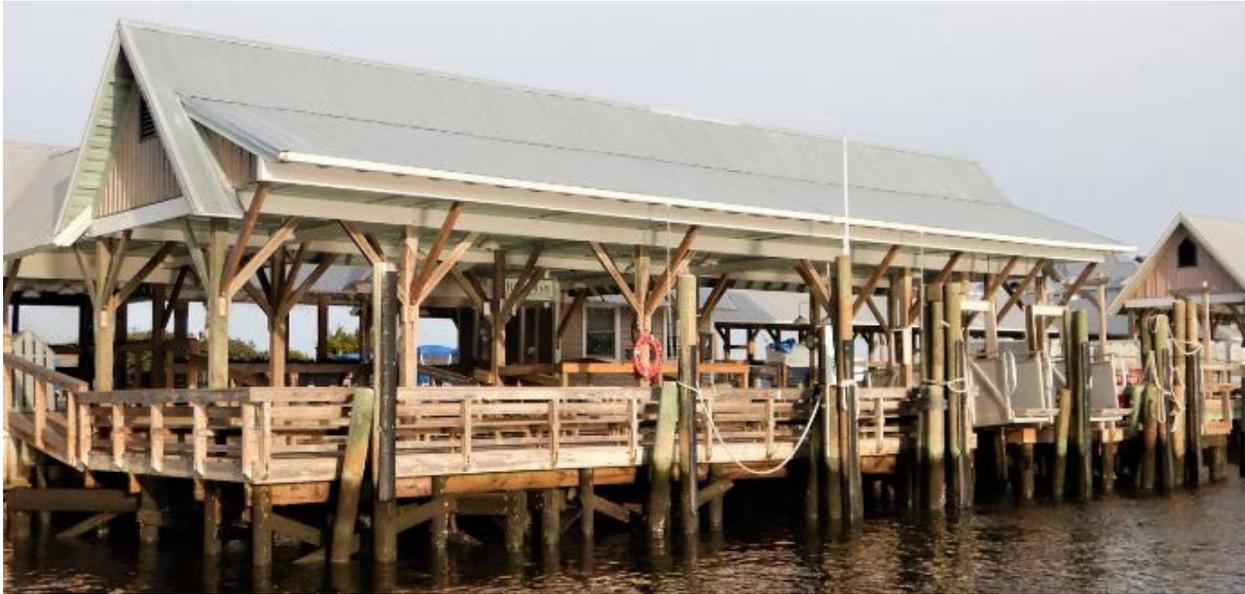
FIGURE 2-24: BHI PASSENGER LANDING ELEVATION VIEW (LOOKING WEST)

The BHI Passenger Landing was found to be in fair overall condition and replacement is recommended within the 10-year planning horizon. Several piles were found to be severely deteriorated with 50% or more section loss. The structure has surpassed the typical expected design life of marine timber structures of 25 years and has undergone significant repairs in order to maintain capacity.
