Bald Head Island, N.C. Beach Monitoring Program

Monitoring Report No. 20 (May 2021 to May 2022)

Prepared for: Village of Bald Head Island

Olsen Associates, Inc. 2618 Herschel Street Jacksonville, FL 32204 (904) 387-6114 (Fax) 384-7368 olsen-associates.com C-1468

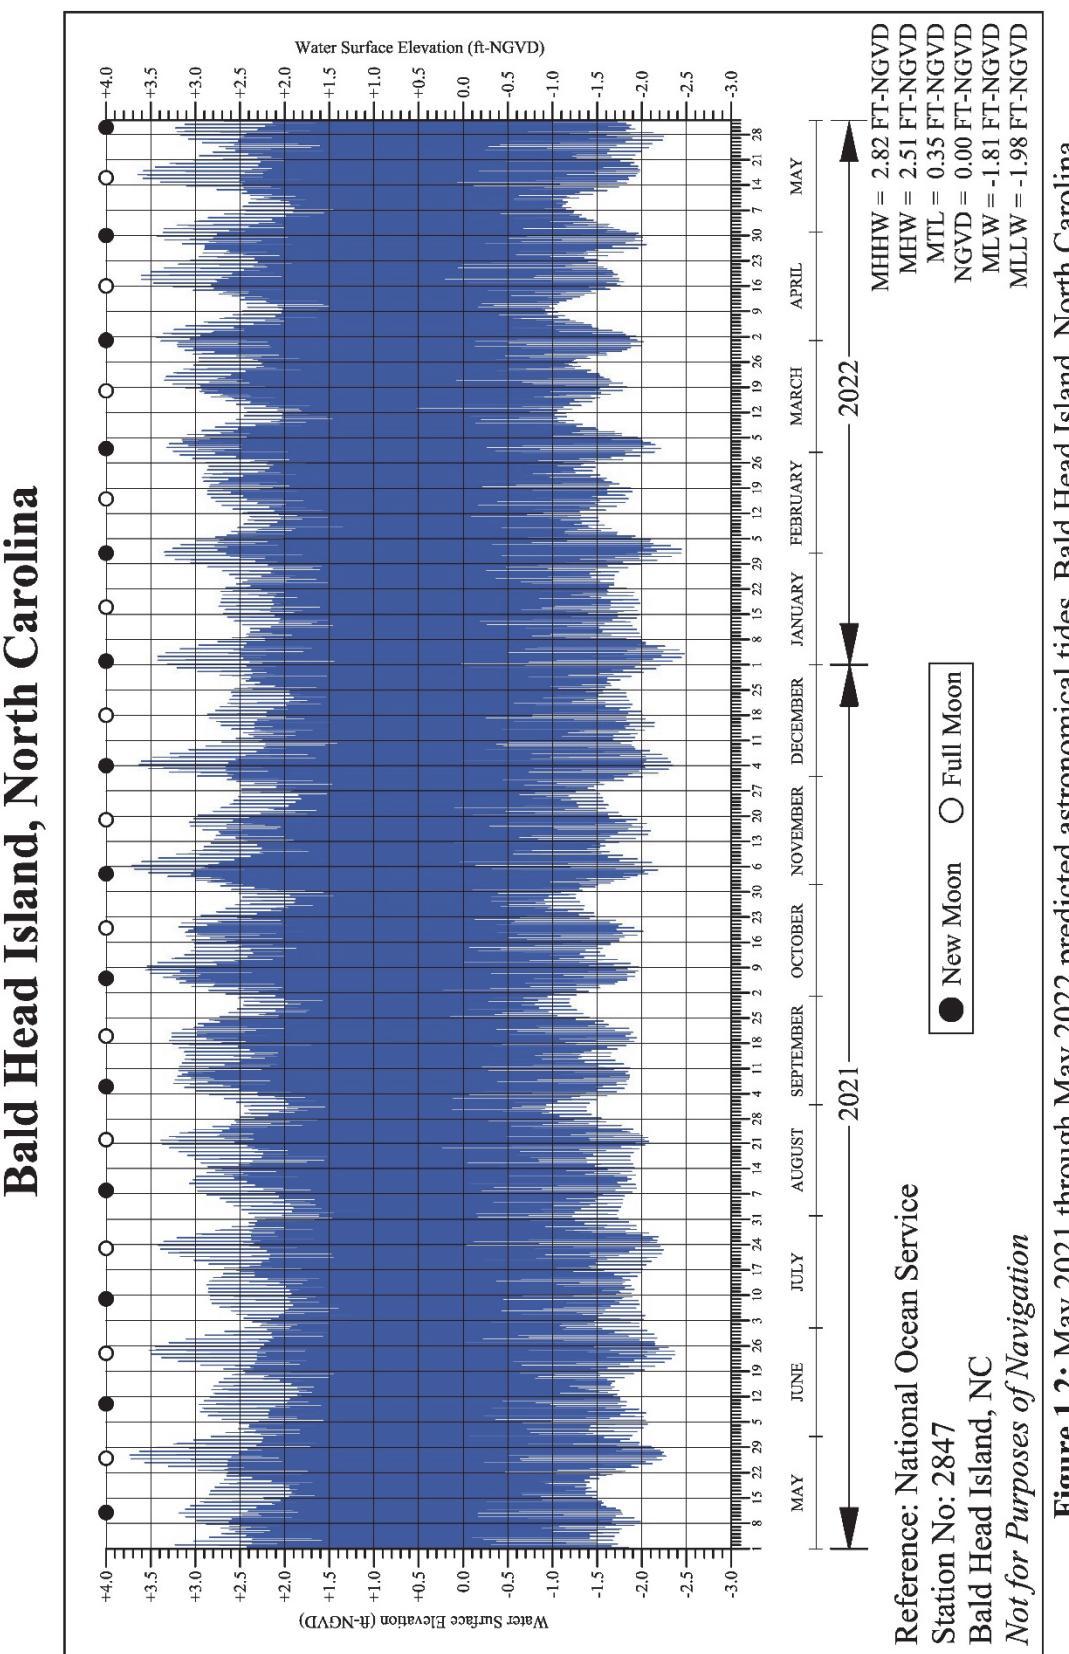
Figure 1.2: May 2021 through May 2022 predicted astronomical tides, Bald Head Island, North Carolina.

The astronomical tides in the vicinity of Bald Head Island are semi-diurnal and have average mean and spring ranges of approximately 4.3 ft and 5.0 ft, respectively. Tidal datums for Bald Head Island are listed in **Table 1.1** and the predicted astronomical tides during the May 2021 to May 2022 monitoring period are plotted as **Figure 1.2**.

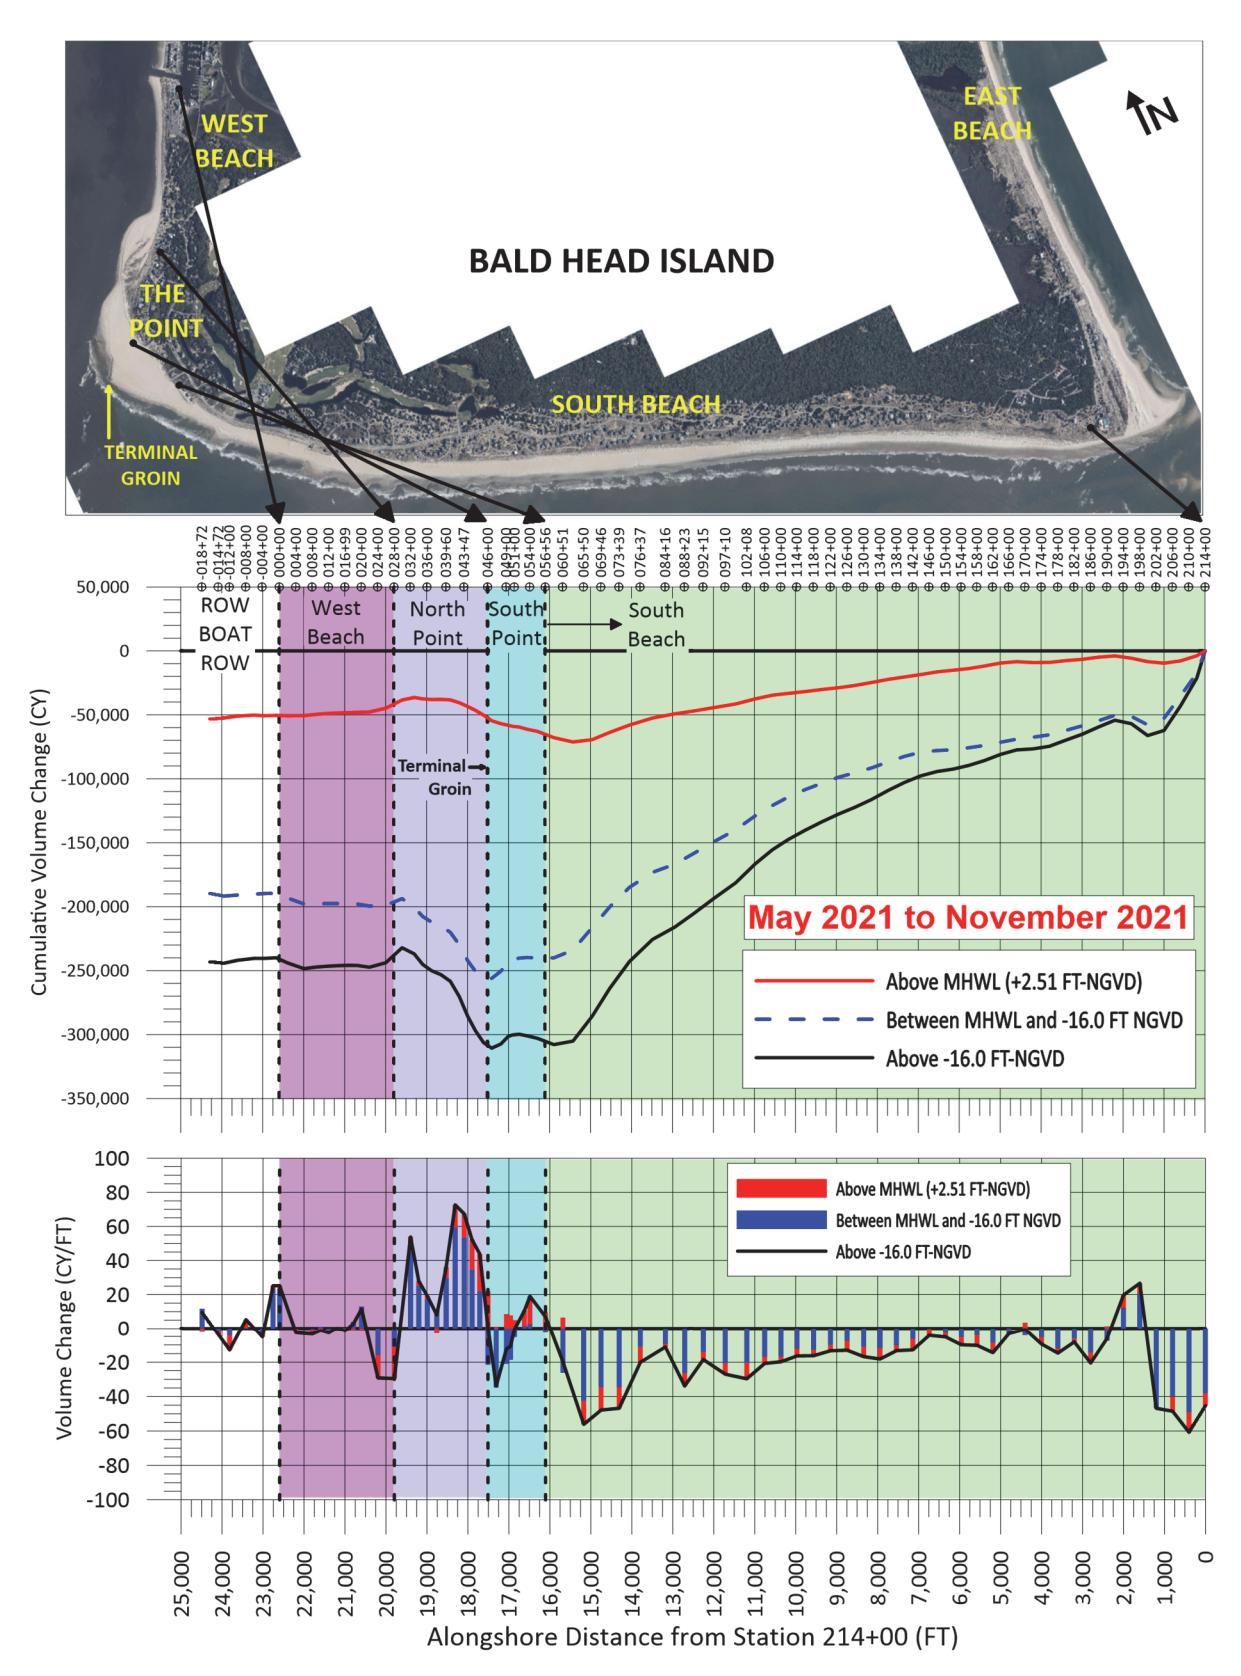
Figure 3.1: Volume change along the Bald Head Island shoreline between May 2021 and November 2021.

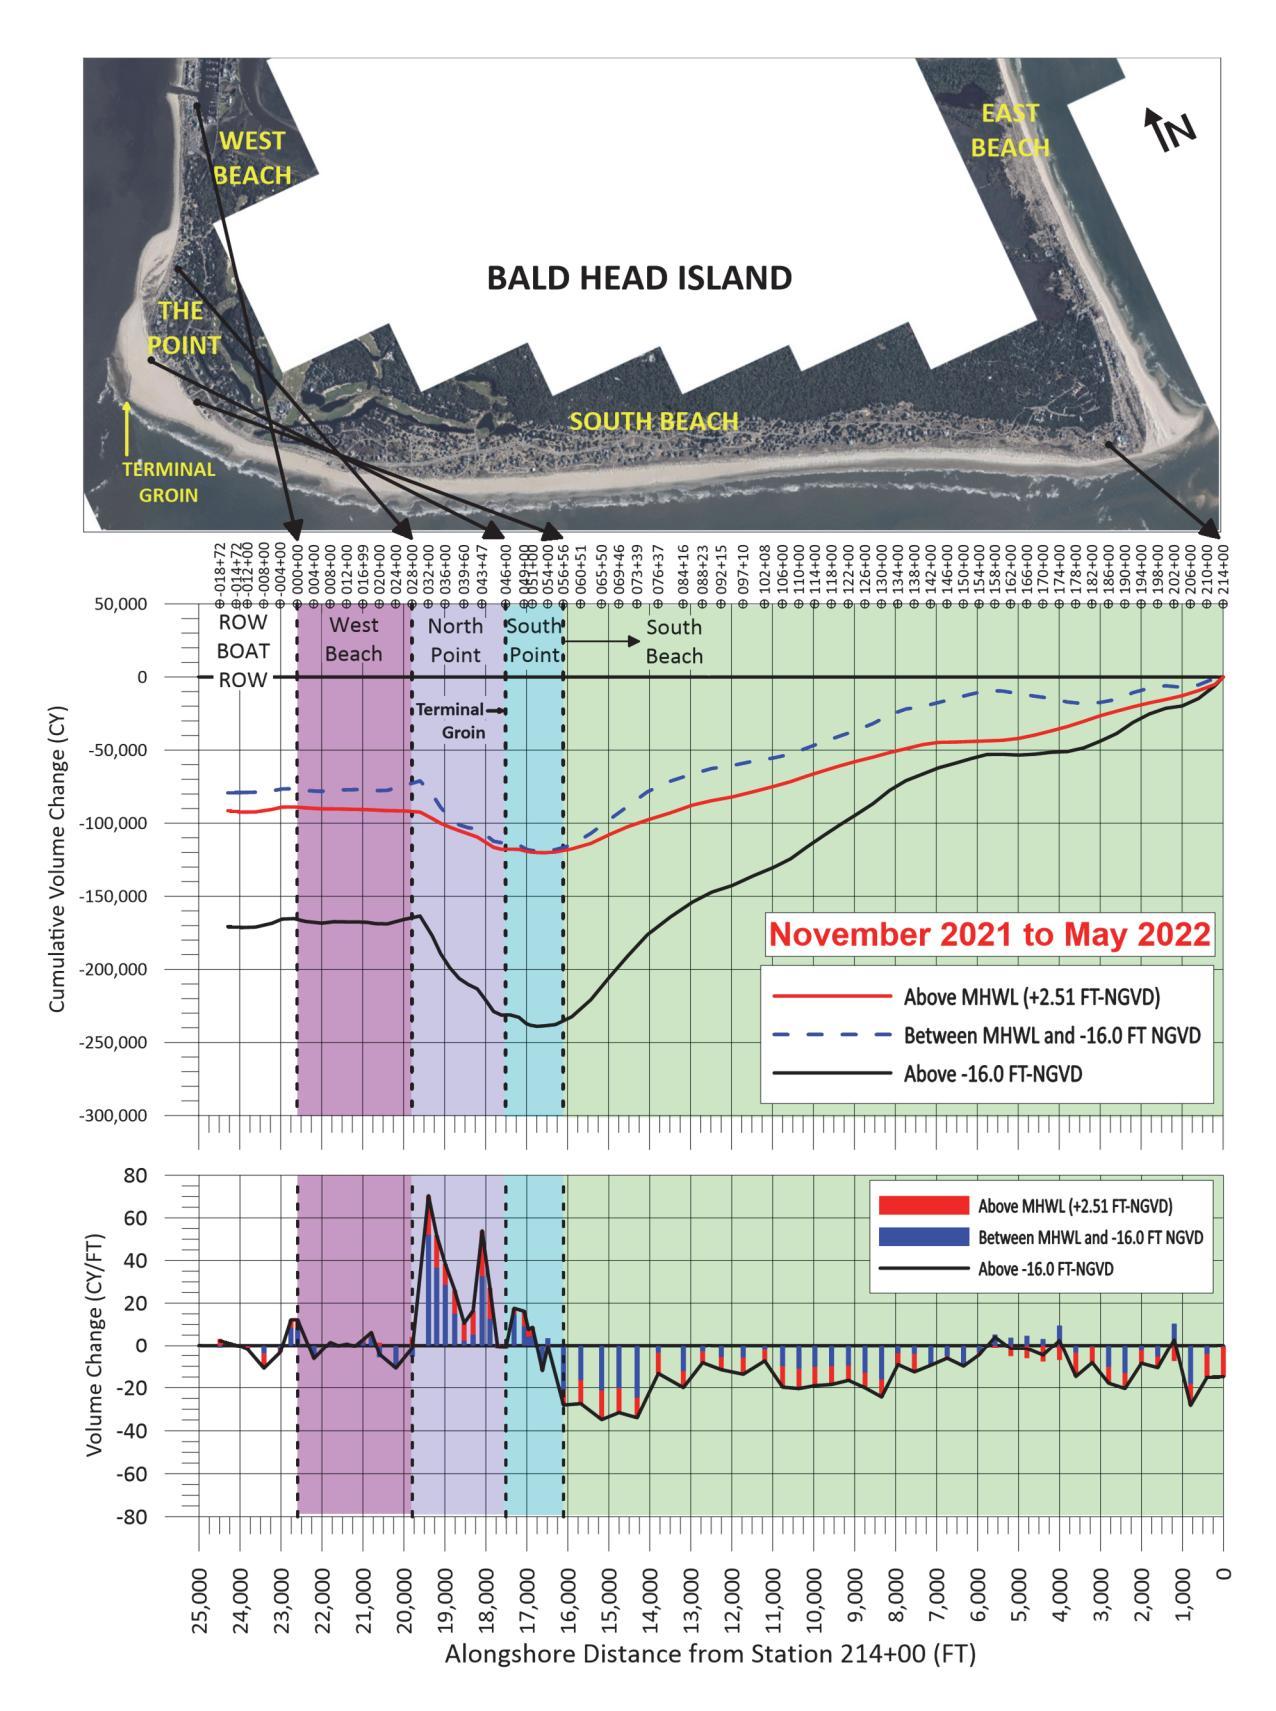
Figure 3.2: Volume change along the Bald Head Island shoreline between November 2021 and May 2022.

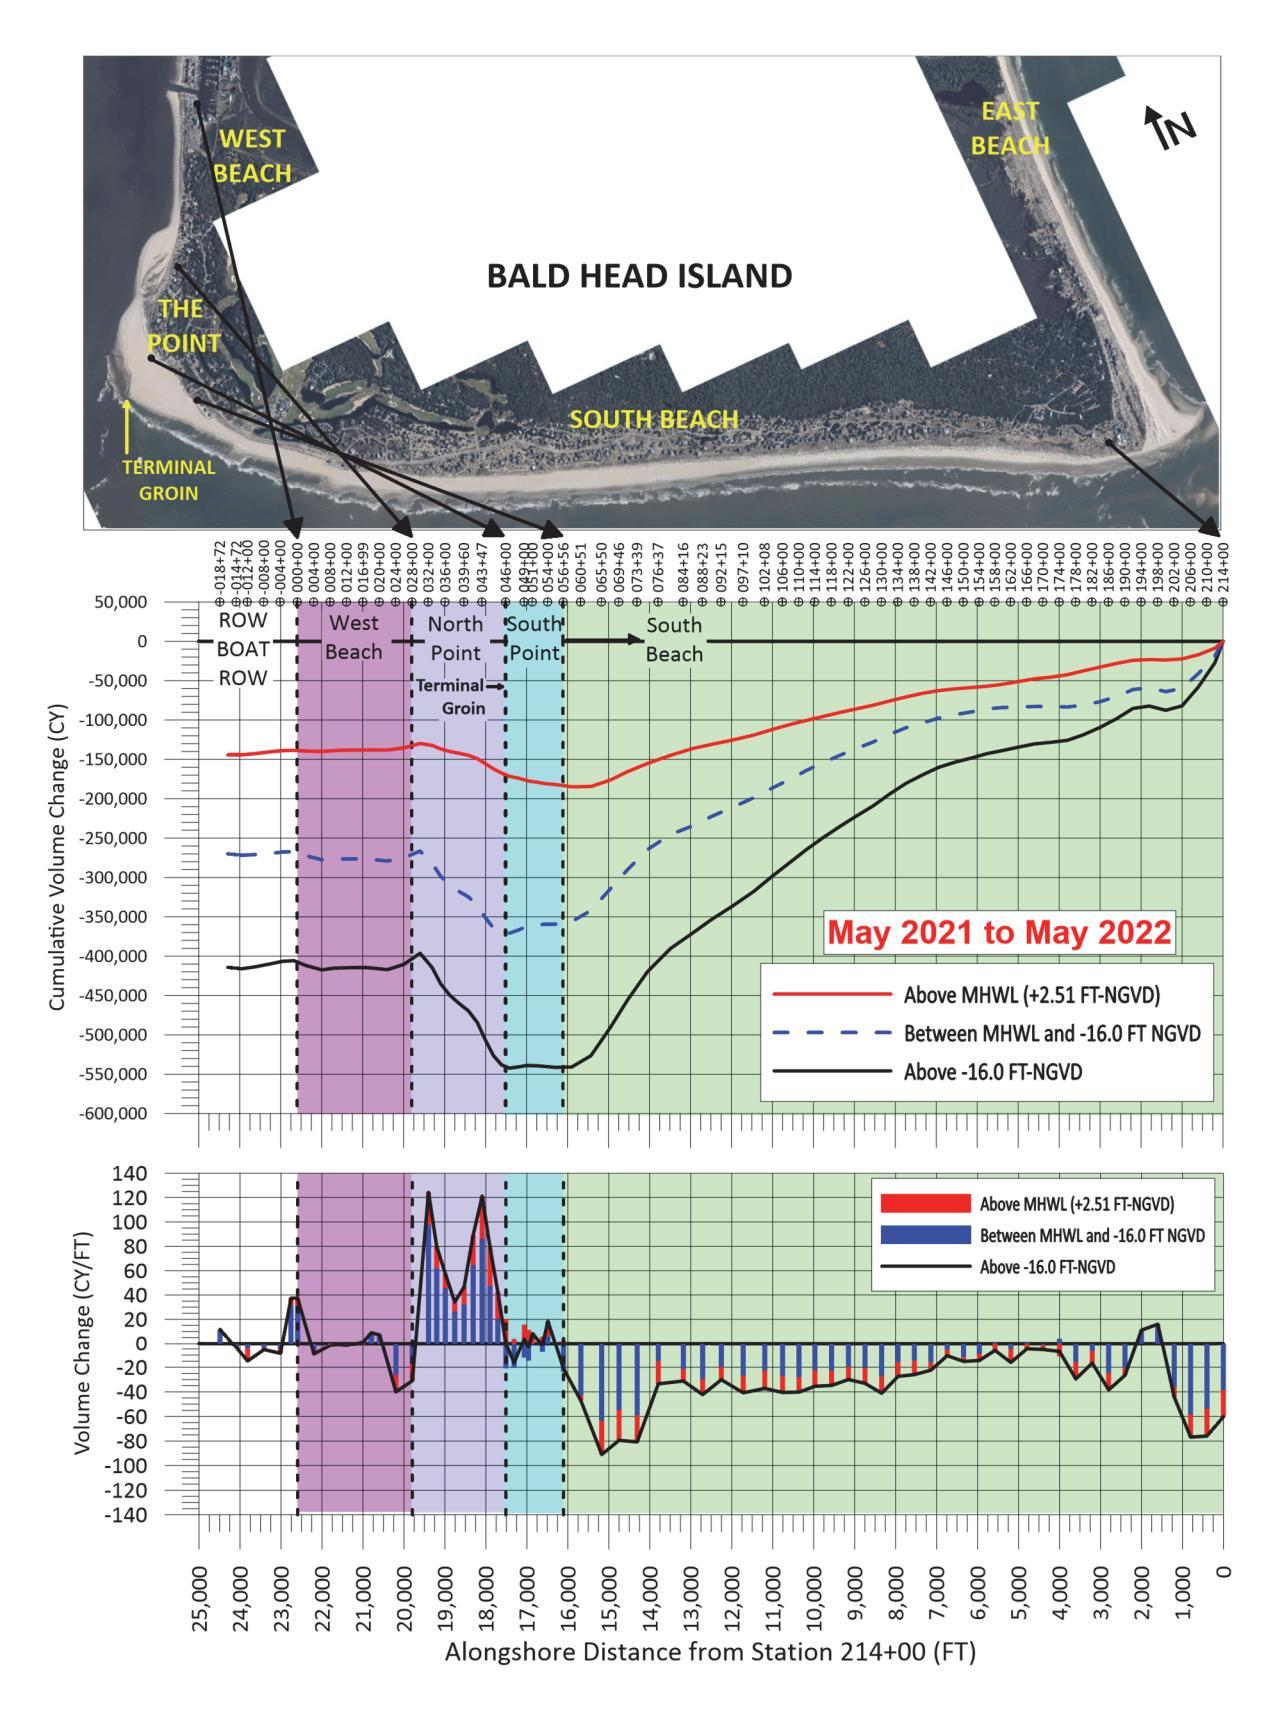
Figure 3.3: Volume change along the Bald Head Island shoreline between May 2021 and May 2022 (Year 21).

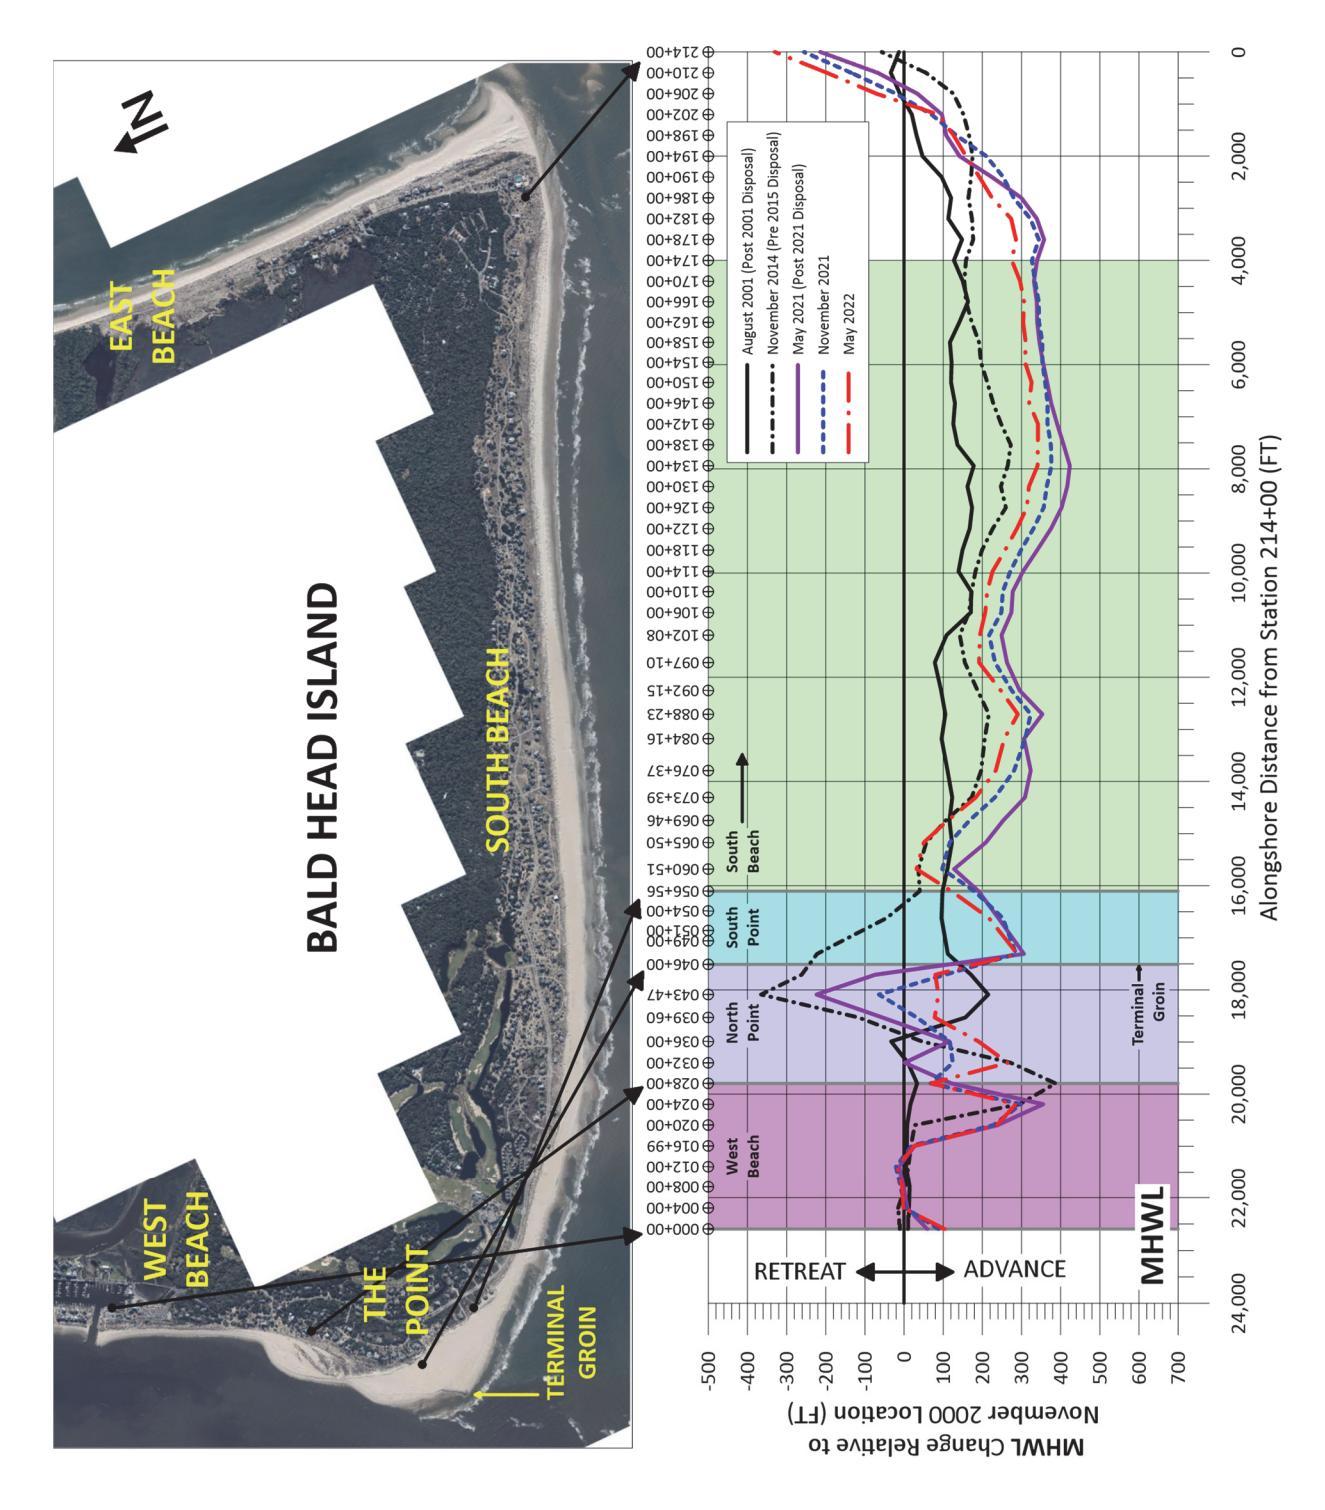
Figure 3.4: Location of the MHWL (+2.51 ft-NGVD) relative to the November 2000 (pre-2001 fill) location.

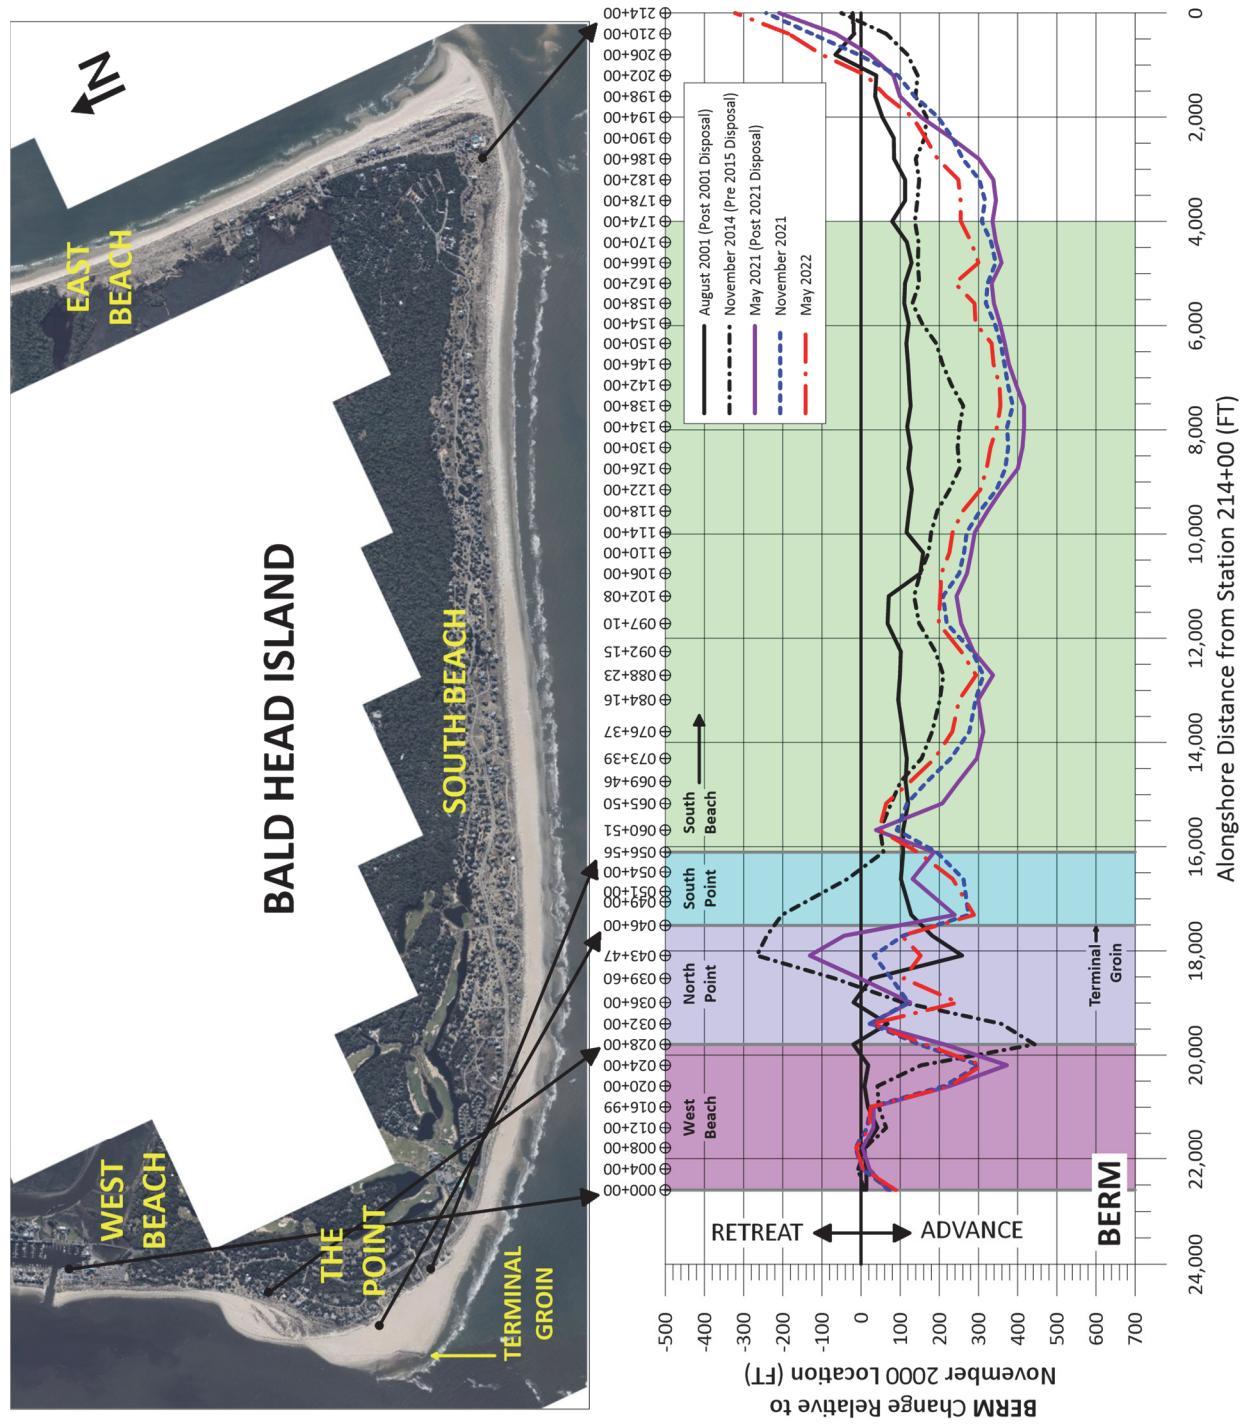
Figure 3.5: Location of the BERM (+6.00 ft-NGVD) relative to the November 2000 (pre-2001 fill) location.

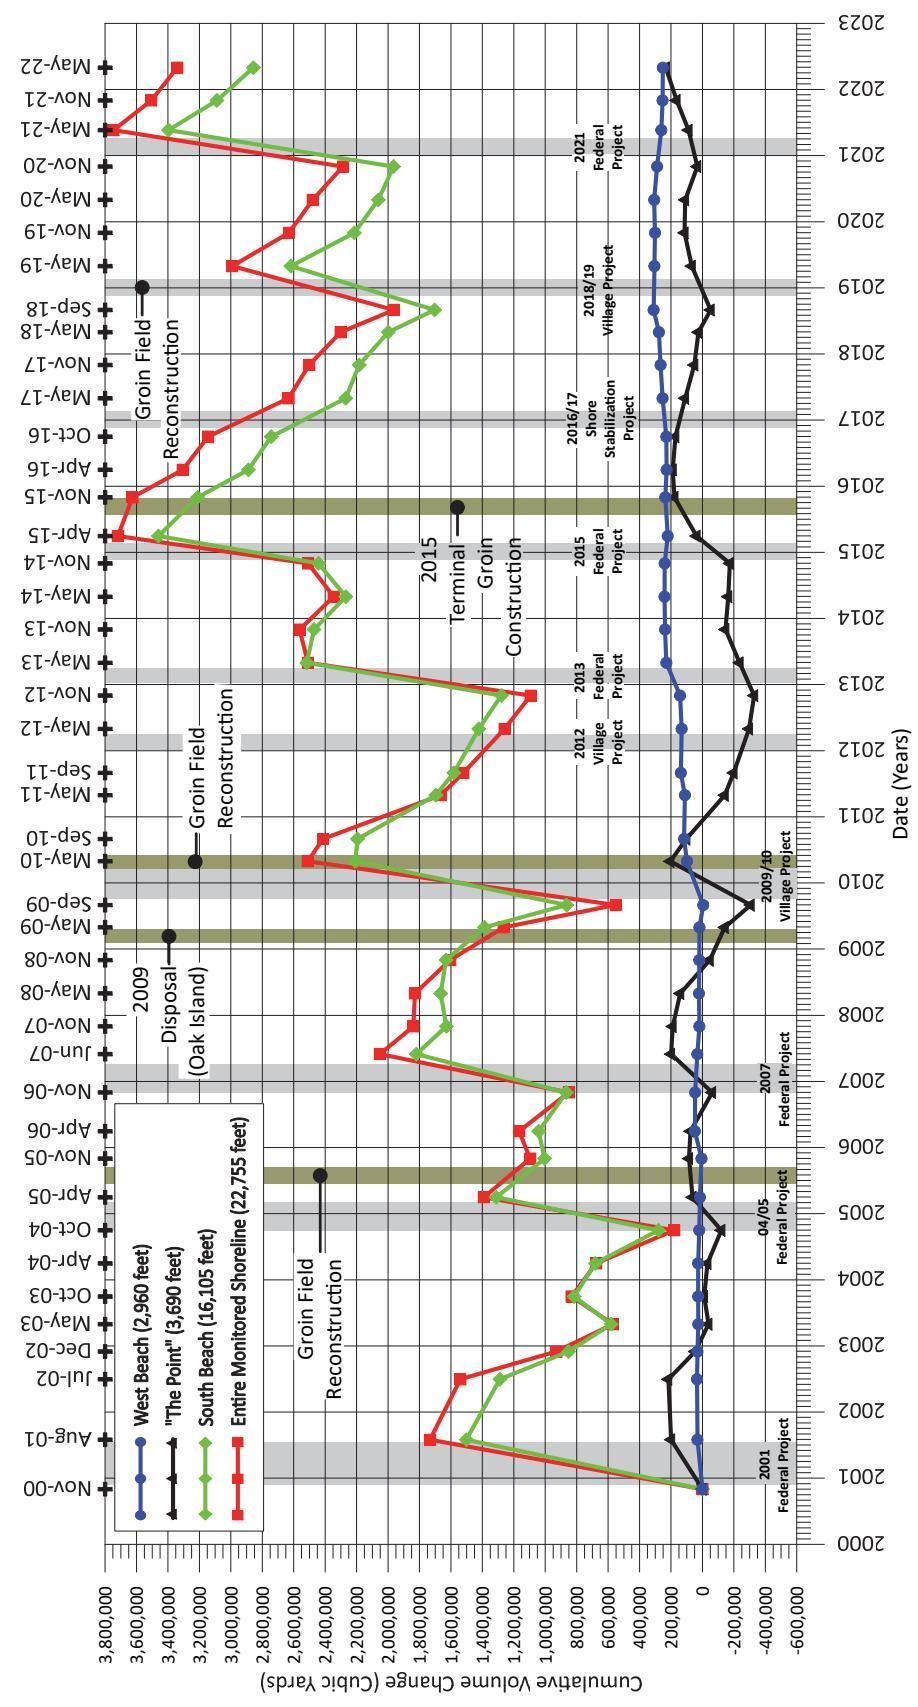
Figure 3.6: Cumulative volume change (above -16 ft-NGVD) relative to November 2000 conditions.

For purposes of tracking gross sand placement performance, **Figure 3.6** plots a time history of cumulative volume change relative to November 2000 conditions. **Figure 3.7** presents net volumetric change (alongshore above -16 ft NGVD) for the maximum period of comparison to date (*i.e.* November 2000 and May 2021). In both Figures the effects of direct South Beach sand placement over time are included. As with other similar analyses over the last decade, East Beach, Cape Fear and Row Boat Row are *excluded* from this analysis.

The classic "saw-tooth" effects of episodic sand placement (and subsequent sand losses over time), as reflected in Figure 3.6, are indicative of the periodic infusion of sand along South Beach at Bald Head Island associated with the placement of sand during initial construction of the channel deepening project, five (5) subsequent beach disposal operations pursuant to the WHSMP, the proactive beach renourishment project constructed by the Village in 2009/10 and to a smaller degree the emergency fill of 2012. The Village 1.85 Mcy fill was constructed with the knowledge gained through monitoring that certain irreparable large-scale impacts to Bald Head Island would predictably occur as a direct result of the proposed diversion of channel maintenance material in 2009 to Oak Island. Note – a similar diversion of Federal sand occurred in the summer of 2018. As a result of the 2018 federal sand disposal at Oak Island, the Village constructed a 1.1 Mcy interim beach fill at South Beach in the fall/winter of 2018/19. The most recent federal beach disposal project was performed in the early months of 2021 (Jan – April) along South Beach on Bald Head Island. Over the last 12 months, mol the fill berm has been subject to equilibration – and therefore a larger than typical net annual sand loss. A portion of that sand can be found as an accretional spit located immediately westward of the terminal groin. That depositional feature was intended by design in order to maintain a sand supply to West Beach - subsequent to terminal groin construction.

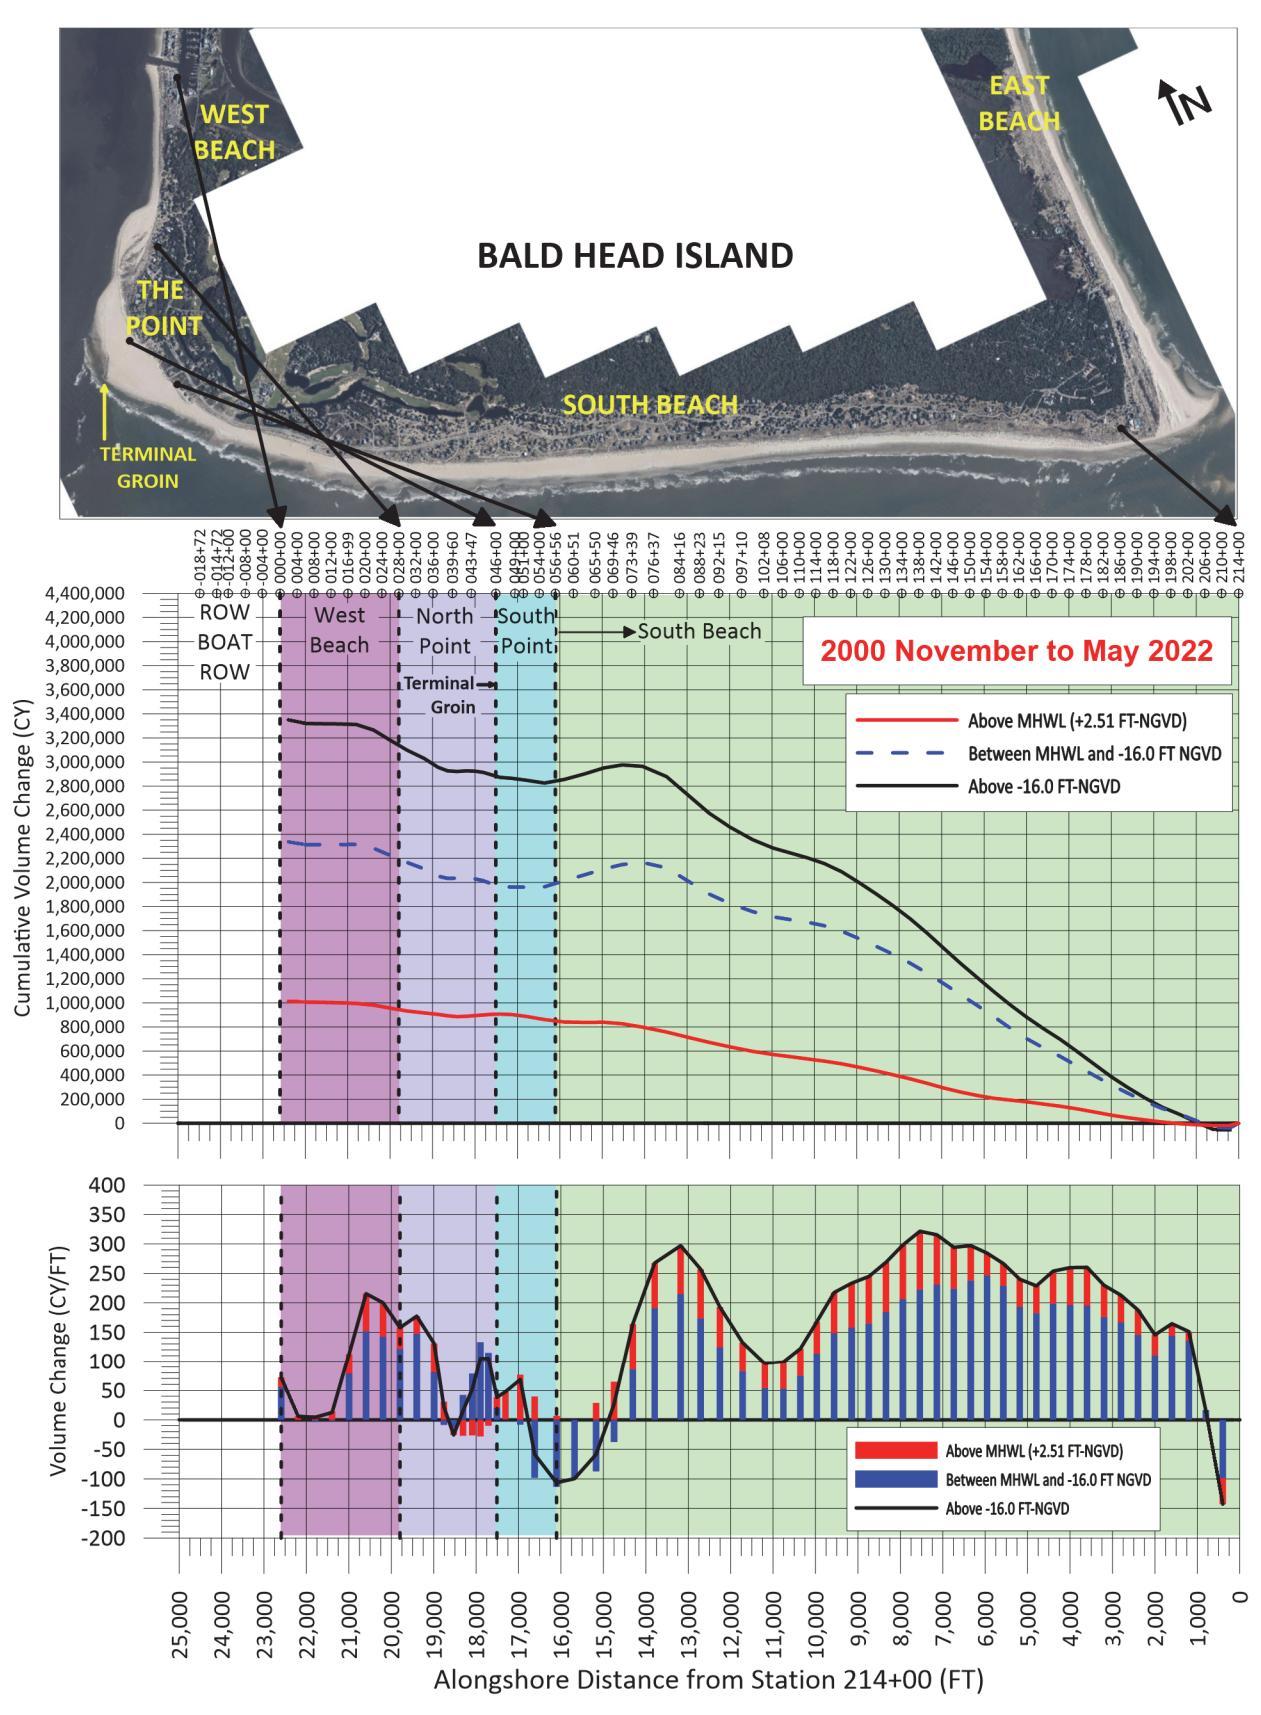
Figure 3.7: Volume change along the Bald Head Island shoreline between November 2000 and May 2022.

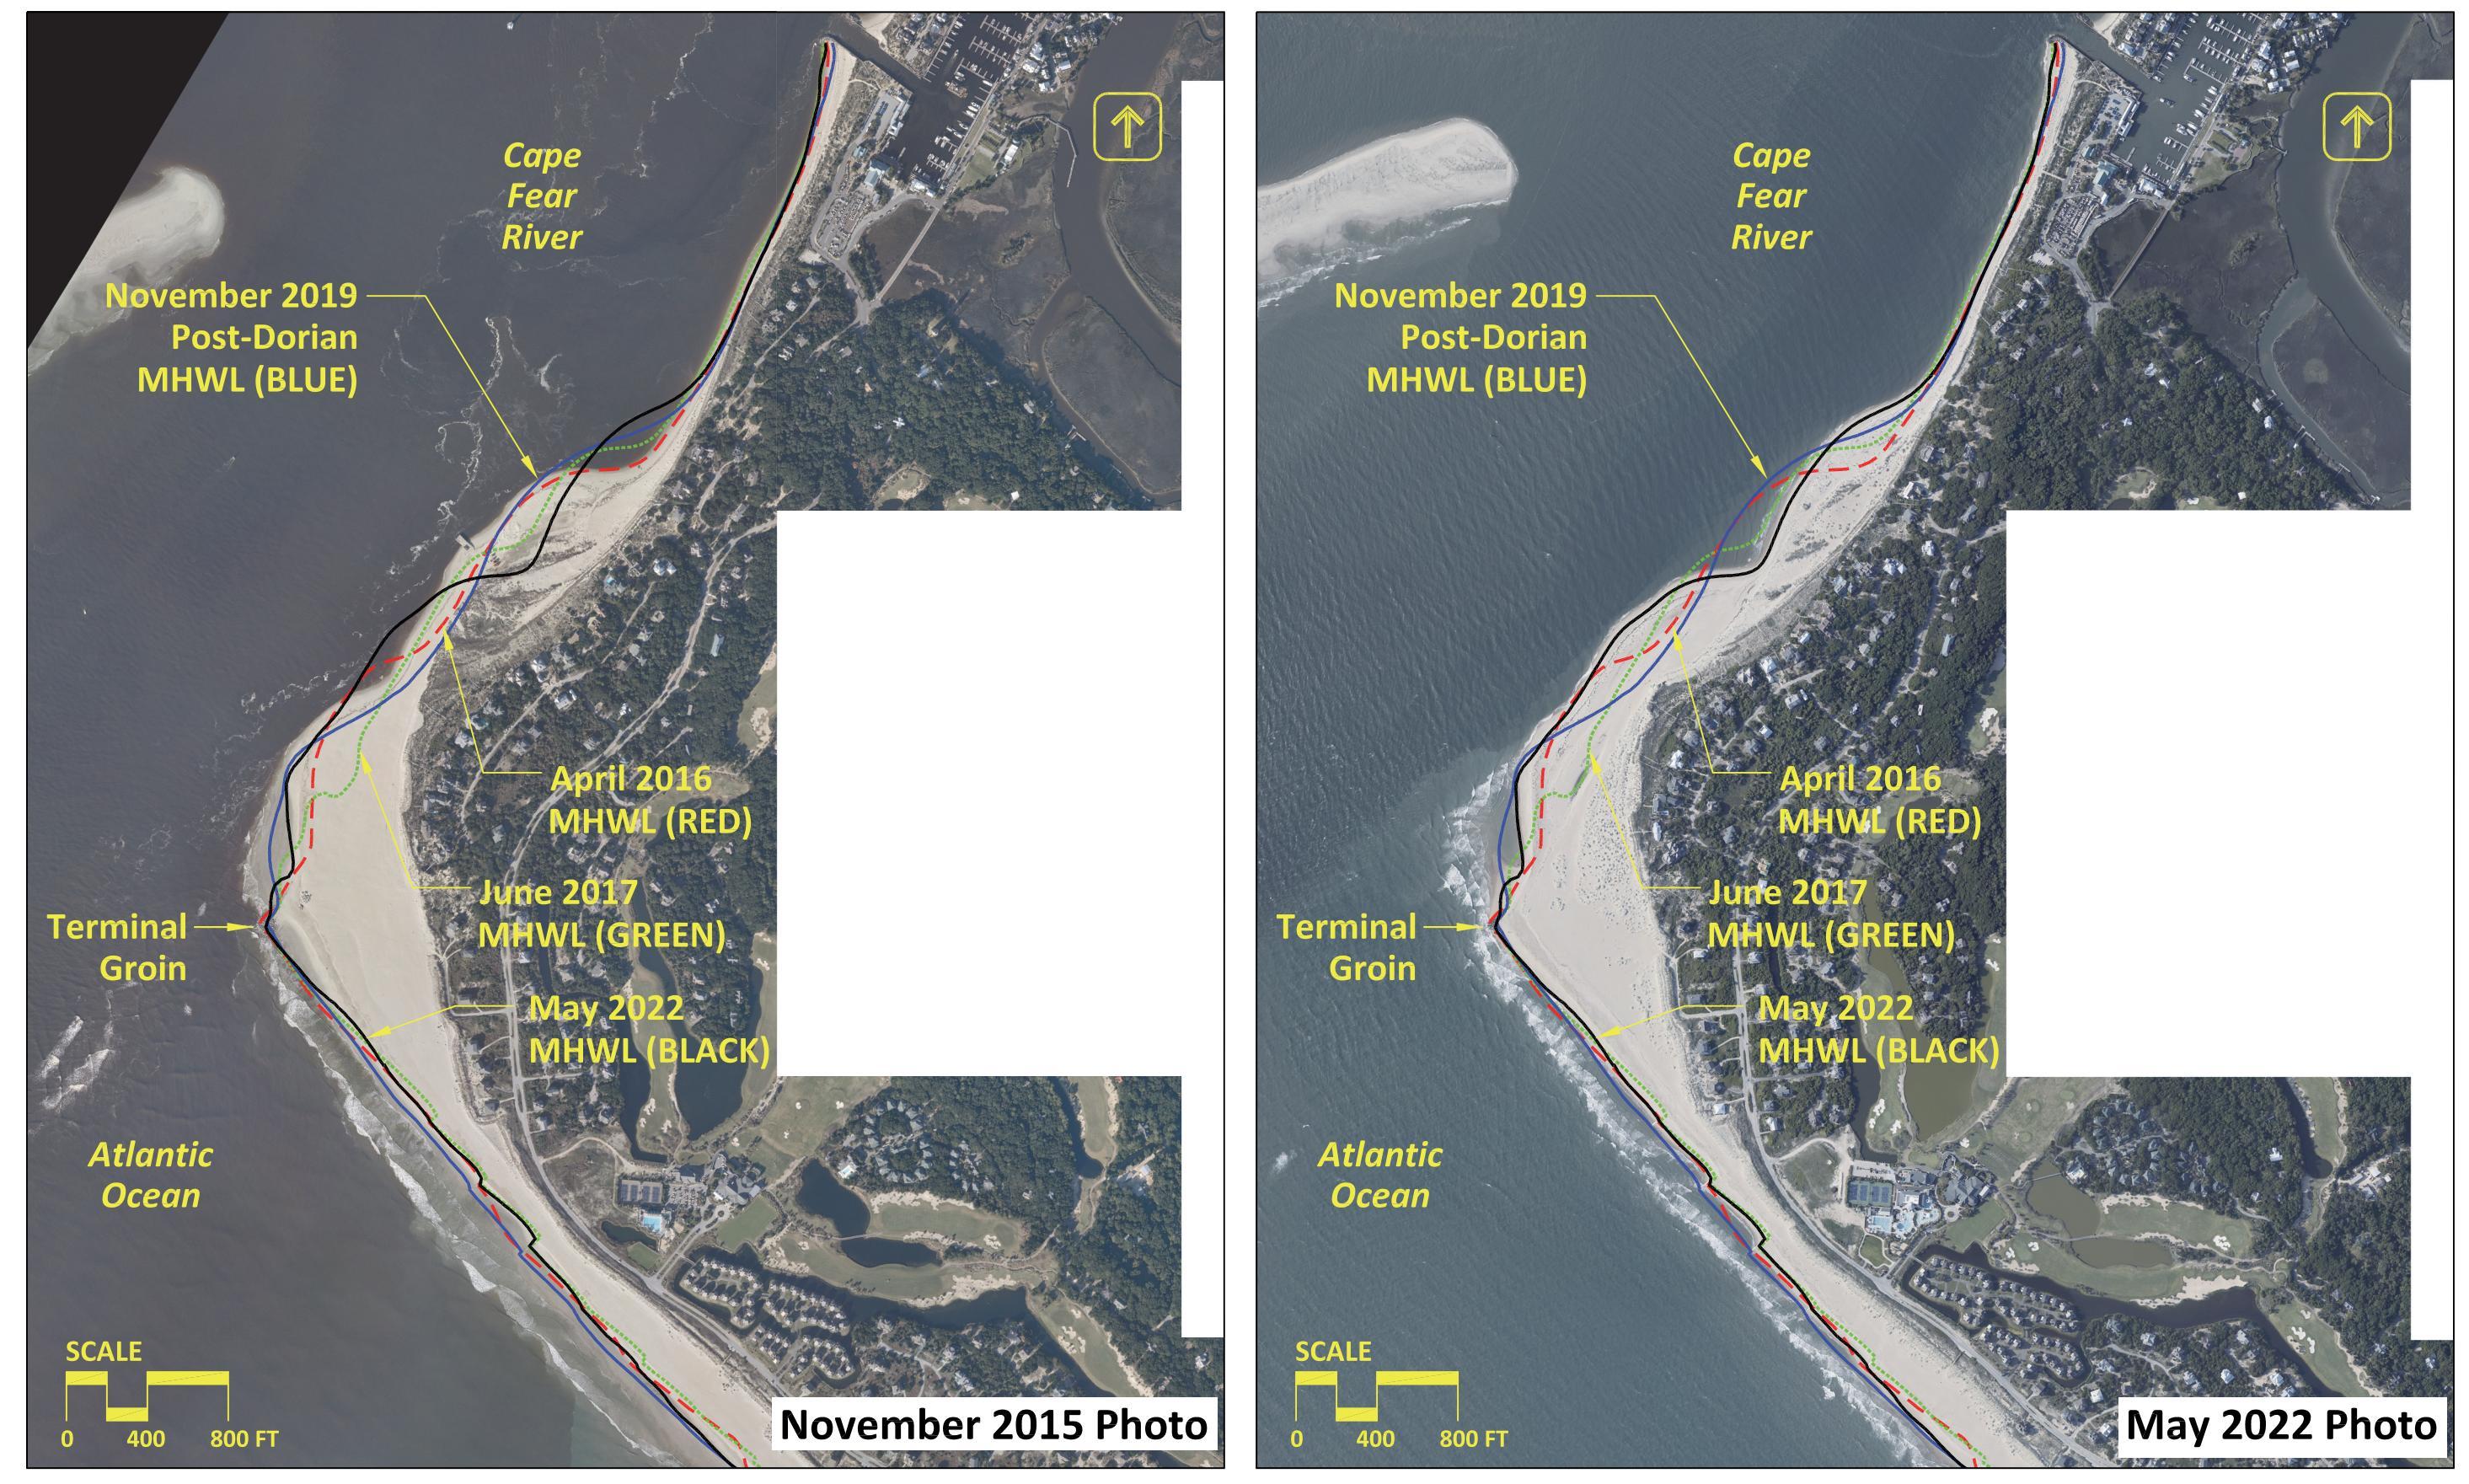
Figure 3.8:

MHWL positions in the vicinity of the terminal groin Bald Head Island, NC

As part of the permit required monitoring for the terminal groin project completed in late 2015, the MHWL was surveyed in December 2015 (post-construction), April 2016 (5 months post-construction), June 2017 (19 months post-construction), May 2018 (30 months post-construction), September 2018 (post-Florence), May 2019 (post-fill), November 2019 (post-Dorian), May 2020, May 2021, and May 2022. Various selected surveys are plotted in **Figure 3.8**. The purpose of the surveys is to be able to intercompare and assess both updrift fillet conditions and the location of the downdrift shoreline fronting the Cape Fear River. Through May 2022, terminal groin project performance – based upon monitoring – has been both as intended and as predicted.
