Bald Head Island, N.C. Beach Monitoring Program

Monitoring Report No. 20 (May 2021 to May 2022)

Prepared for: Village of Bald Head Island

Olsen Associates, Inc. 2618 Herschel Street Jacksonville, FL 32204 (904) 387-6114 (Fax) 384-7368 olsen-associates.com C-1468

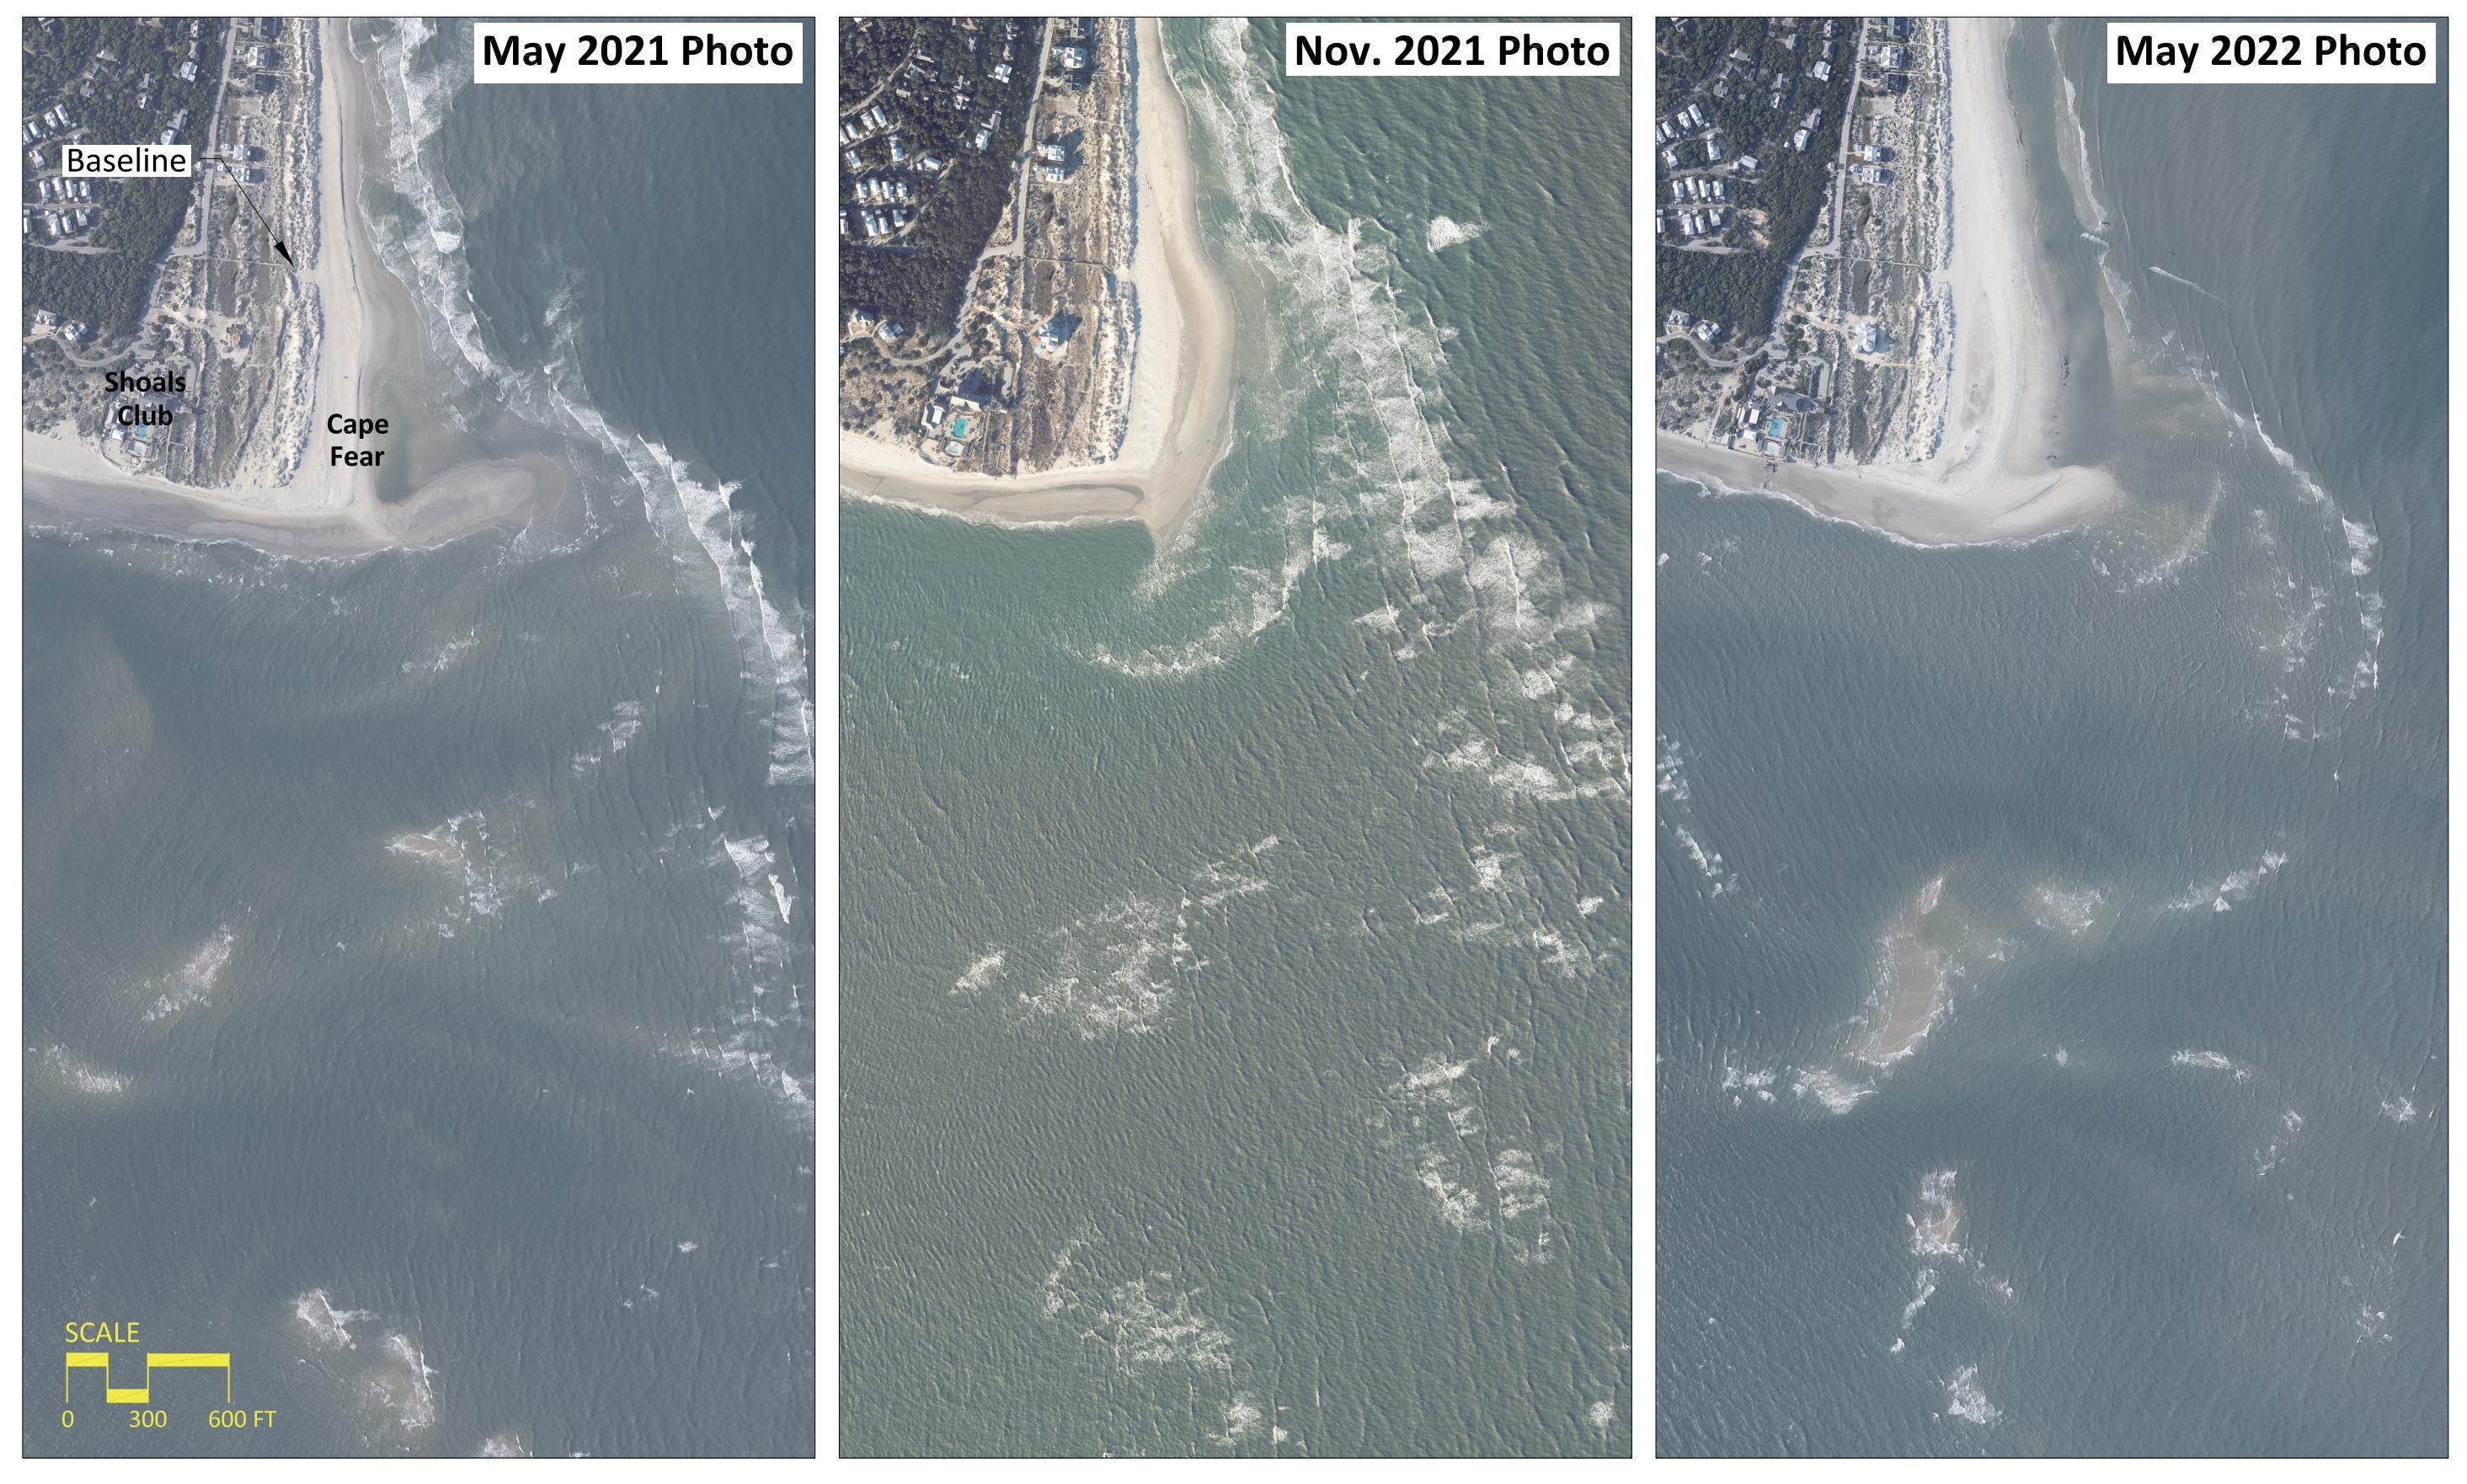
Figure 3.9: Cape Fear aerial photography Bald Head Island, NC

As demonstrated by the survey and photographic data (**Figure 3.9**), it can be reasonably assumed that the condition of East Beach at any one time is, has been and will continue to be highly influenced by the configuration of the depositional spit and shoals associated with the "Cape Fear Point". Of further interest are the variations in spit size and orientation over the 12 years (2008-2022) which are depicted by **Figure 3.10**. In its simplest sense, the Cape Fear spit is a highly dynamic feature which is influenced by sand supply originating from both the west (along South Beach) and the north (along East Beach). The Point is also highly susceptible to storm waves originating from *both* the west (Atlantic Ocean) and the east (Onslow Bay) and resultant tidal channels which episodically break through and subsequently influence localized patterns of sand deposition (or erosion).

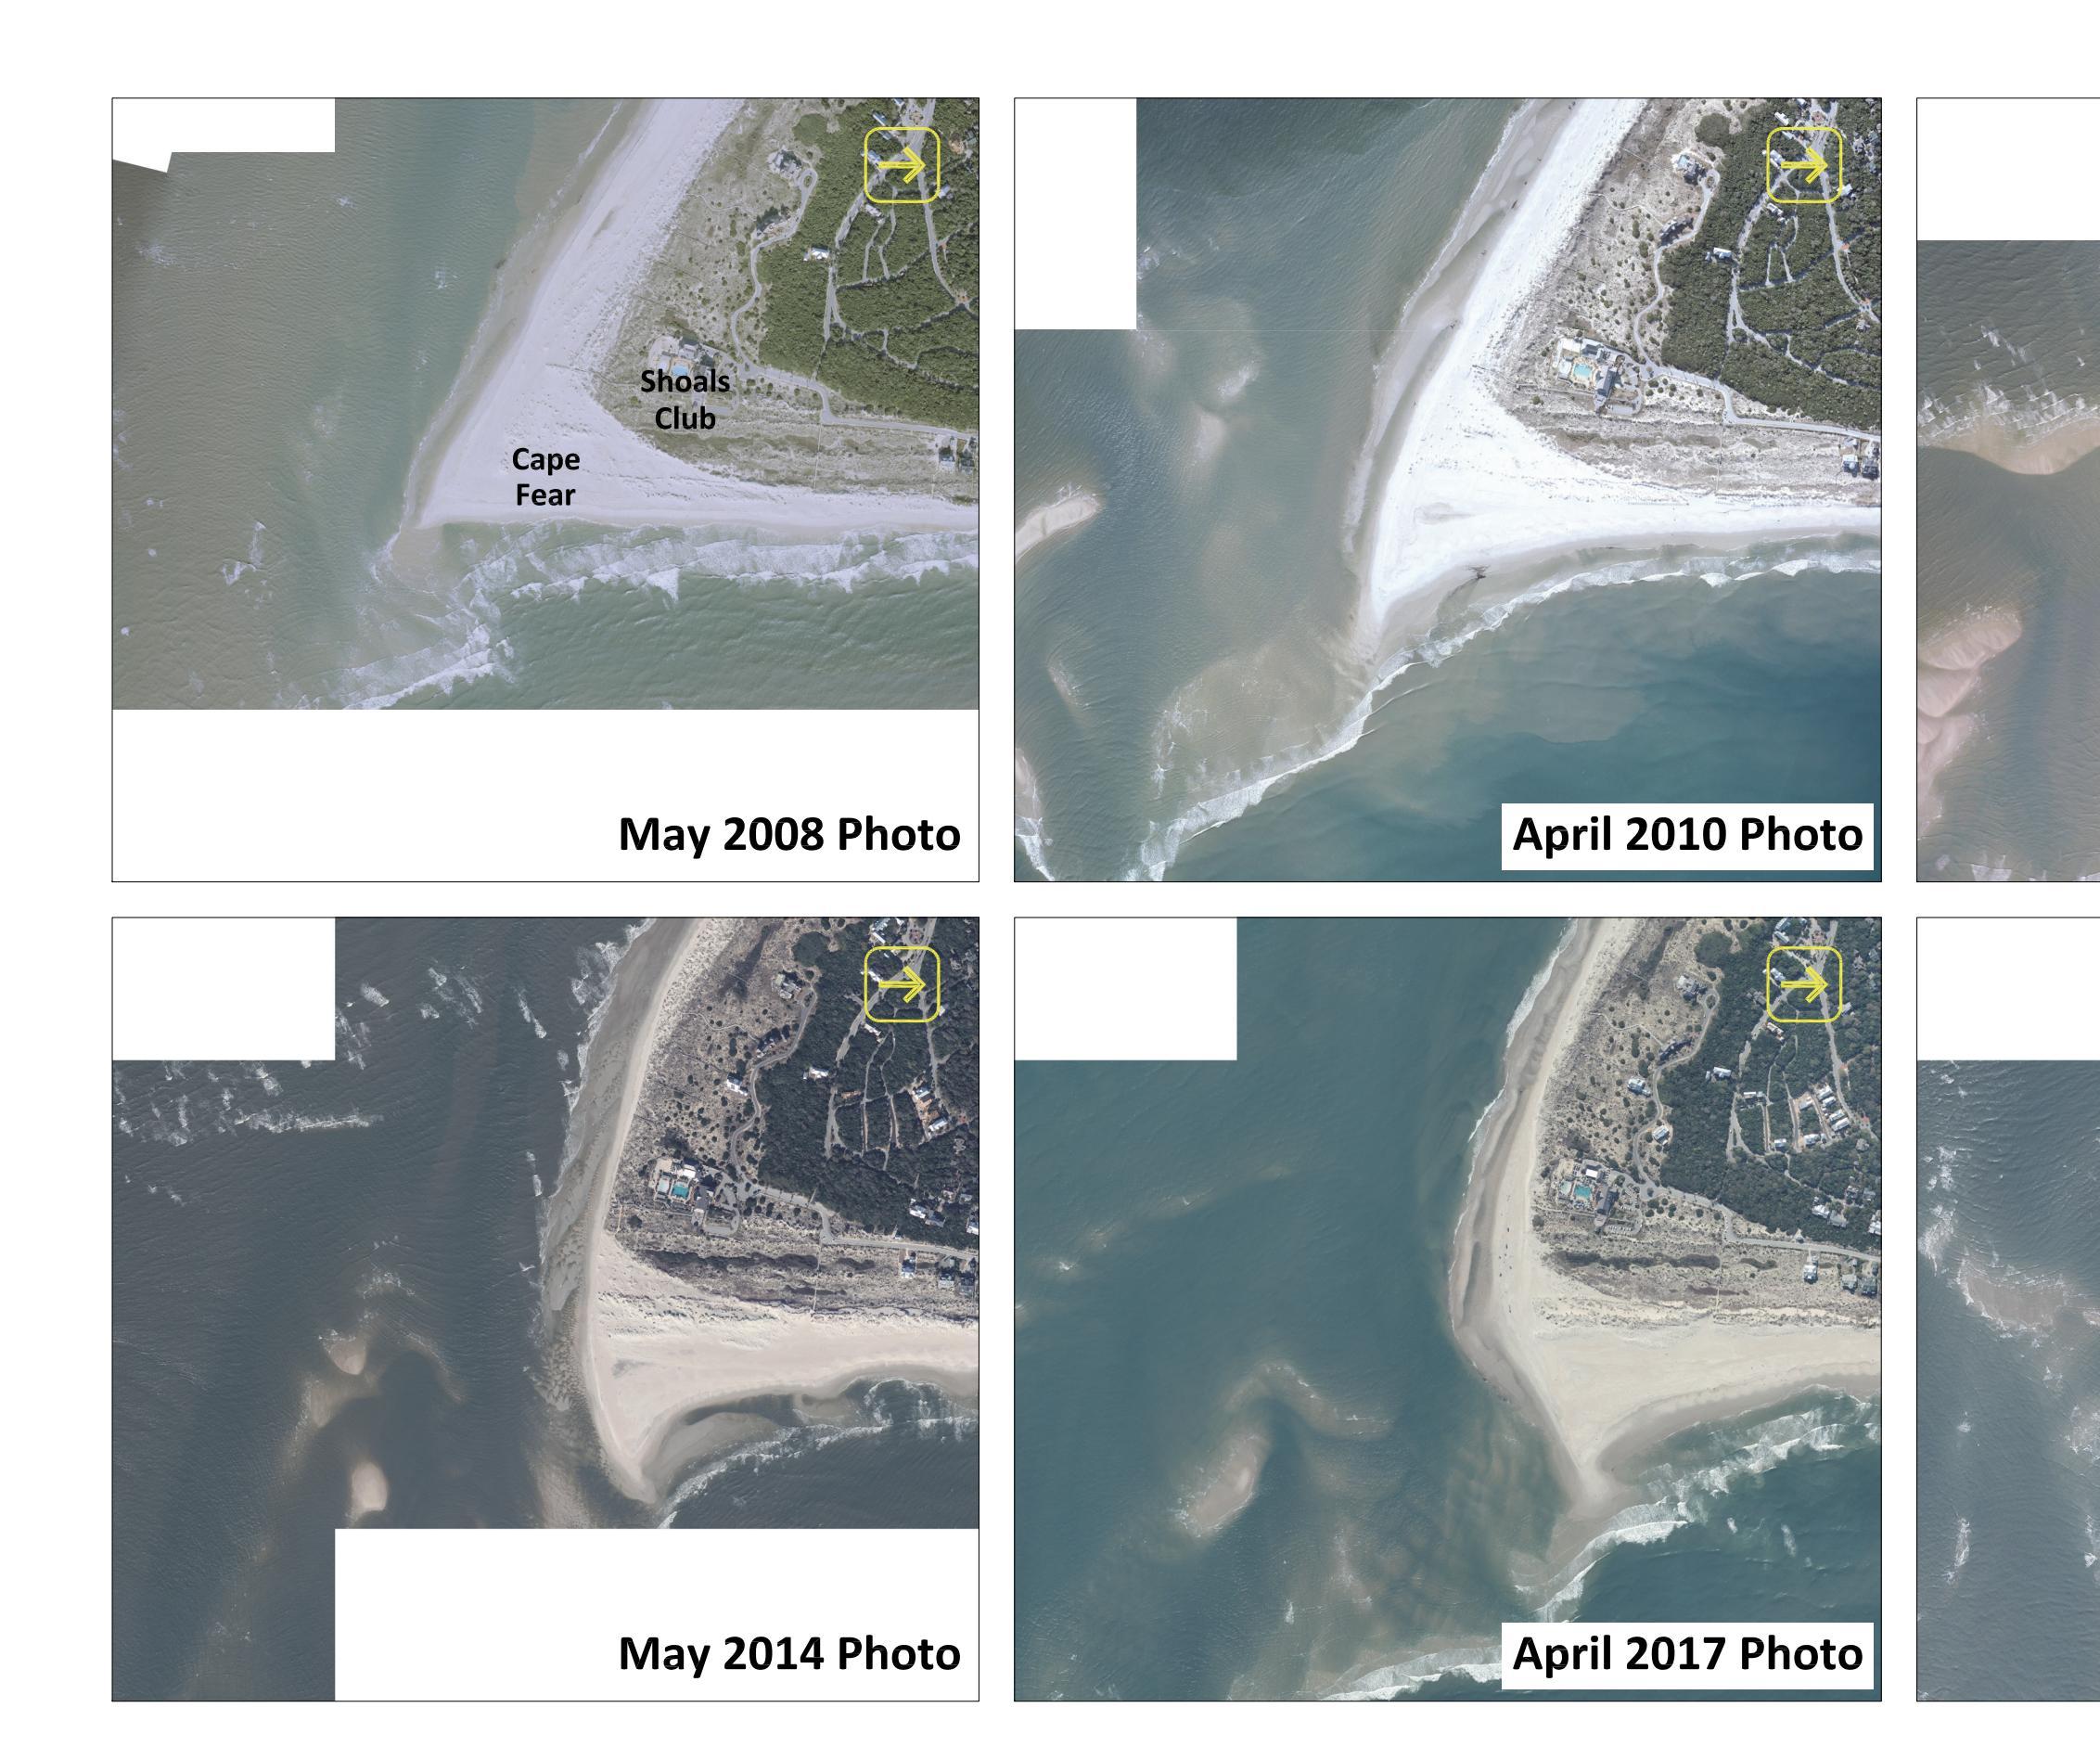
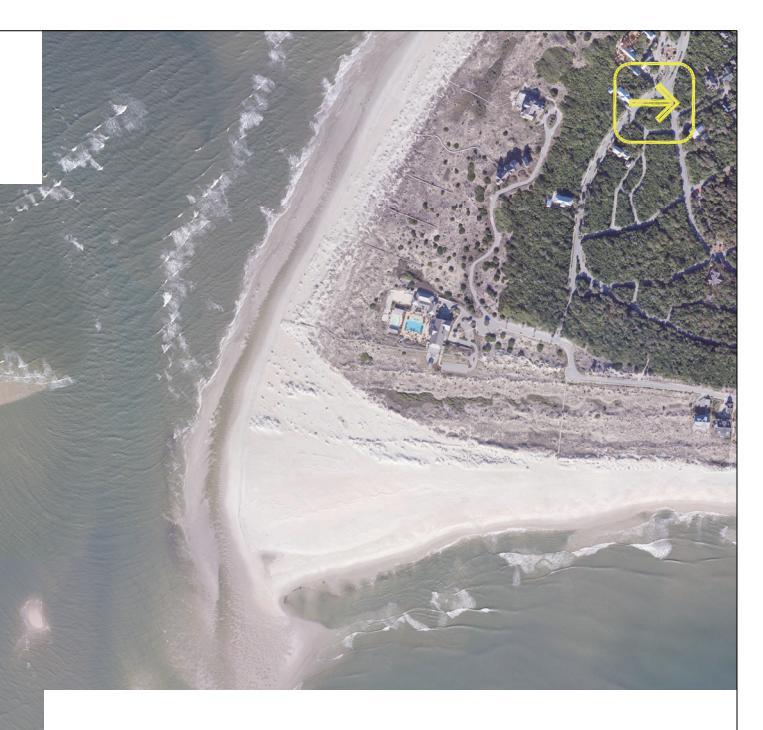
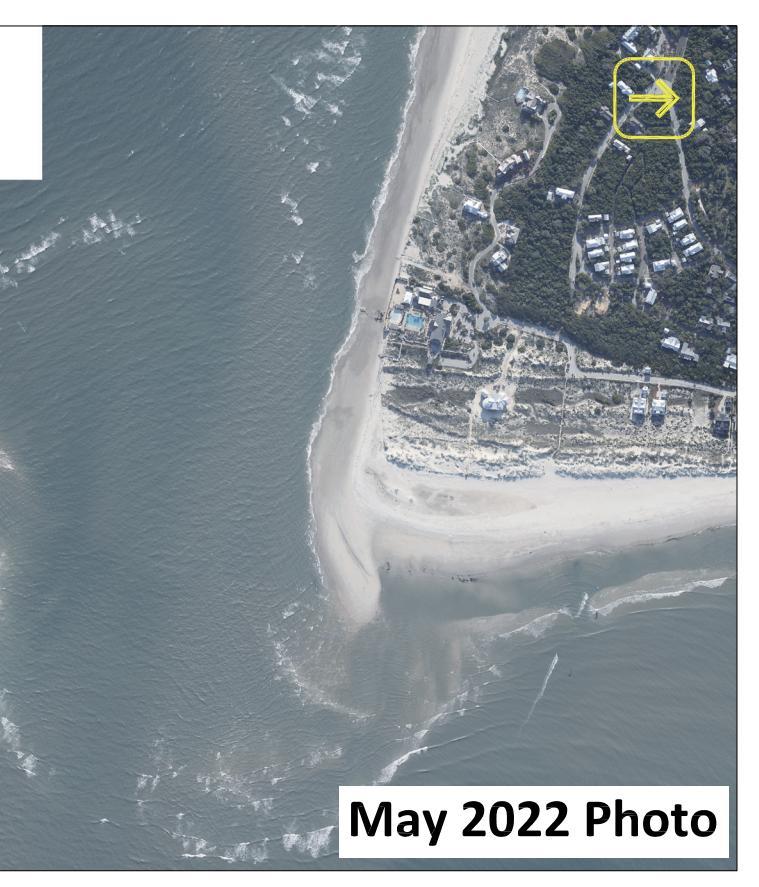
Figure 3.10: Cape Fear aerial photography Bald Head Island, NC

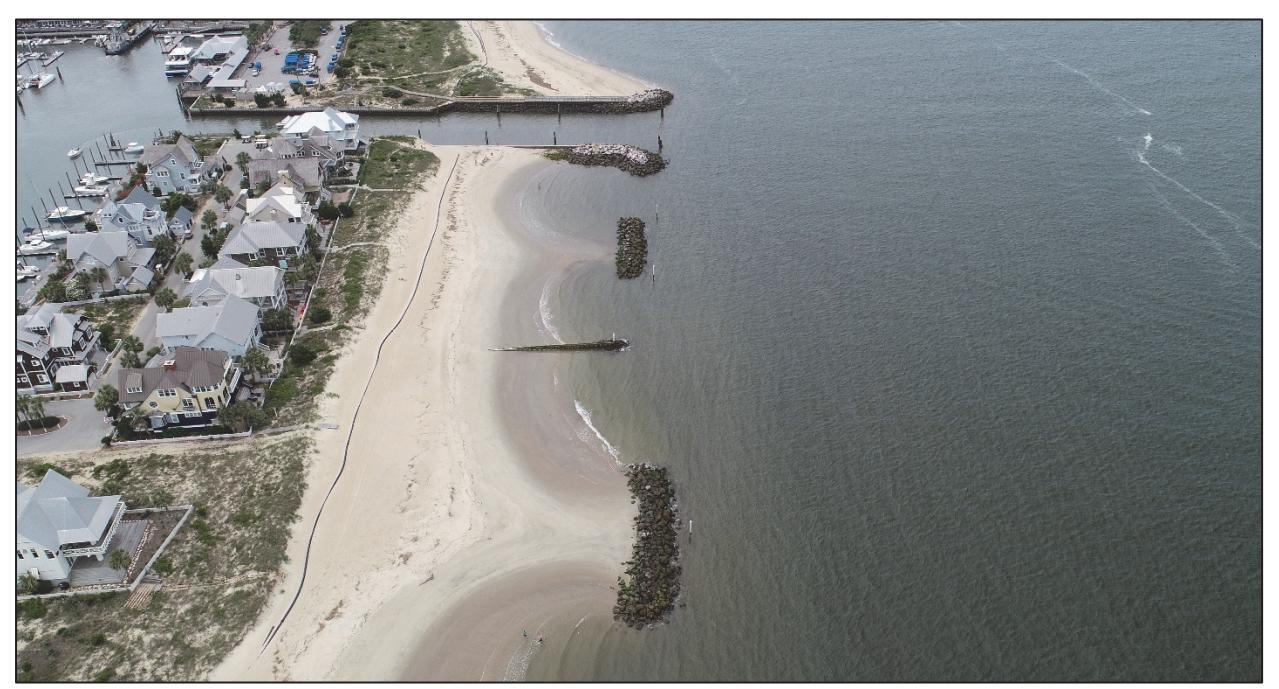
Figure 3.11: Southward looking view of the Row-Boat-Row shoreline detached breakwaters (June 2021 photo).

In early 2017, after completion of a 26,000 cy beach fill placed by Marcol Dredging along the Row Boat Row shoreline, two detached rock breakwaters were constructed by Intra Coastal Marine Construction. Final acceptance of the project occurred in July 2017. Subsequently, the shorefront within the influence of the two shore parallel structures has equilibrated into a series of discrete crenulate features between tombolos which extend from the center of each breakwater in a landward direction (**Figure 3.11**).

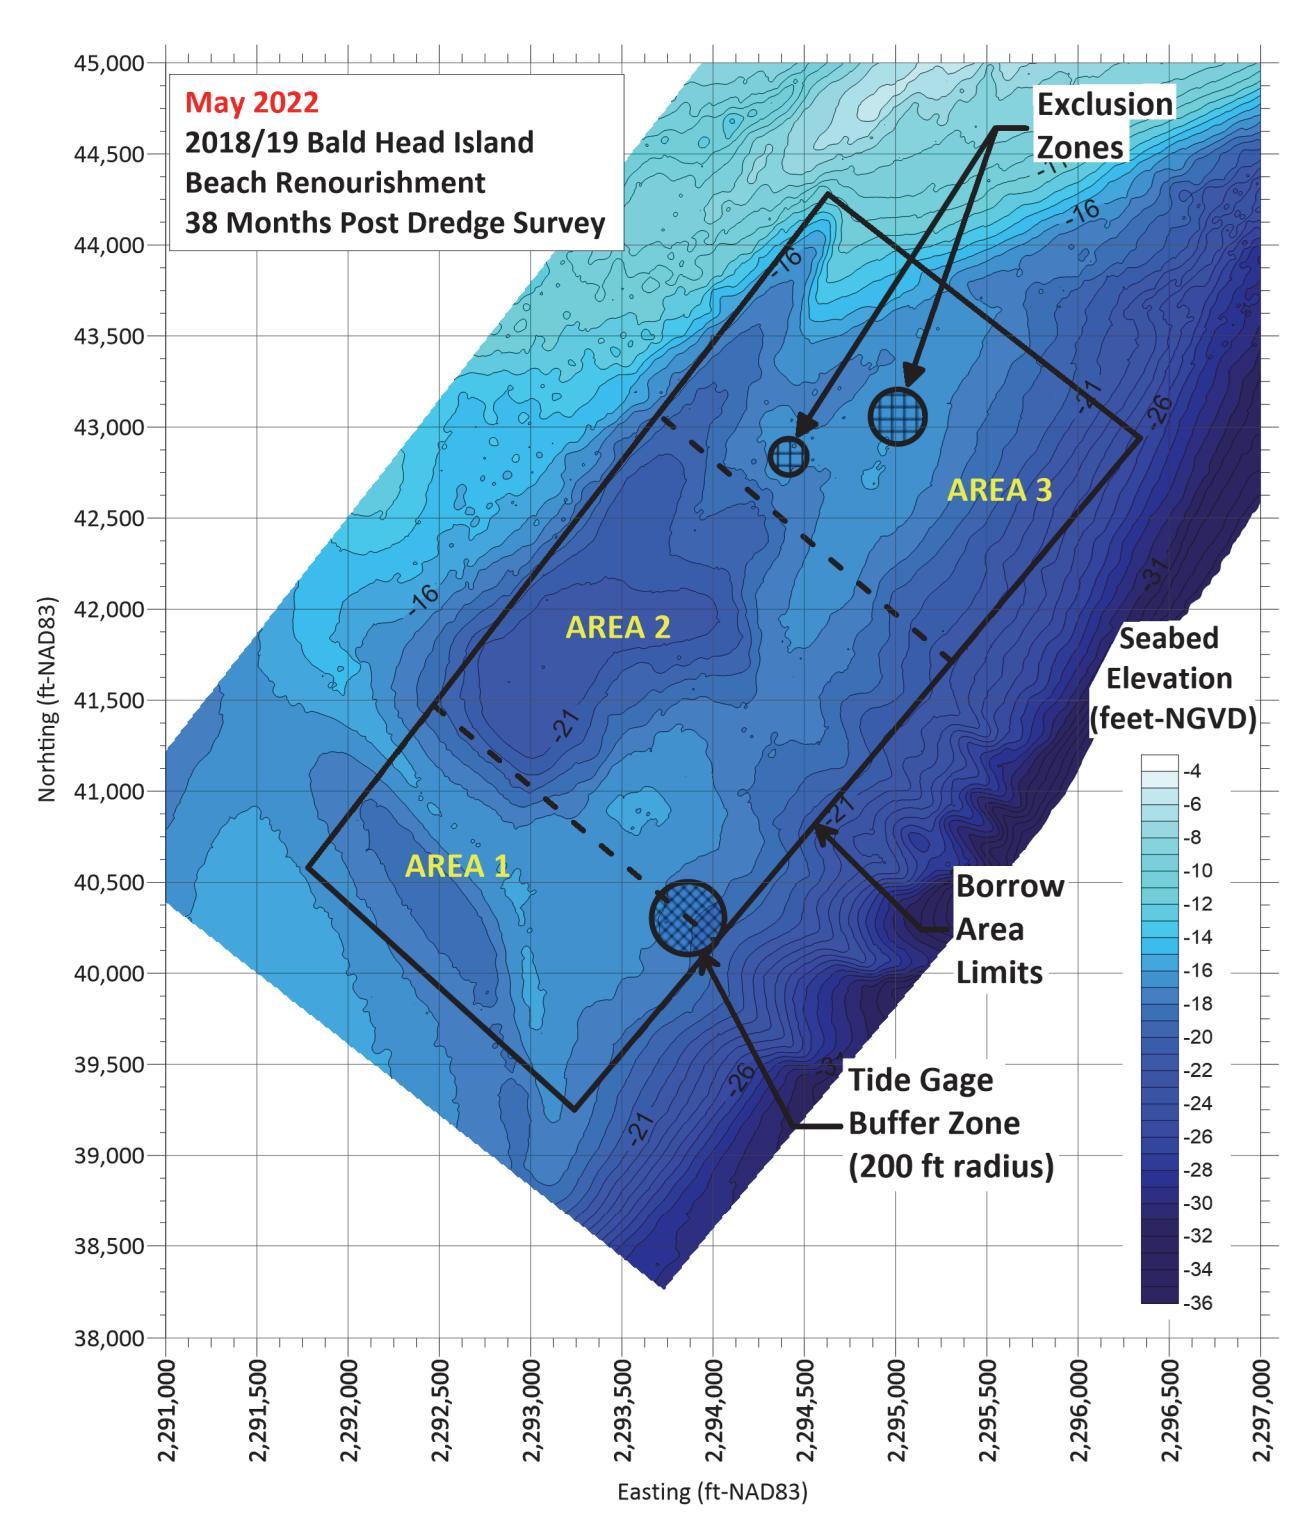
Figure 4.1: Jay Bird Shoals borrow site conditions in May 2022 (38 months post-dredge 2018/19 project).

Figure 4.1 depicts the most recent borrow site (May 2022) seabed elevations. This plot represents conditions approximately 3 years post-2018/19 project and 12 years post-2009/10 project conditions. In the plot, the full permitted borrow area limits are shown. The permitted limits are further subdivided into three sub-areas. For the 2009/10 project, only portions of Area 1 and Area 3 were excavated. For the 2018/19 project, only portions of Area 3 were excavated. Also plotted in the figure are the locations of two dredging exclusion zones¹² (both located in Area 3) and a 200 ft tide gage buffer zone (Area 1 & 2). No excavation was conducted within either the exclusion or buffer zones during the 2009/10 and 2018/19 projects.

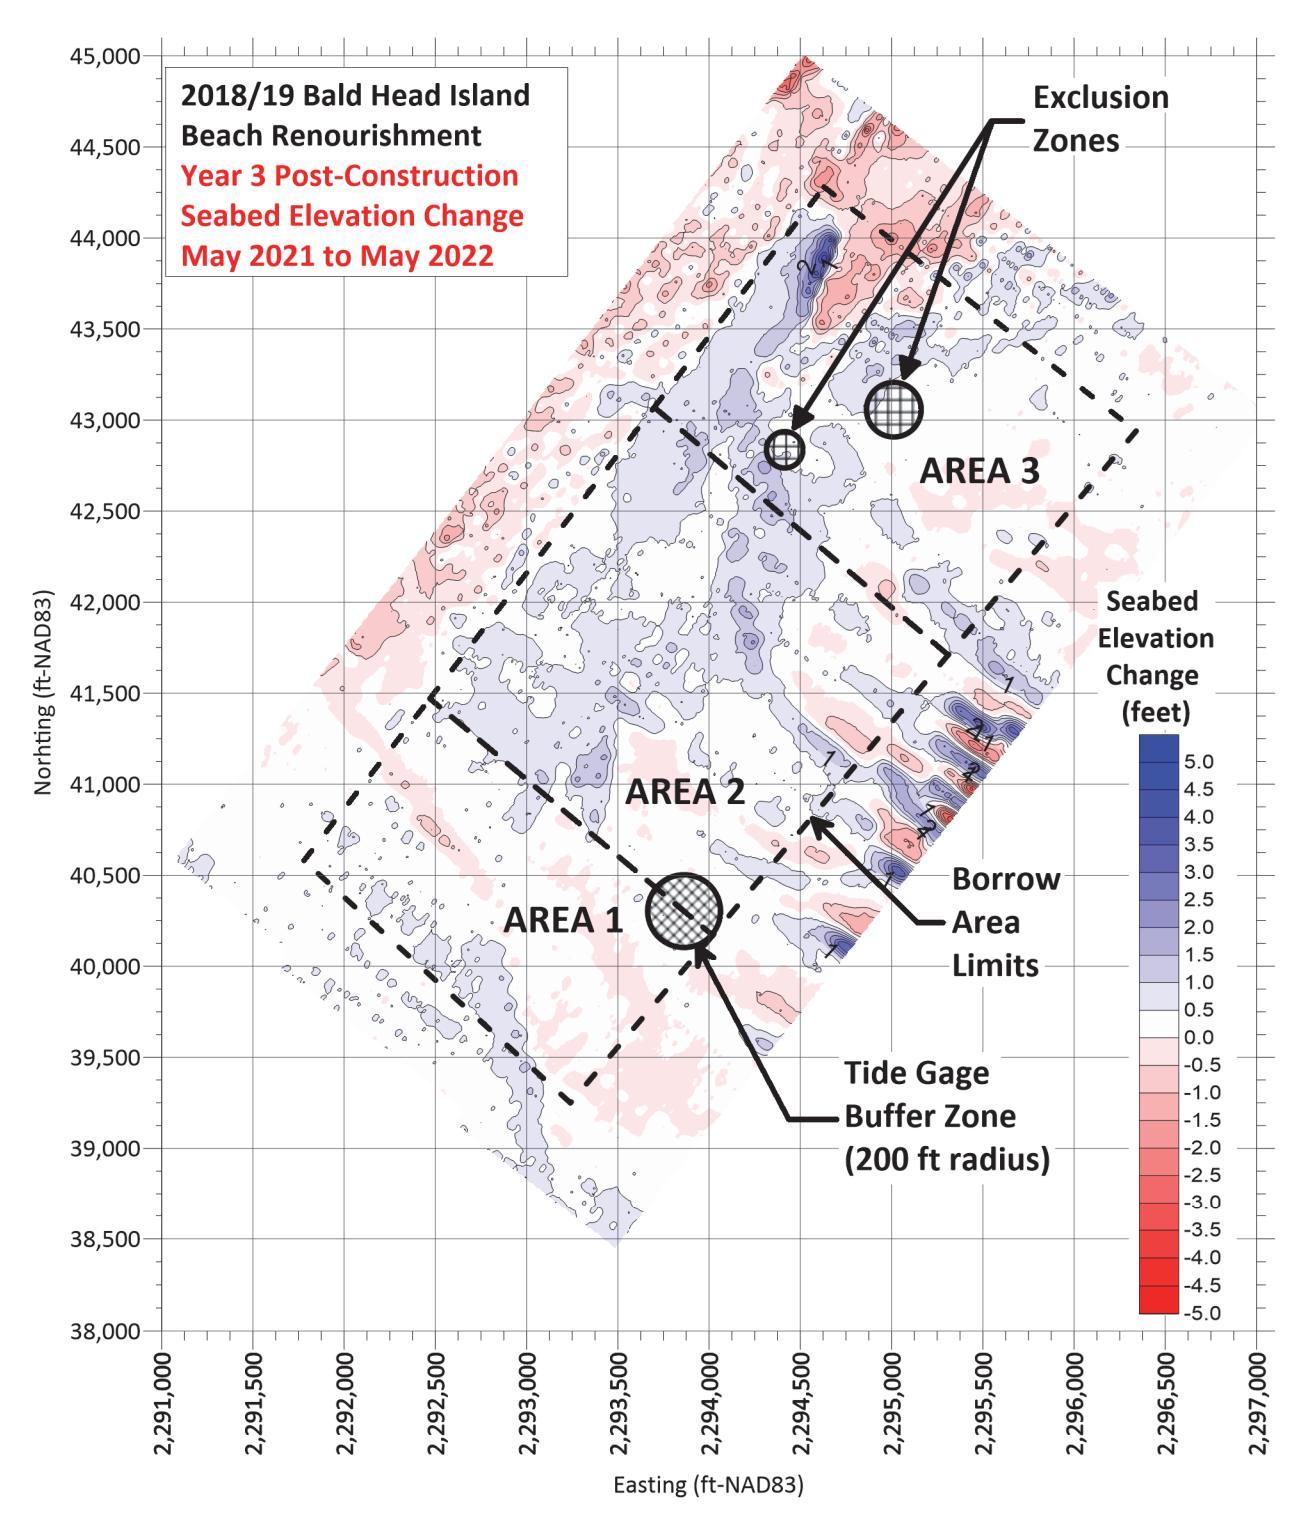
Figure 4.2: Jay Bird Shoals seabed elevation changes during the Year 3 Post-Construction for the 2018/19 project (May 2021 to May 2022).

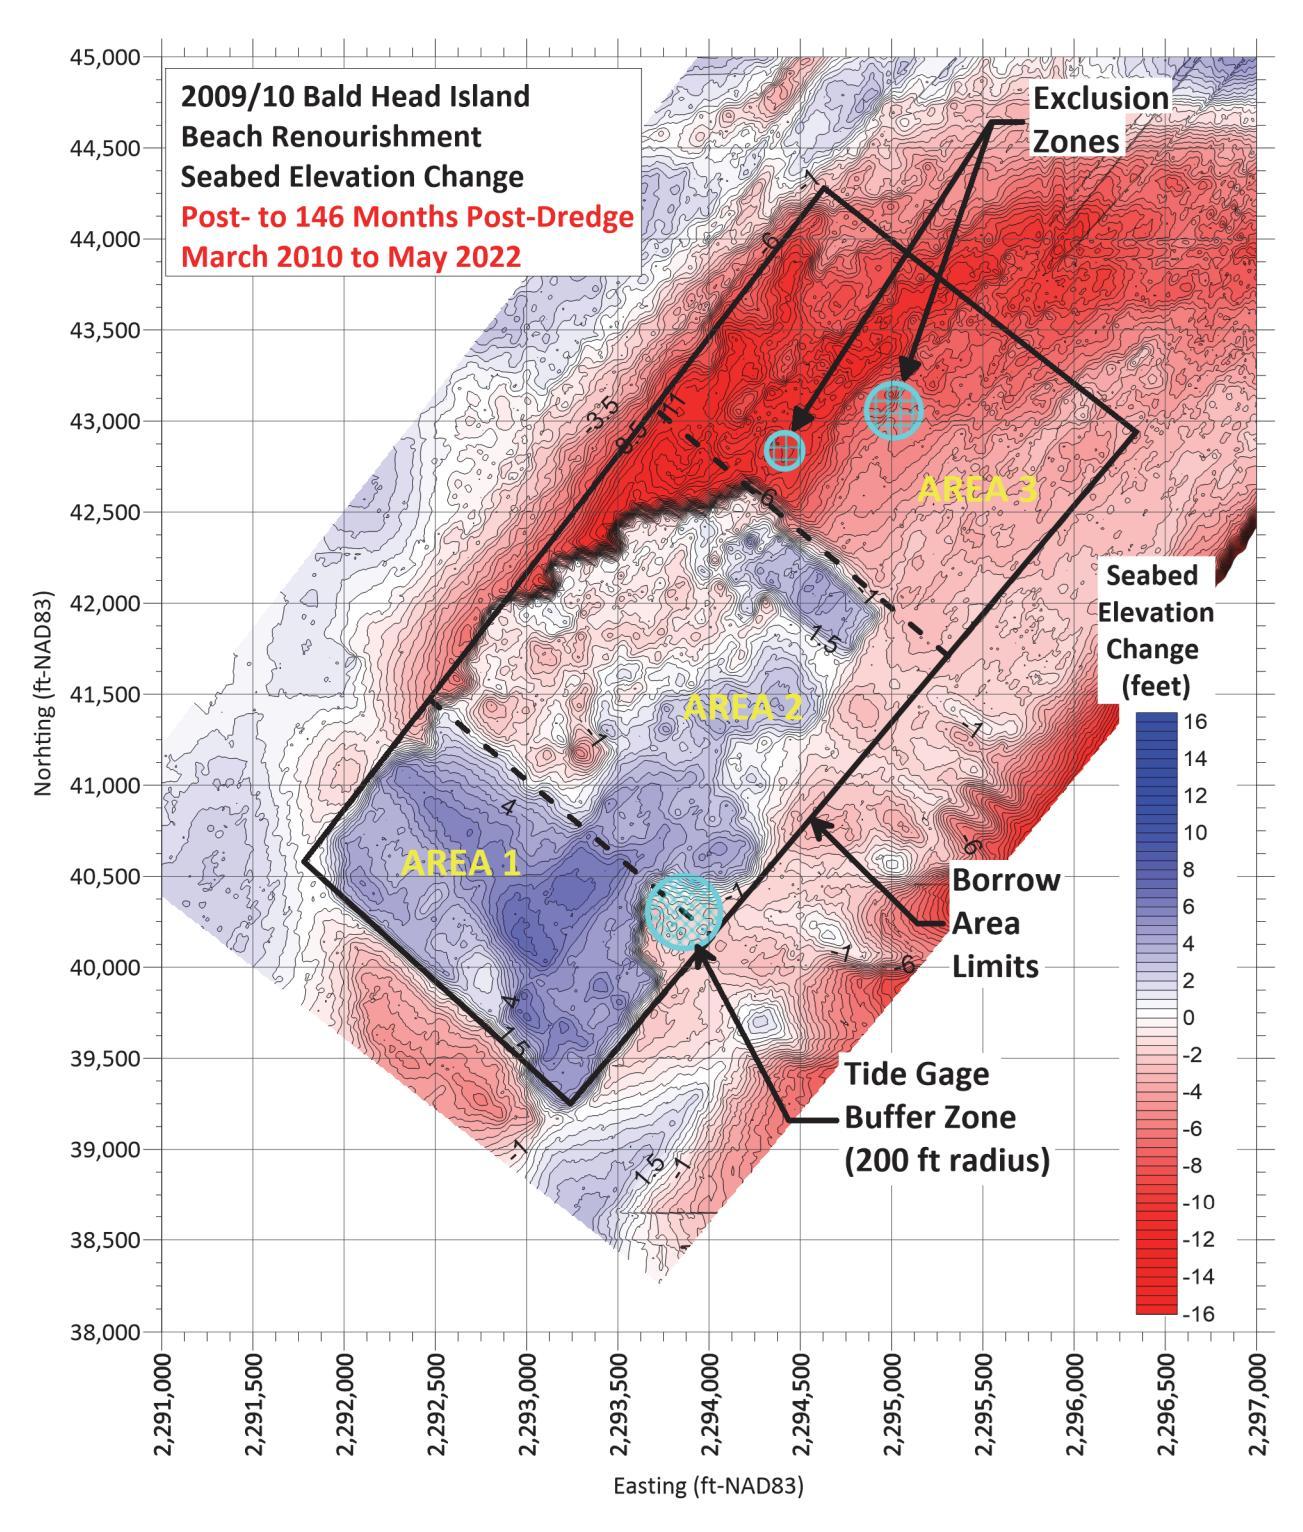
Figure 4.3: Jay Bird Shoals seabed elevation changes since the initial 2009/10 project completion (March 2010 to May 2022).
