Village of Bald Head Island  
Structure Fire Water Flow Brief  
November 20-21, 2021

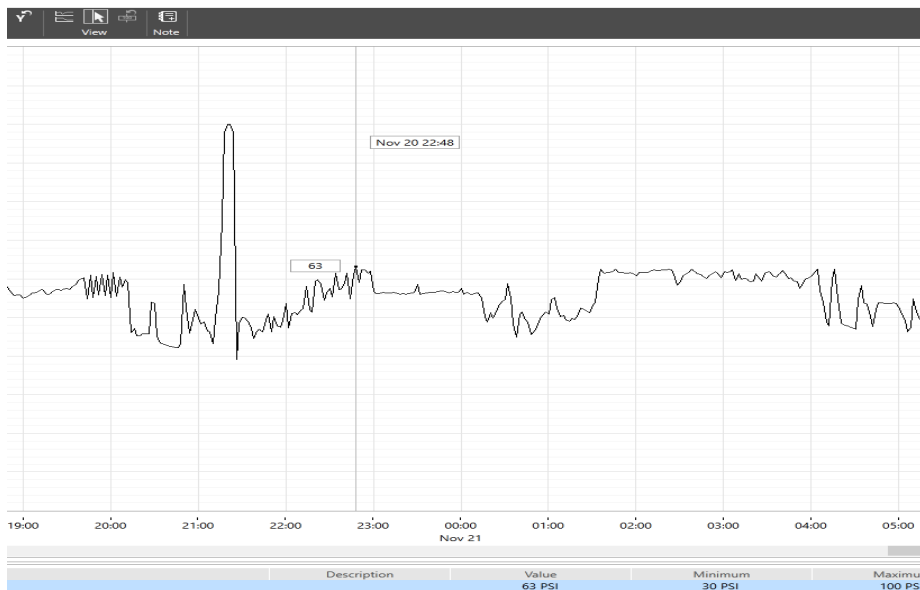
Looking at the SCADA screen graph at approximately 2037 the system water pressure drops to approximately 45psi and maintains that average until the fire distribution pump is engaged. At approximately 2115 the system water pressure increases to 100 PSI where it remained for approximately 5-10 minutes. The fire distribution pump was turned off and the system water pressure went to approximately 50 PSI, plateaued at 63 PSI and then retreated to an average of approximately 57 PSI for the remainder of the event.

Please note, the variations on the attached graph are gauge readings only and need to be interpolated to present system pressures. The water gauge reading fluctuates visually on paper and are reflected as a more constant water system pressure.

Hydrant flow tests proved to be accurate, what affected the water flow at the specific hydrants was the proximity of access that were exercised during the fire suppression process.
